Vanguard Chapter – Oakland County Michigan
Paint Creek Woody Habitat Installation – Phase 2
May of 2022

Overview of Phase 2:

The report and photos show the installed Phase 2 in-stream woody debris habitat structures in a section of the Paint Creek that flows through Rochester Hills, Michigan. These pictures were taken in May of 2022, almost a year after installation, to document how the structures survived the winter and the seasonal spring high water events. This report can be compared to a similar one made after the structures were installed in the summer of 2021.

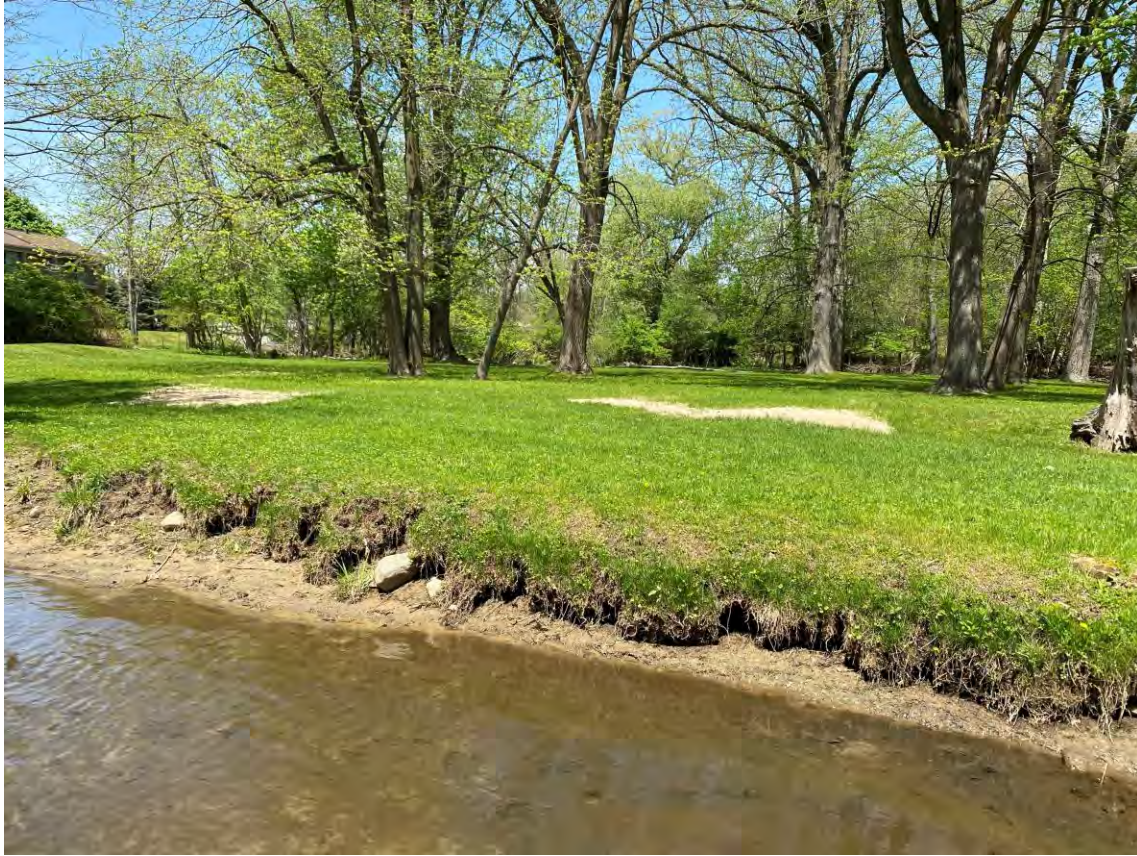
Looking upstream across the “Ox-Bow” where the river crossed and deposited sand as it receded back to the natural creek bed.

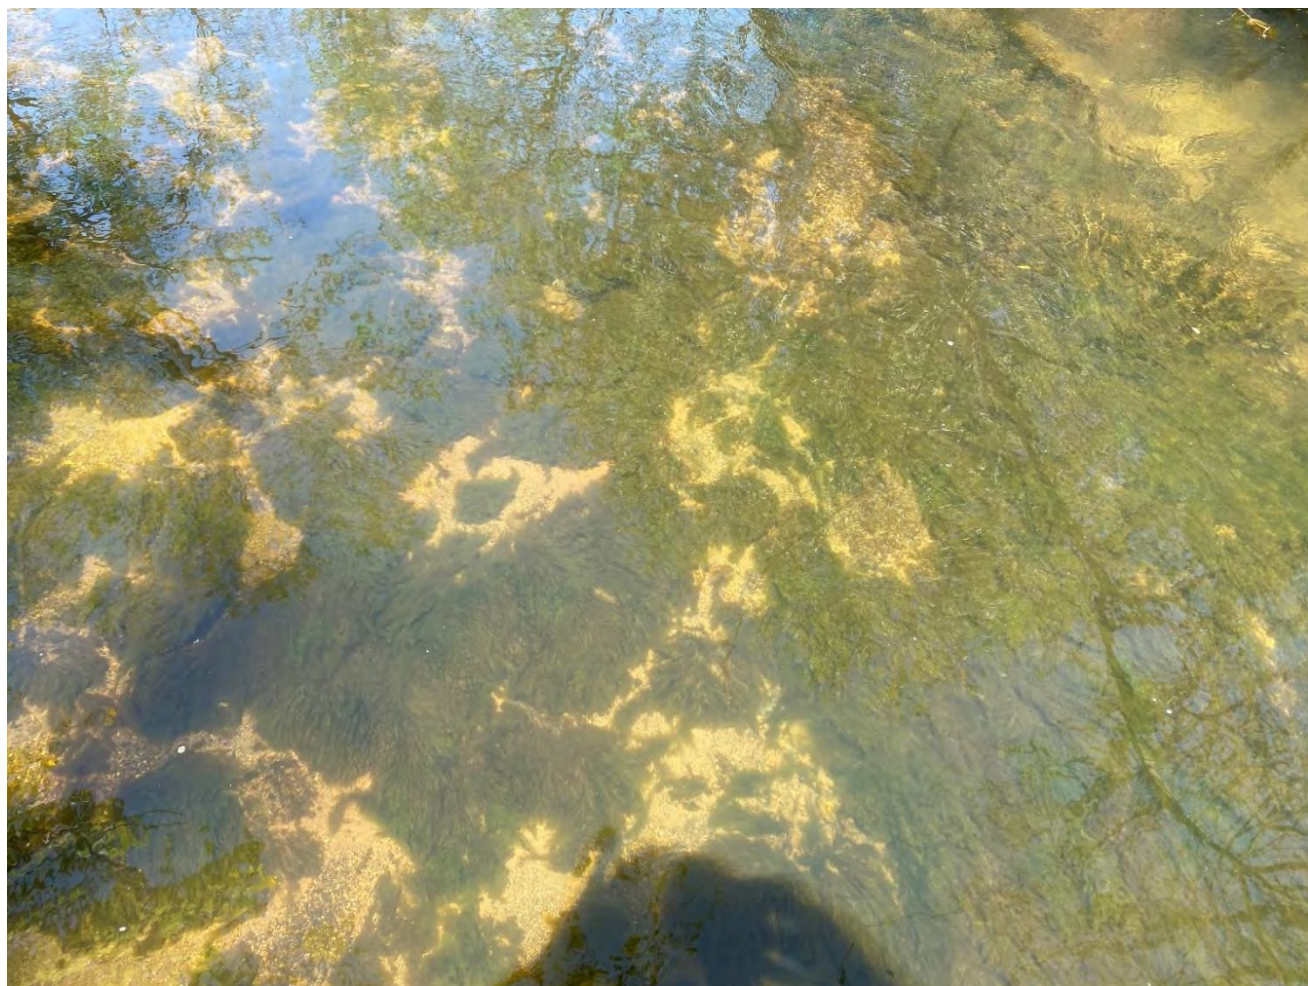
A picture of the heavy algae slime found on all the rocks this year.

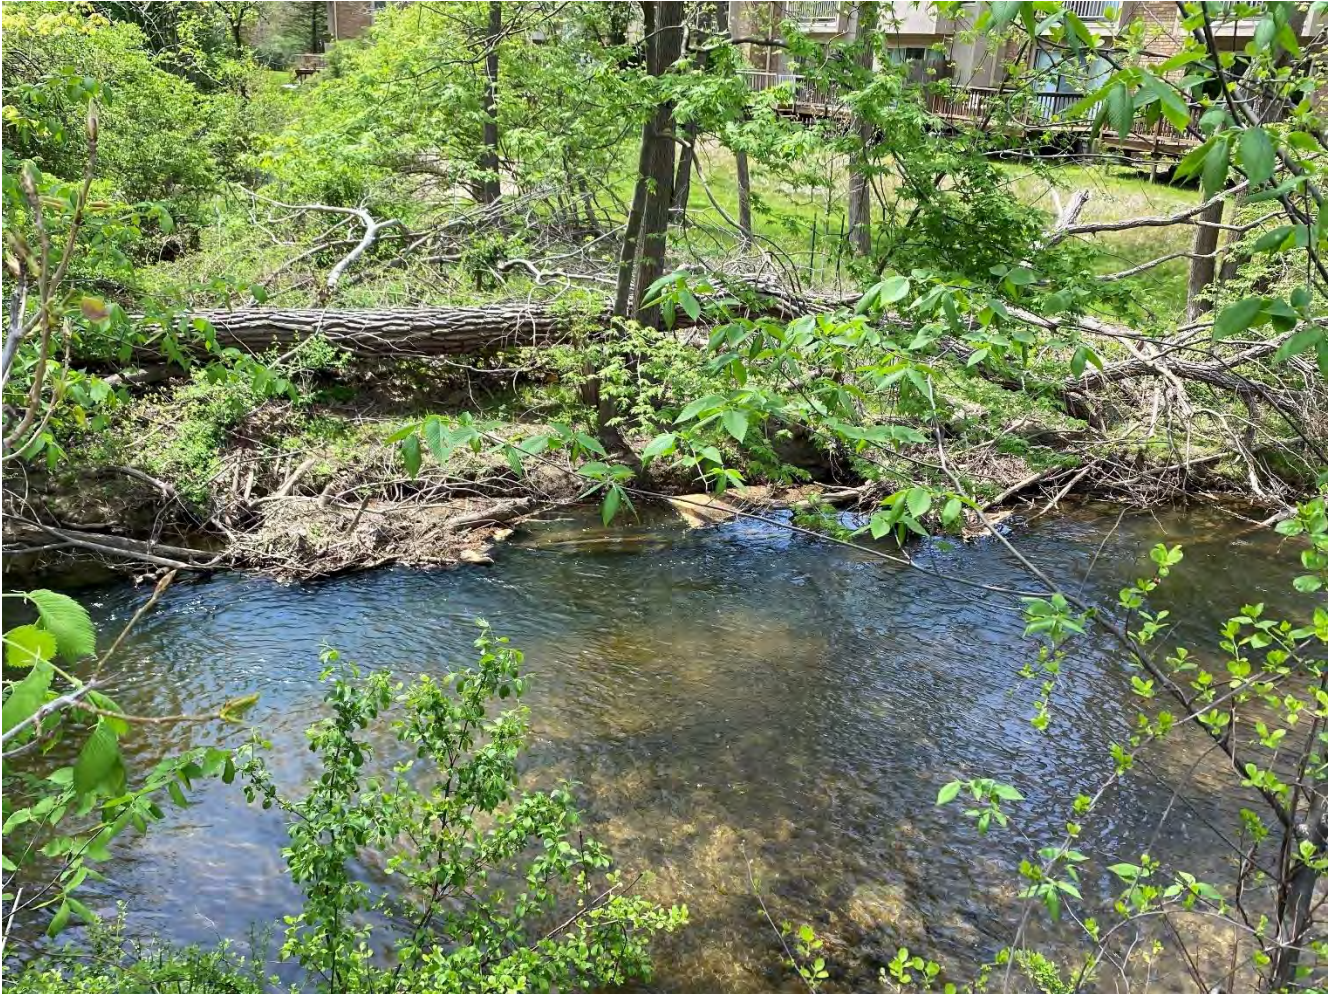
Habitat Structure 1 – Logs were placed parallel to the current flow and along the curve in the creek providing a deep hole for fish habitat and bank protection. In this picture you can see some of the underwater logs that were installed in 2021. A large tree has fallen over some of the in-stream structures creating additional in-stream habitat.

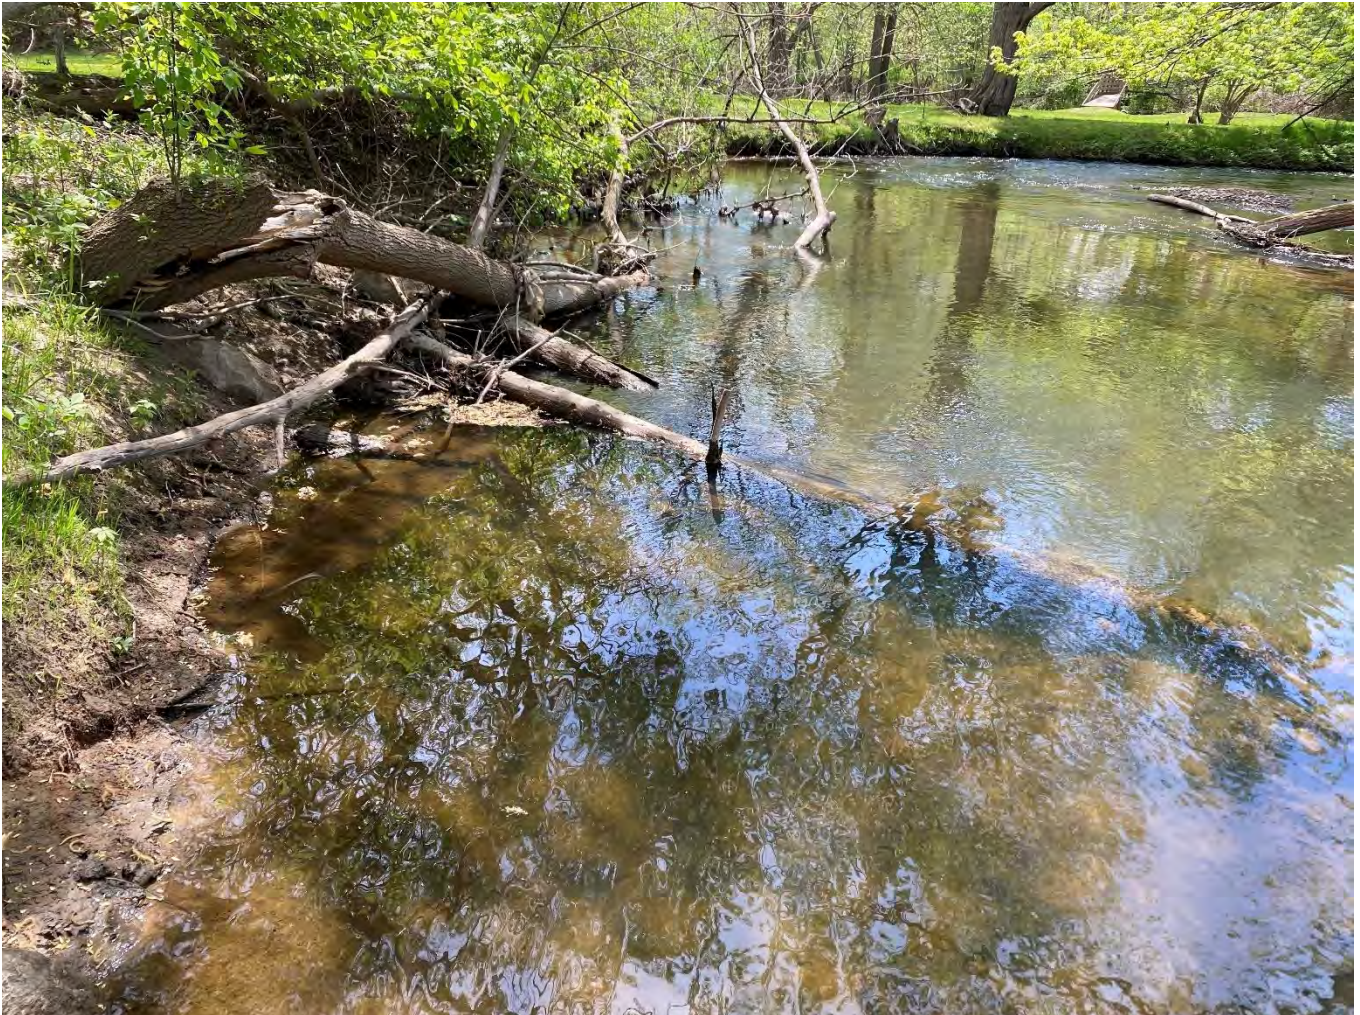
Habitat Structure 2 – Log vanes were installed on an eroding bend just below Structure 1. The large tree above the structures was blown down possibly by the same wind that took down the tree by Structure 1.

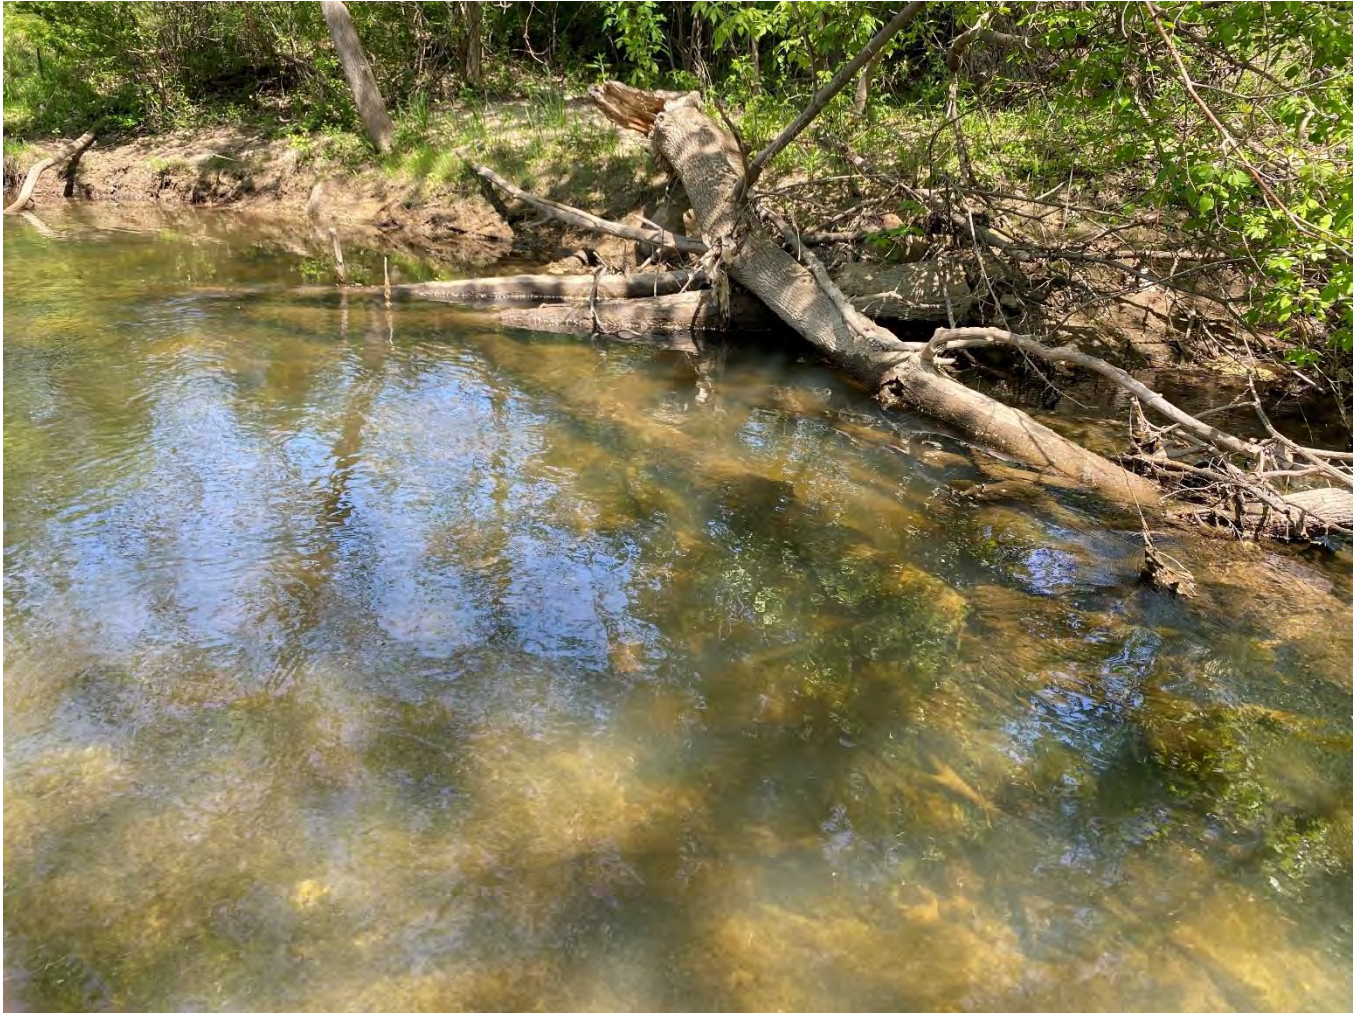
Habitat Structure 3 – An underwater log was installed just below habitat Structure 2. It runs parallel to the creek flow to provide fish habitat. It was also somewhat covered by the fallen tree.

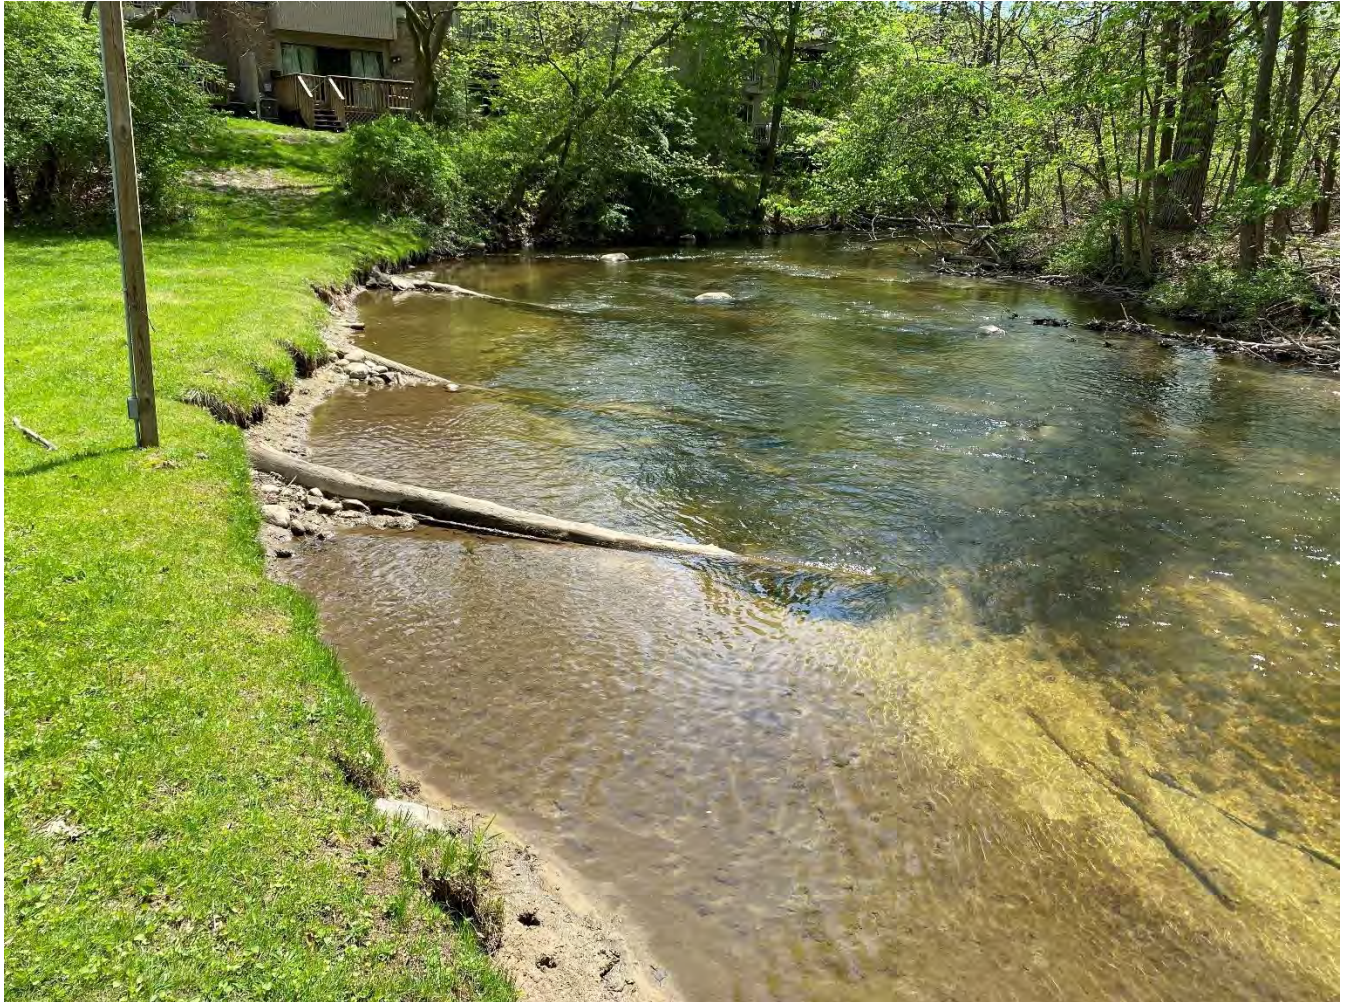
Habitat Structure 4 – Three vanes were placed in a high erosion area to build up the bank and to create more stream center flow. You can see the silt & sand buildup along the bank they are creating.

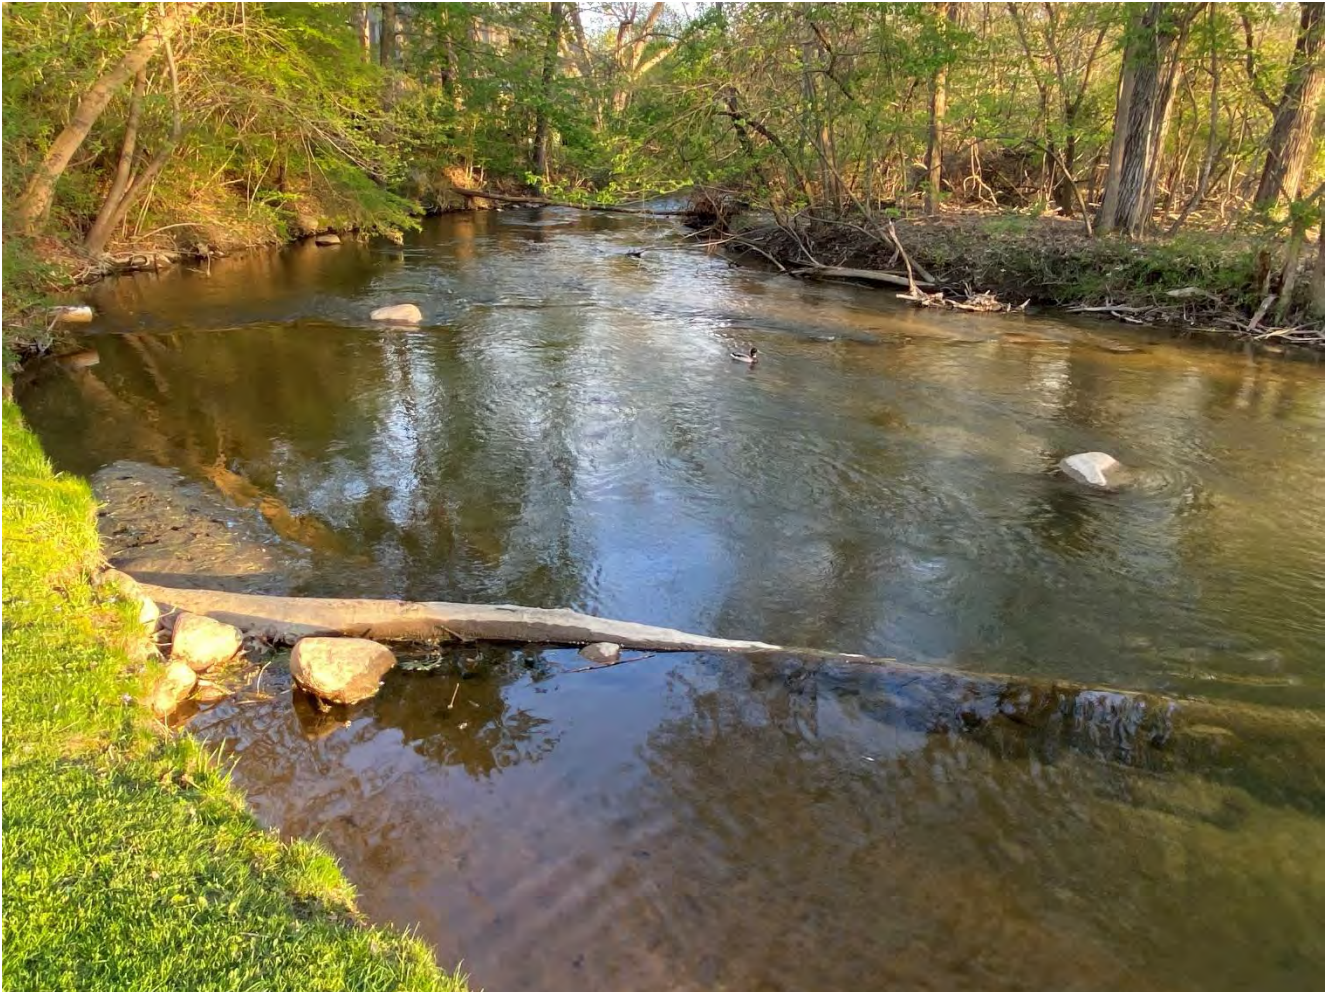
Habitat Structure 5 – A small rock dam just below the third vane was opened in the middle to promote greater center flow. You can still see some remaining rocks on either side. This rock dam removal also helped eliminate the creation of a full sun shallow pool that heated up the water. Note the shoreline silt buildup behind the Vane.

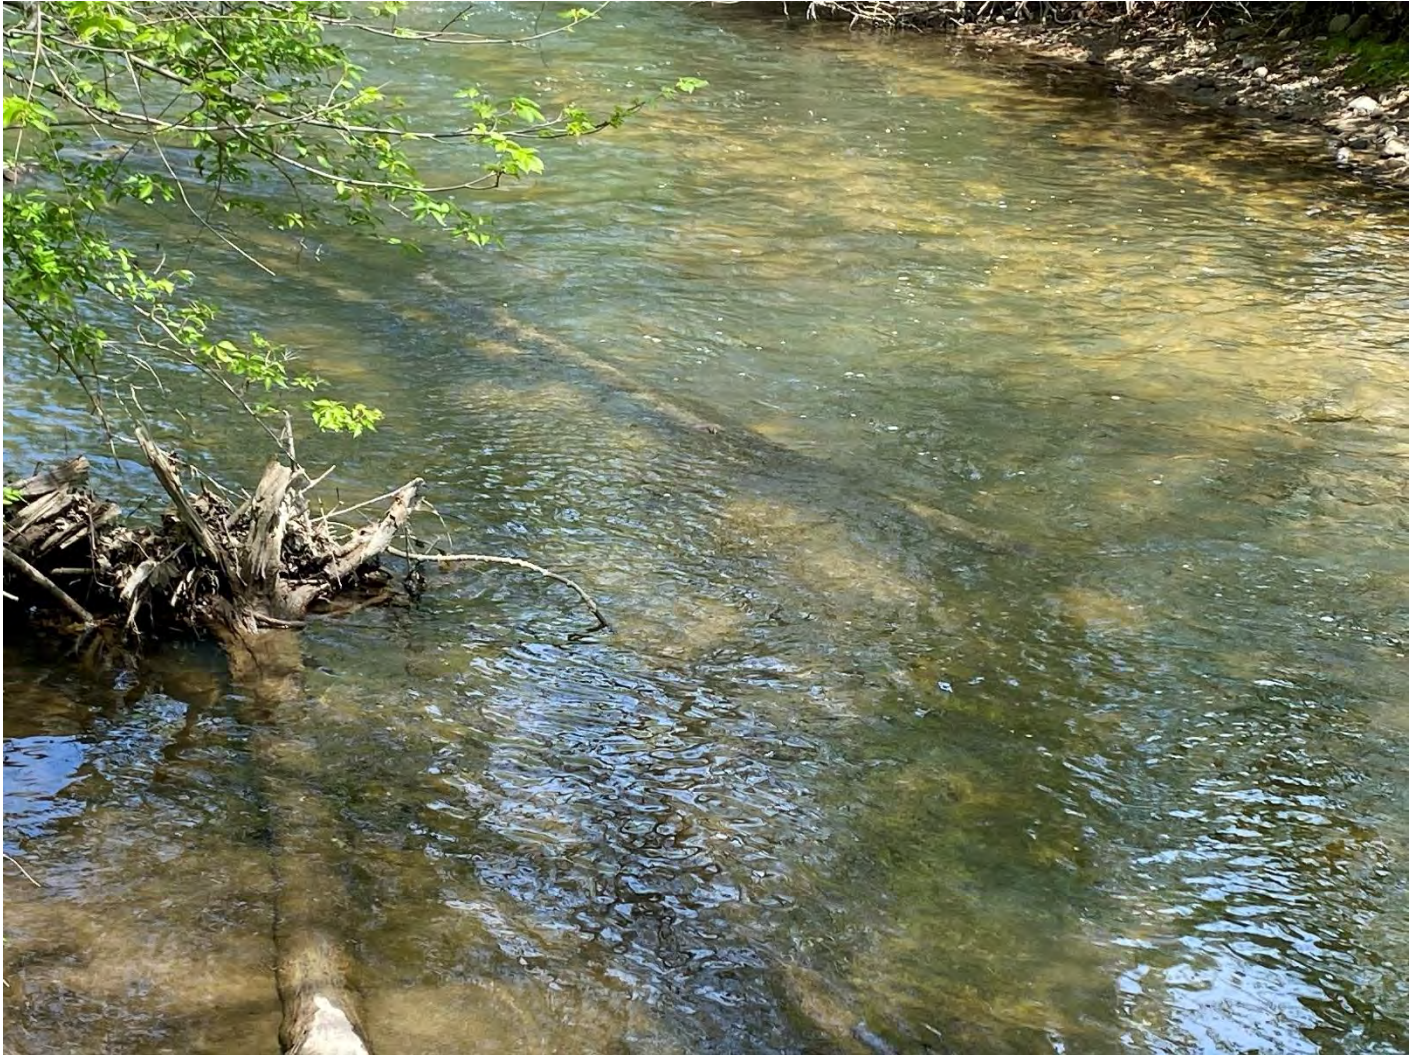
Habitat Structure 6 – A log structure was installed just below habitat Structure 5, the opened-up rock dam. This log provides in-stream fish cover and runs parallel to the creek flow.

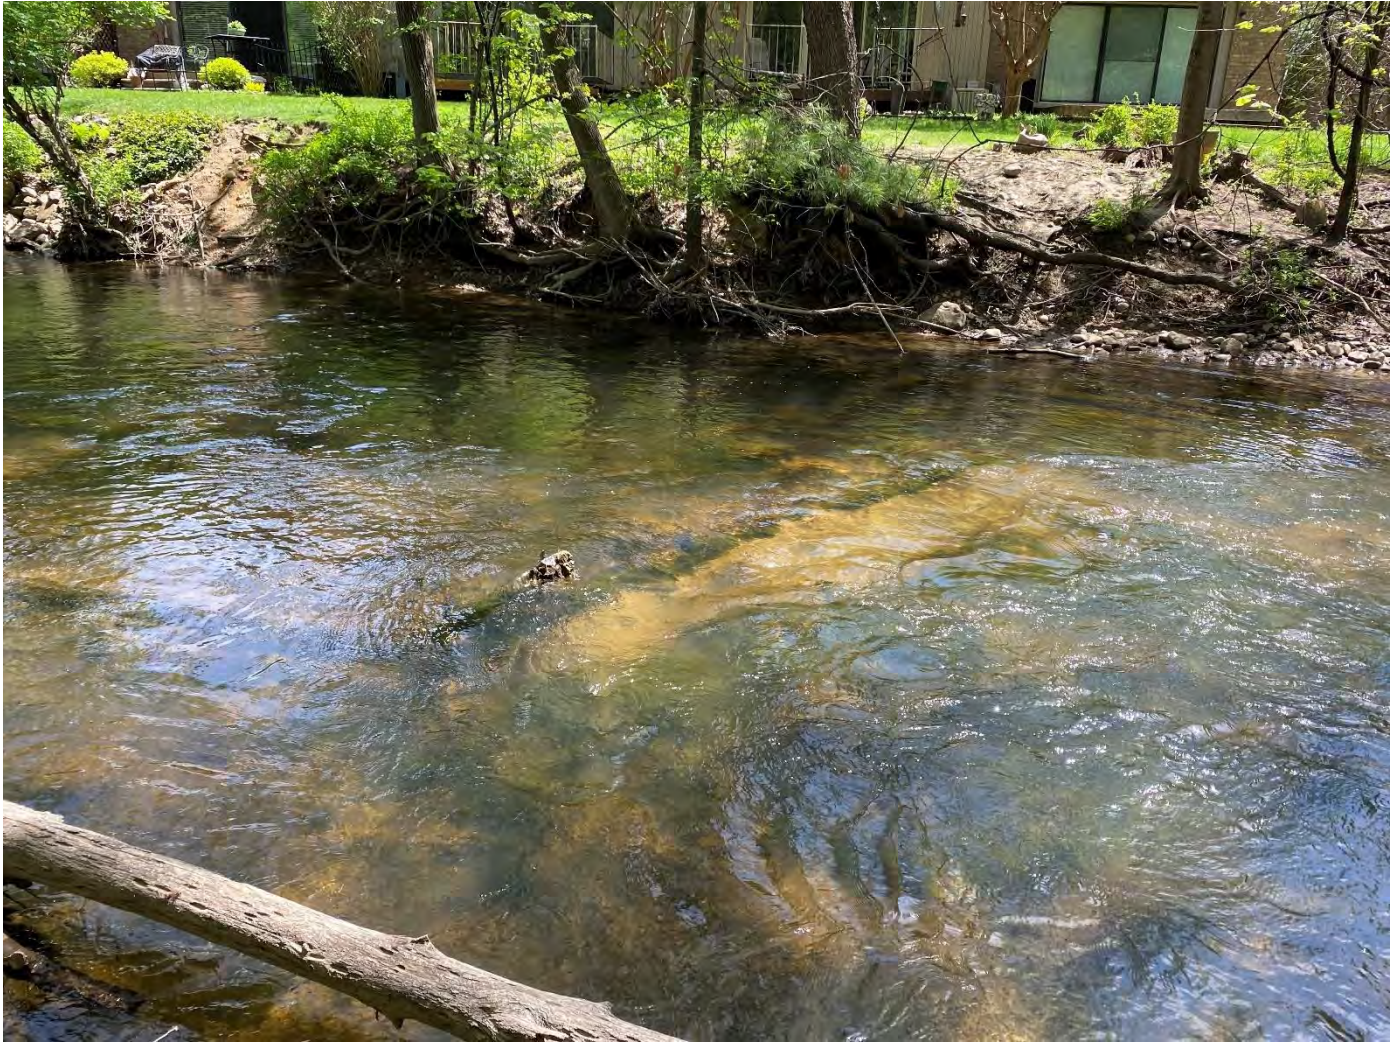
Habitat Structure 7 – A log structure was installed across the stream flow to provide cover and riffles in a slow flow area. Note the deeper pool that has formed downstream of the log.

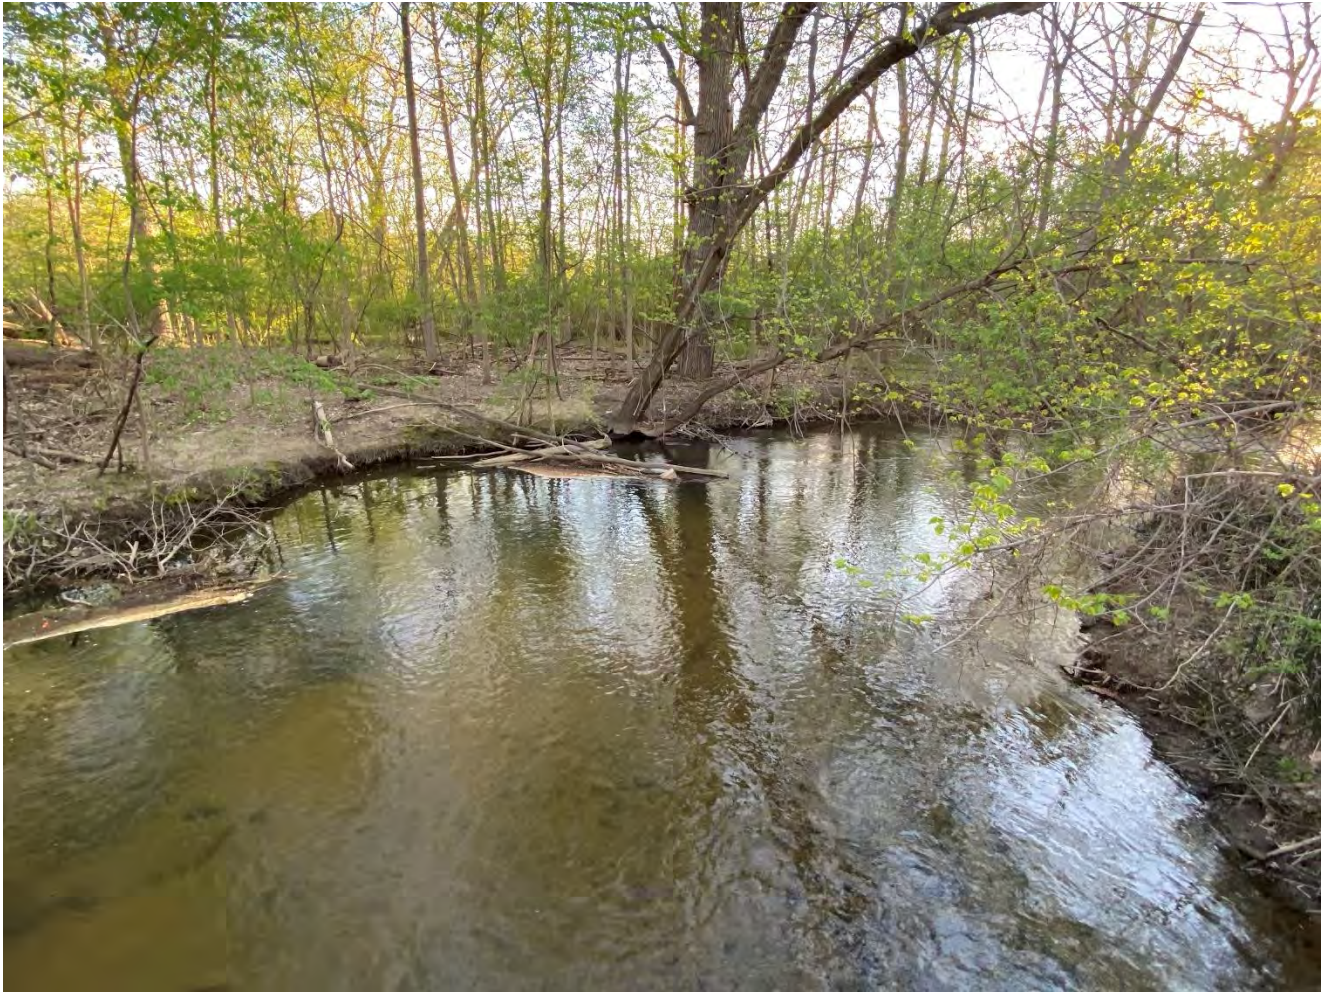
Habitat Structure 8 – Logs were placed in-stream along an eroding bank curve to protect it from further erosion during high water and to provide some in-stream habitat in the deeper pool area that was at the bend. Some drift logs have lodged themselves above the in-stream structure.

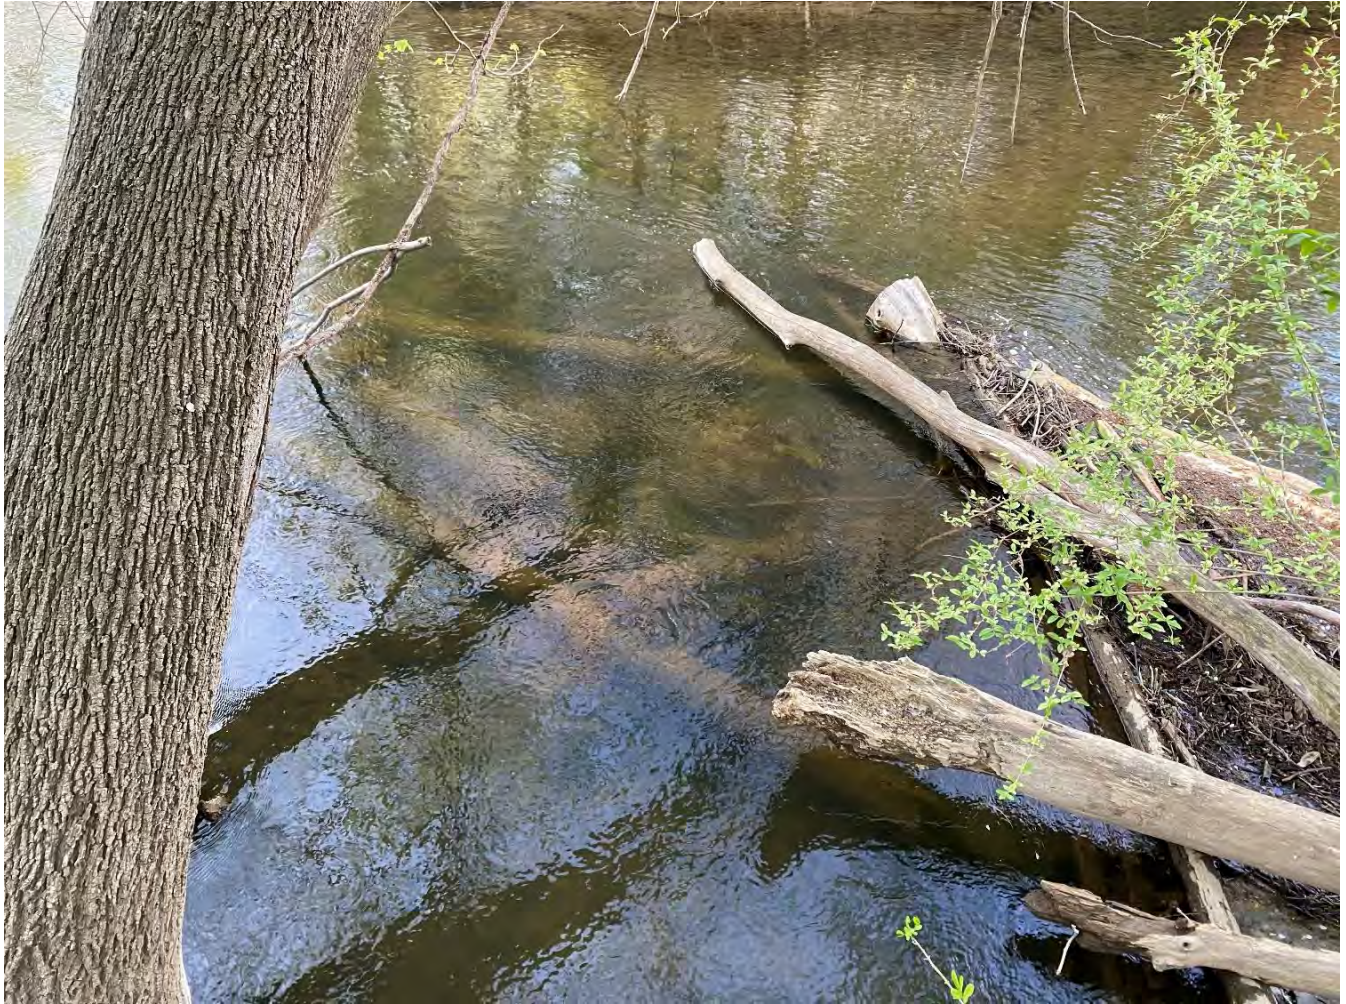
Habitat Structure 8 – Another view of the logs placed in the deeper pool to protect the bank and to provide in-stream habitat.

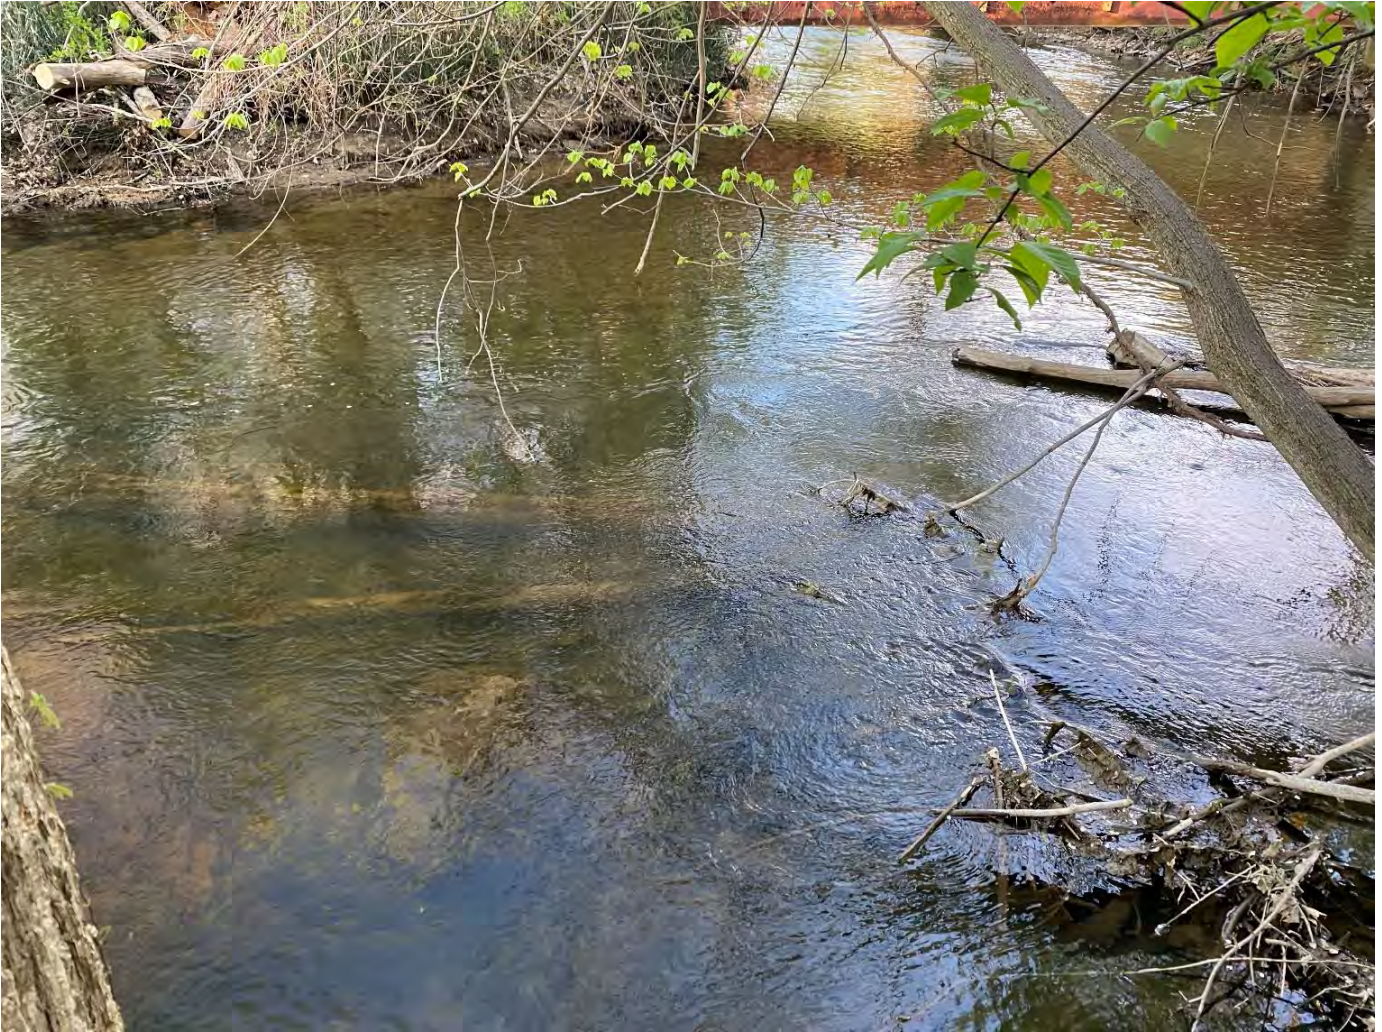
Habitat Structure 9 – In-stream logs were anchored to the creek bottom just above the sandbar and deep pool. These logs are just below Habitat Structure 8, and at the top end of another pool to provide in-stream cover.

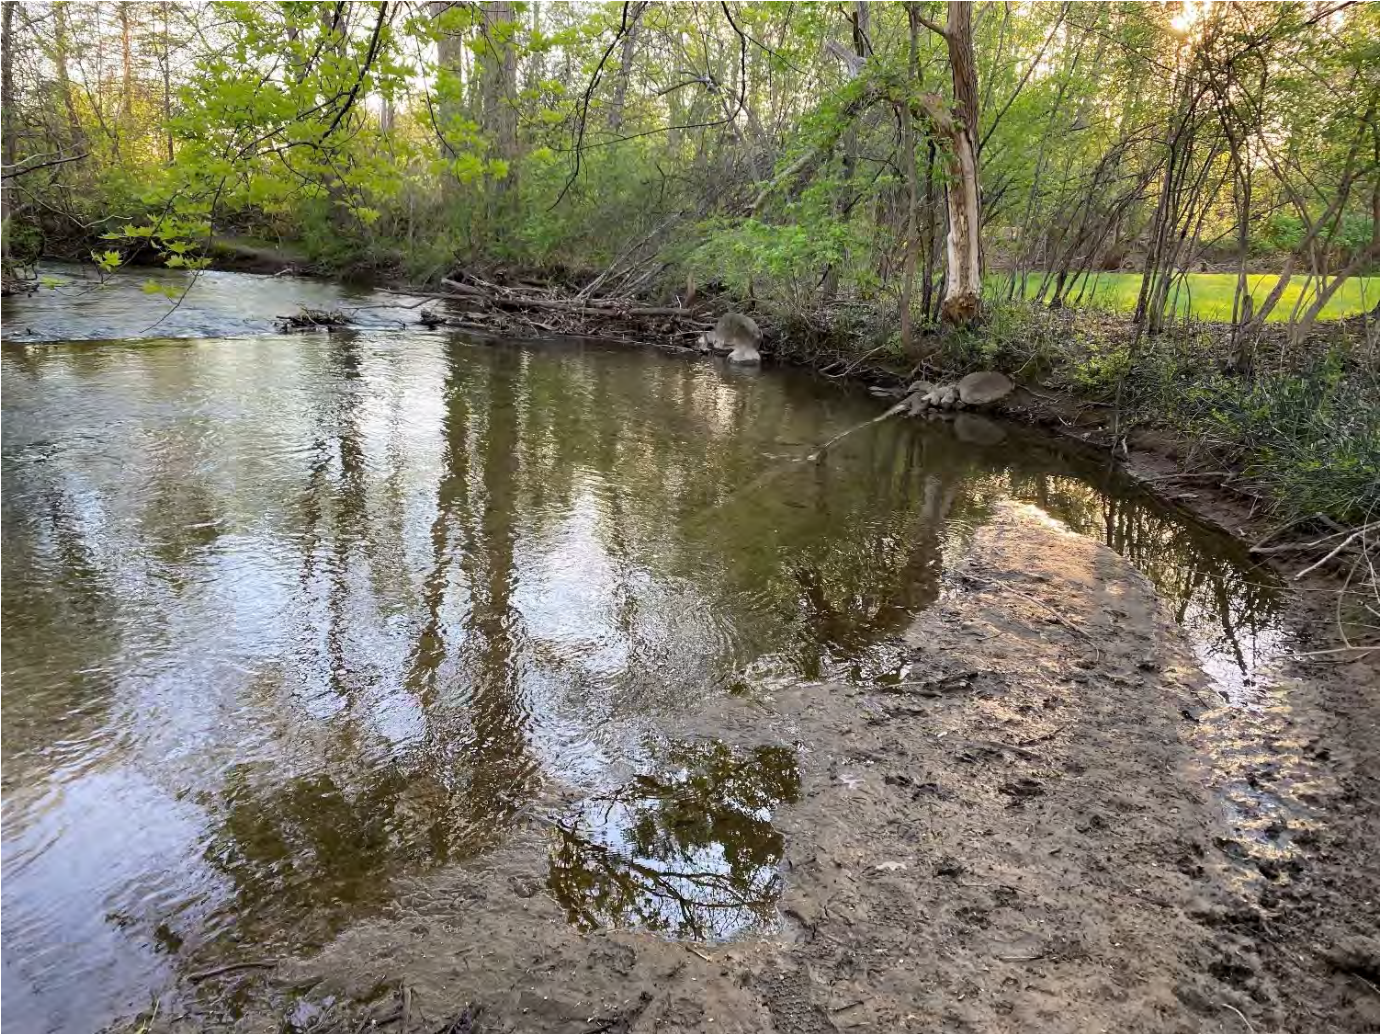
Habitat Structure 10 – This vane was installed to protect and build back an eroding bank. This location is just below Habitat Structure 9. The position of this vane also improved the center flow of the creek. Note the significant sand & silt buildup along the bank.

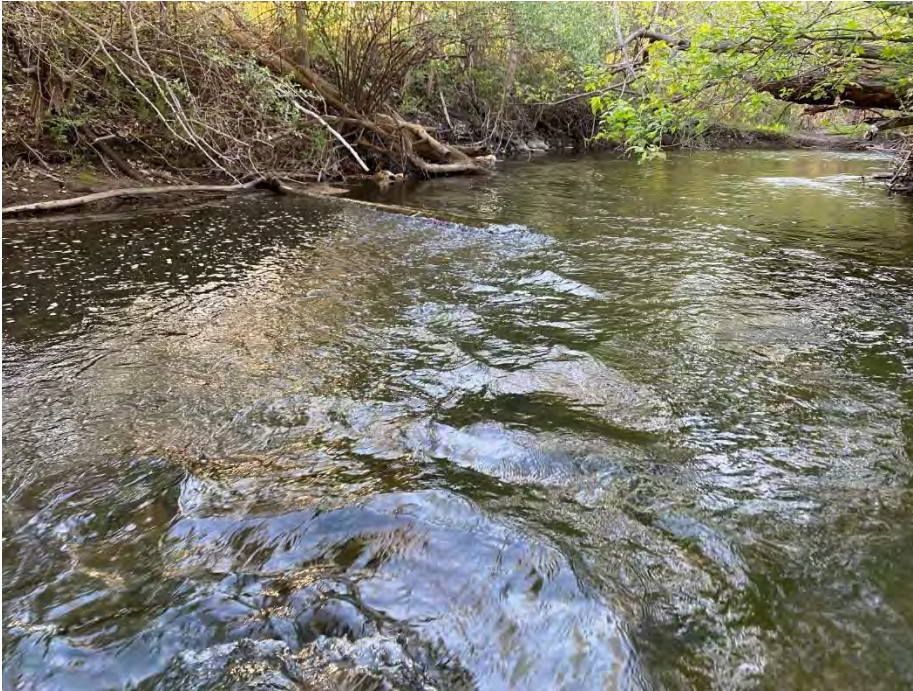
Habitat Structure 11 – This vane was installed to improve center flow of the creek and to provide in-stream cover just above some riffles and a deep pool.

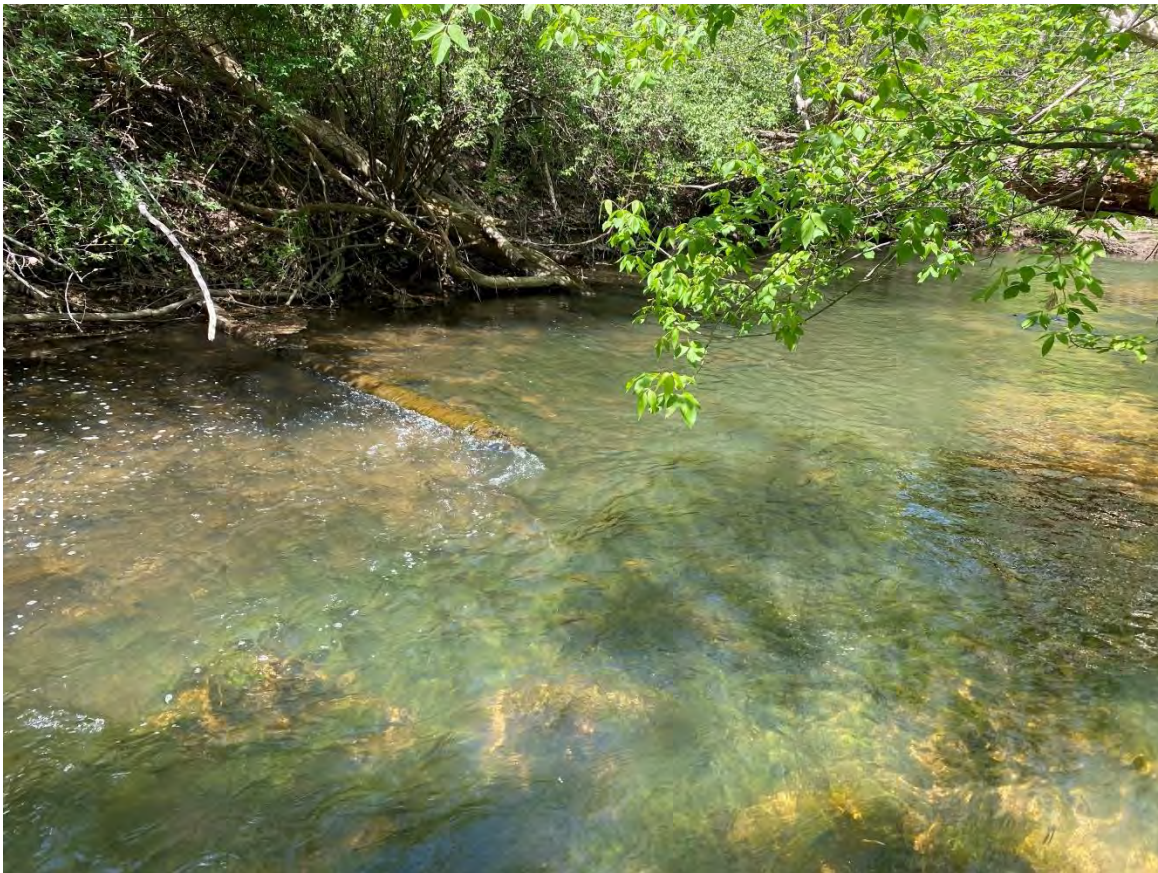
Habitat Structure 11 – Note the heavy green algae on the rocks and the log.

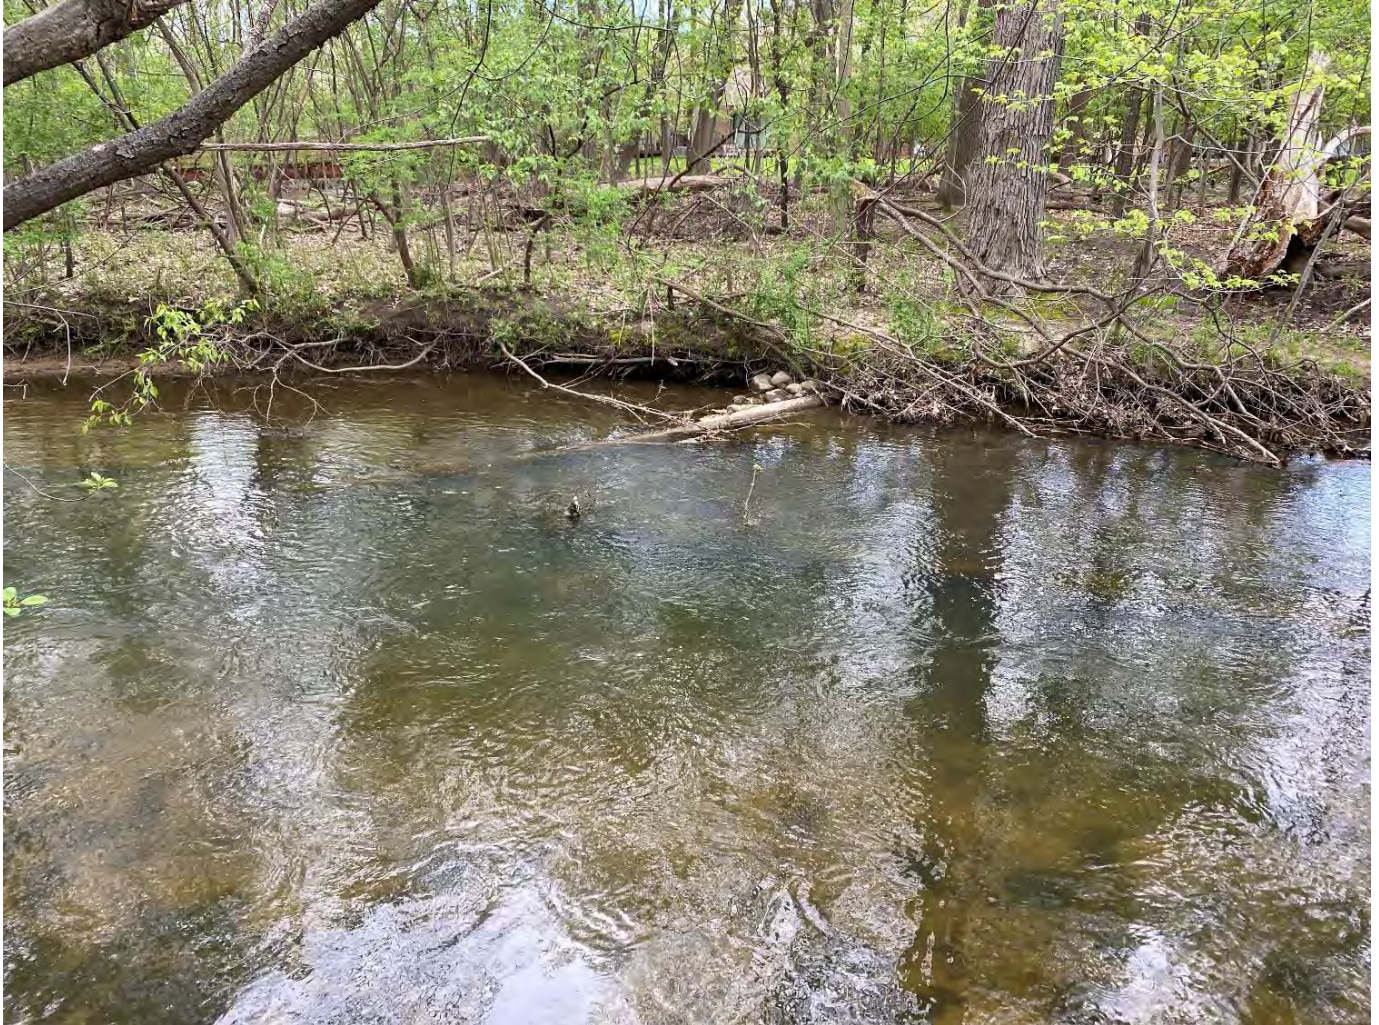
Habitat Structure 12 – Several in-stream logs and a vane were installed to protect the bank, with added logs crisscrossing in the pool. The placement of the structure is under the large tree in a deeper pool area to help reduce erosion at its base.

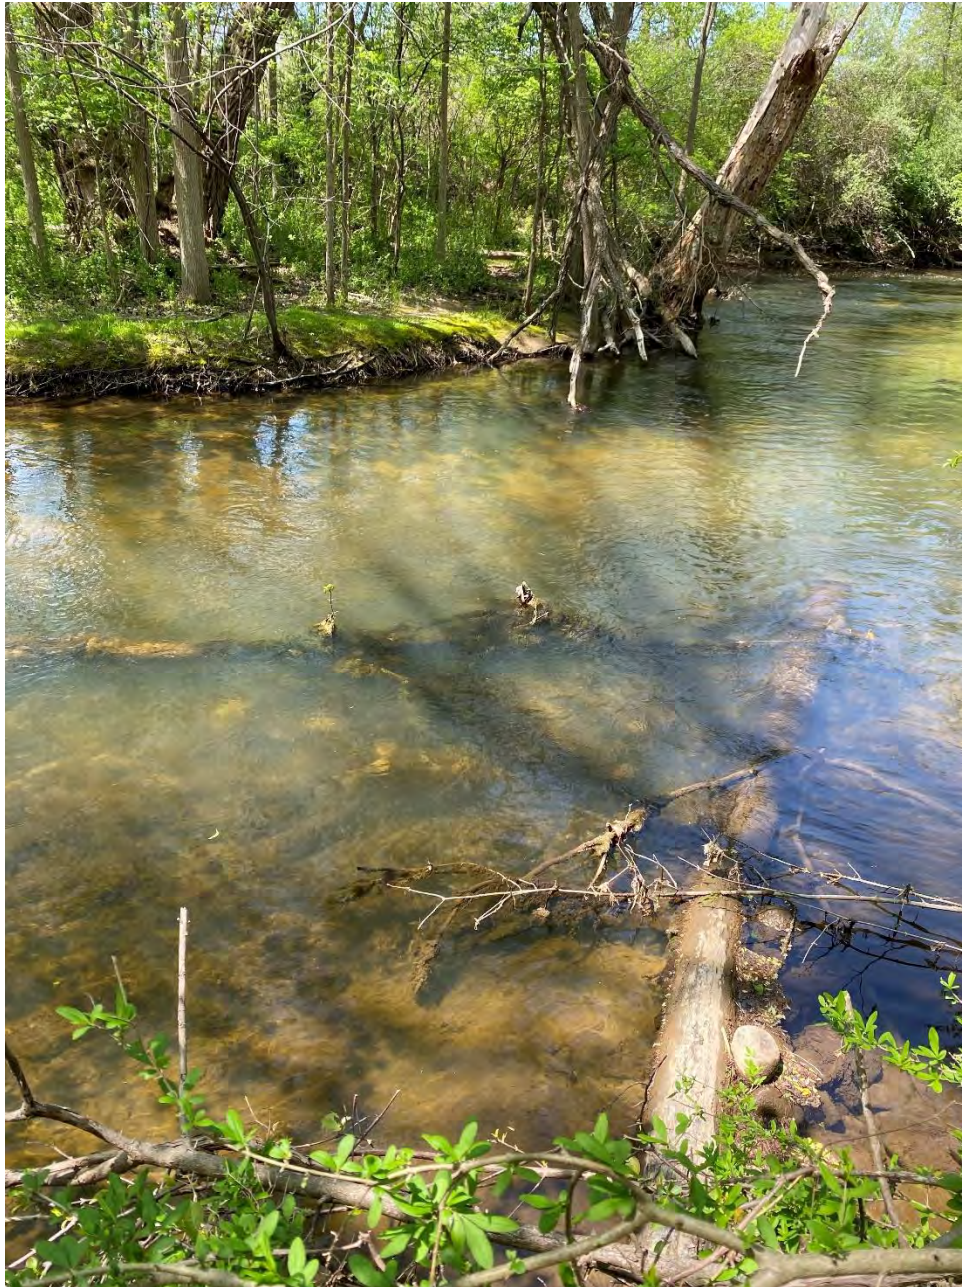
Habitat Structure 12 – Several in-stream logs and a vane were installed to protect the bank, with added logs crisscrossing in the pool that you can see in this picture. The placement of the structure is under the large tree in a deeper pool area to help reduce erosion at its base. Notice the silt build-up at the bank on the upper side of the Vane.
