Vanguard Chapter – Oakland County Michigan
Paint Creek Woody Habitat Installation – Phase 2
May of 2022

Overview of Phase 2:

The report and photos show the installed Phase 2 in-stream woody debris habitat structures in a section of the Paint Creek that flows through Rochester Hills, Michigan. These pictures were taken in May of 2022, almost a year after installation, to document how the structures survived the winter and the seasonal spring high water events. This report can be compared to a similar one made after the structures were installed in the summer of 2021.

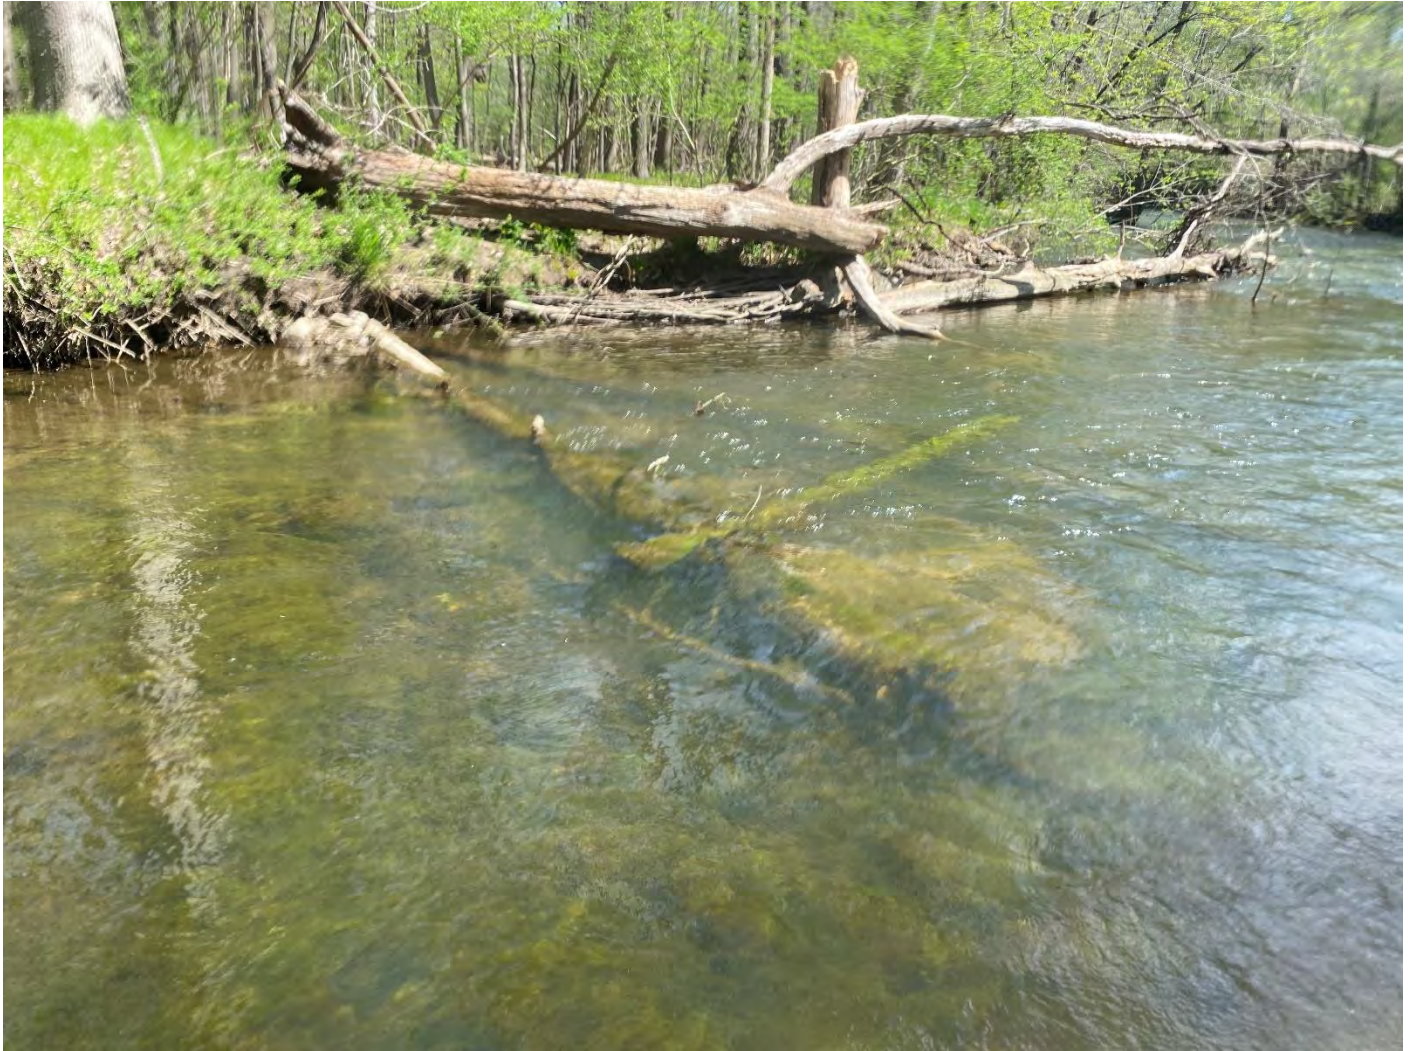
Habitat Structure 13 – This vane was installed to help direct center flow and to protect and build back an eroding bank. Since there was also a developed pool, several other underwater logs were placed here to establish additional deeper water habitat. You can see an older rotting tree fell to the right this winter creating more in-stream habitat along the bank.

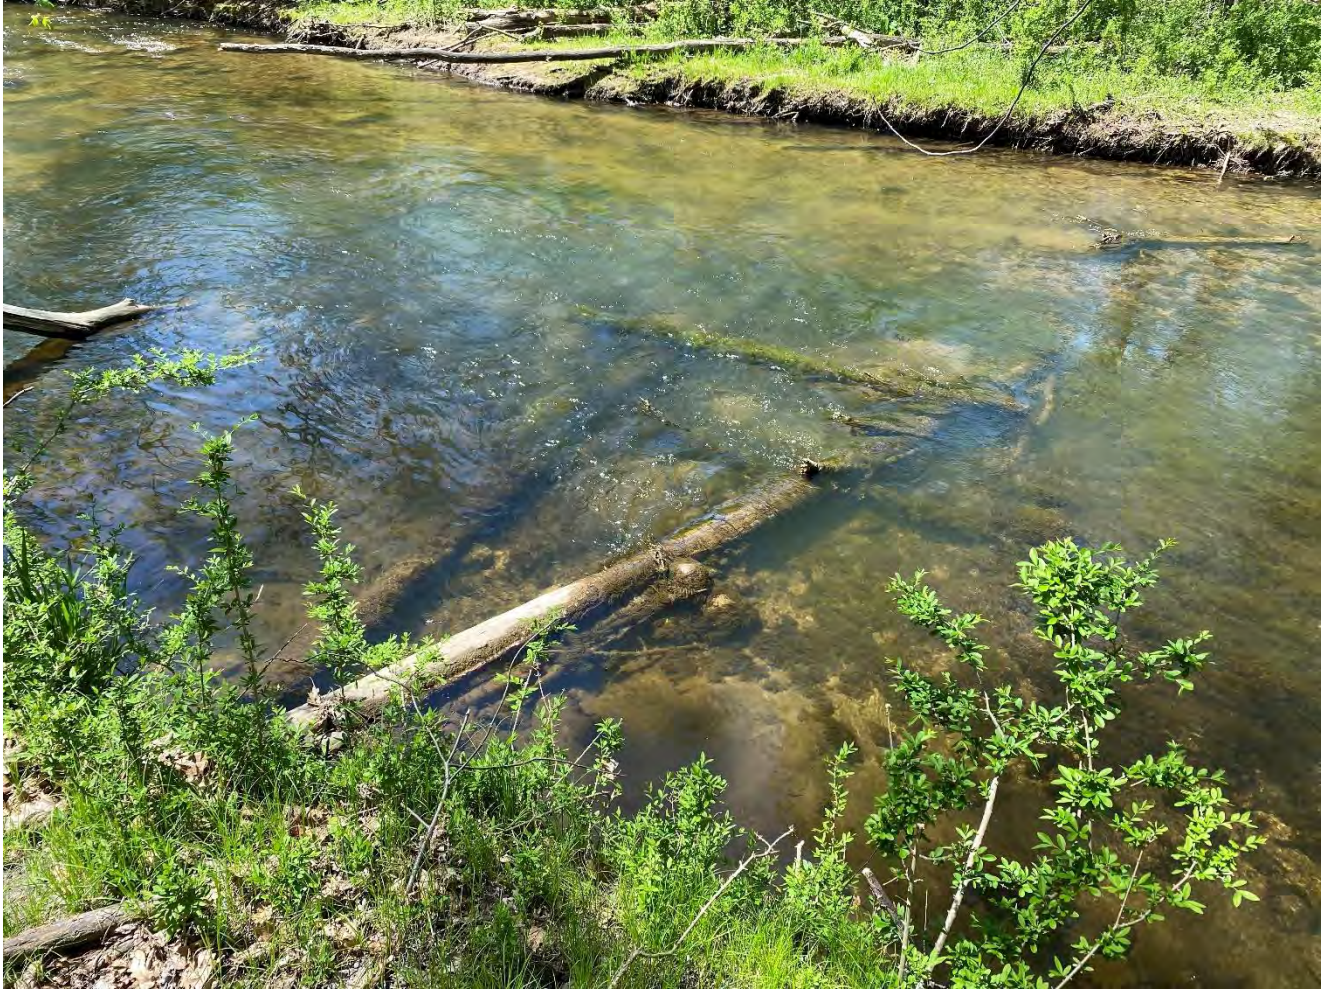
Habitat Structure 13 – This vane was installed to help direct center flow and to protect and build back an eroding bank. Since there was also a developed pool, several other underwater logs were placed here to establish additional deeper water habitat.

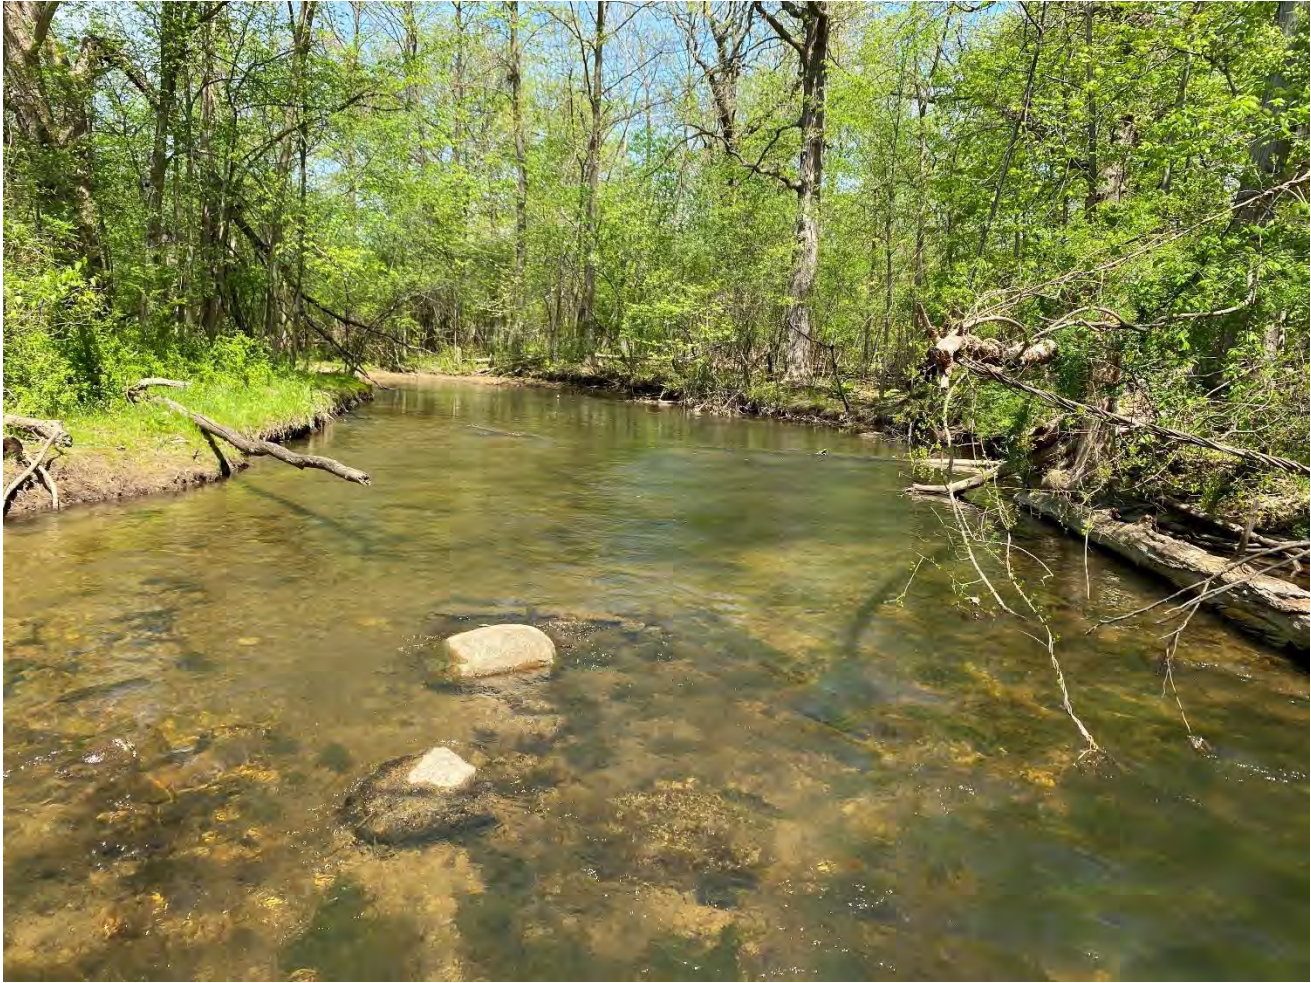
An upstream look at Paint Creek where Structures 12 and 13 are located on the right bank.

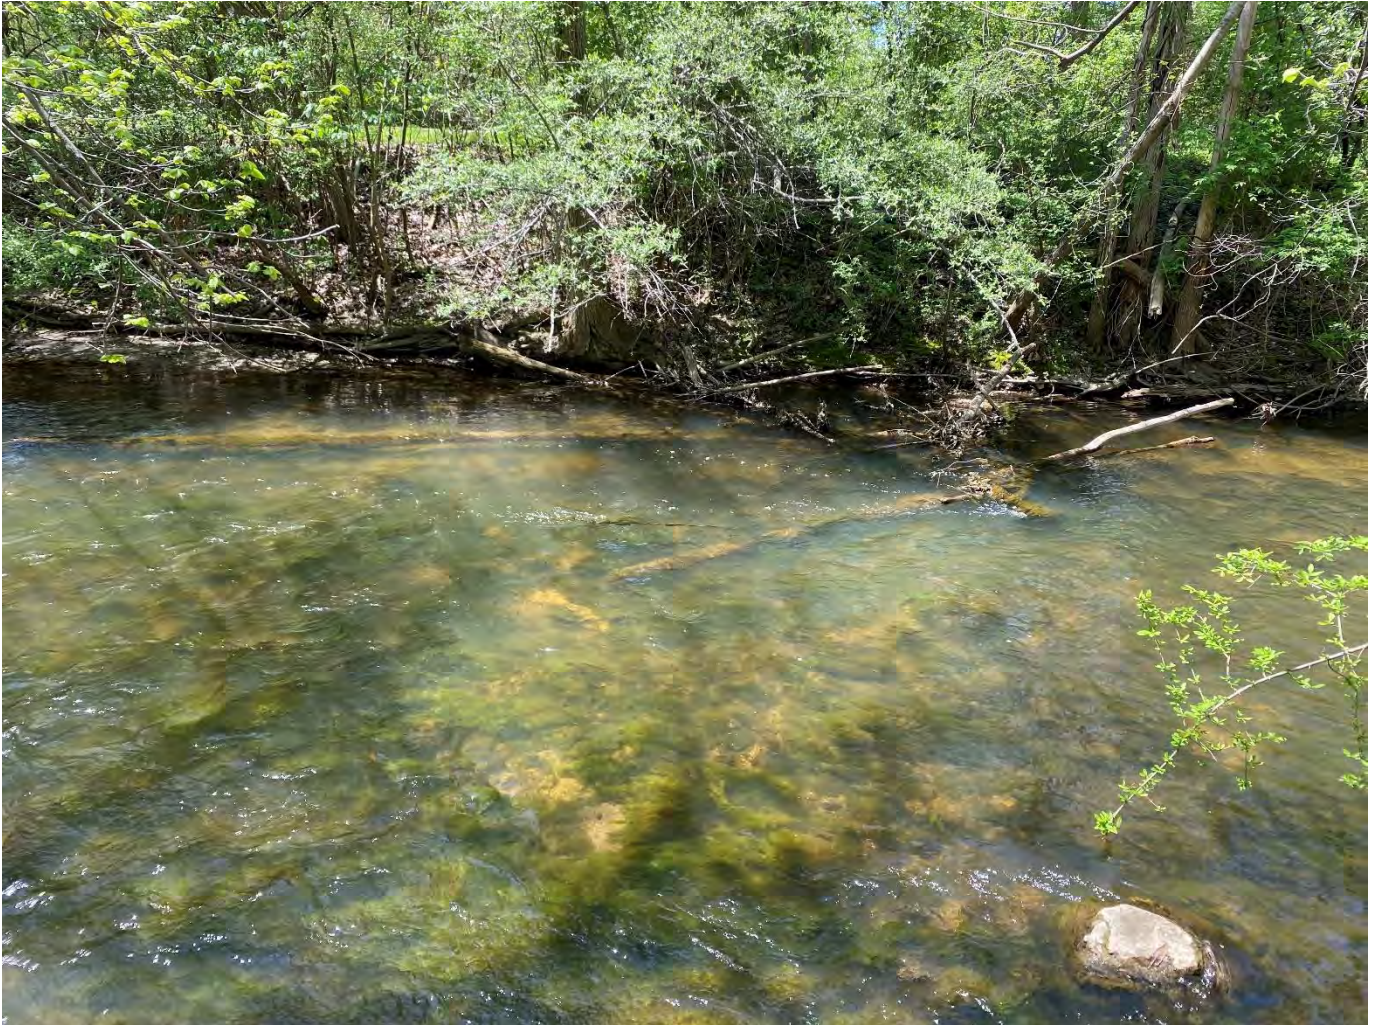
Habitat Structure 14 – A vane was placed to protect the bank under a large tree and to direct more center flow. Another underwater log was placed just below the vane, parallel to the flow, to provide additional in-stream cover.

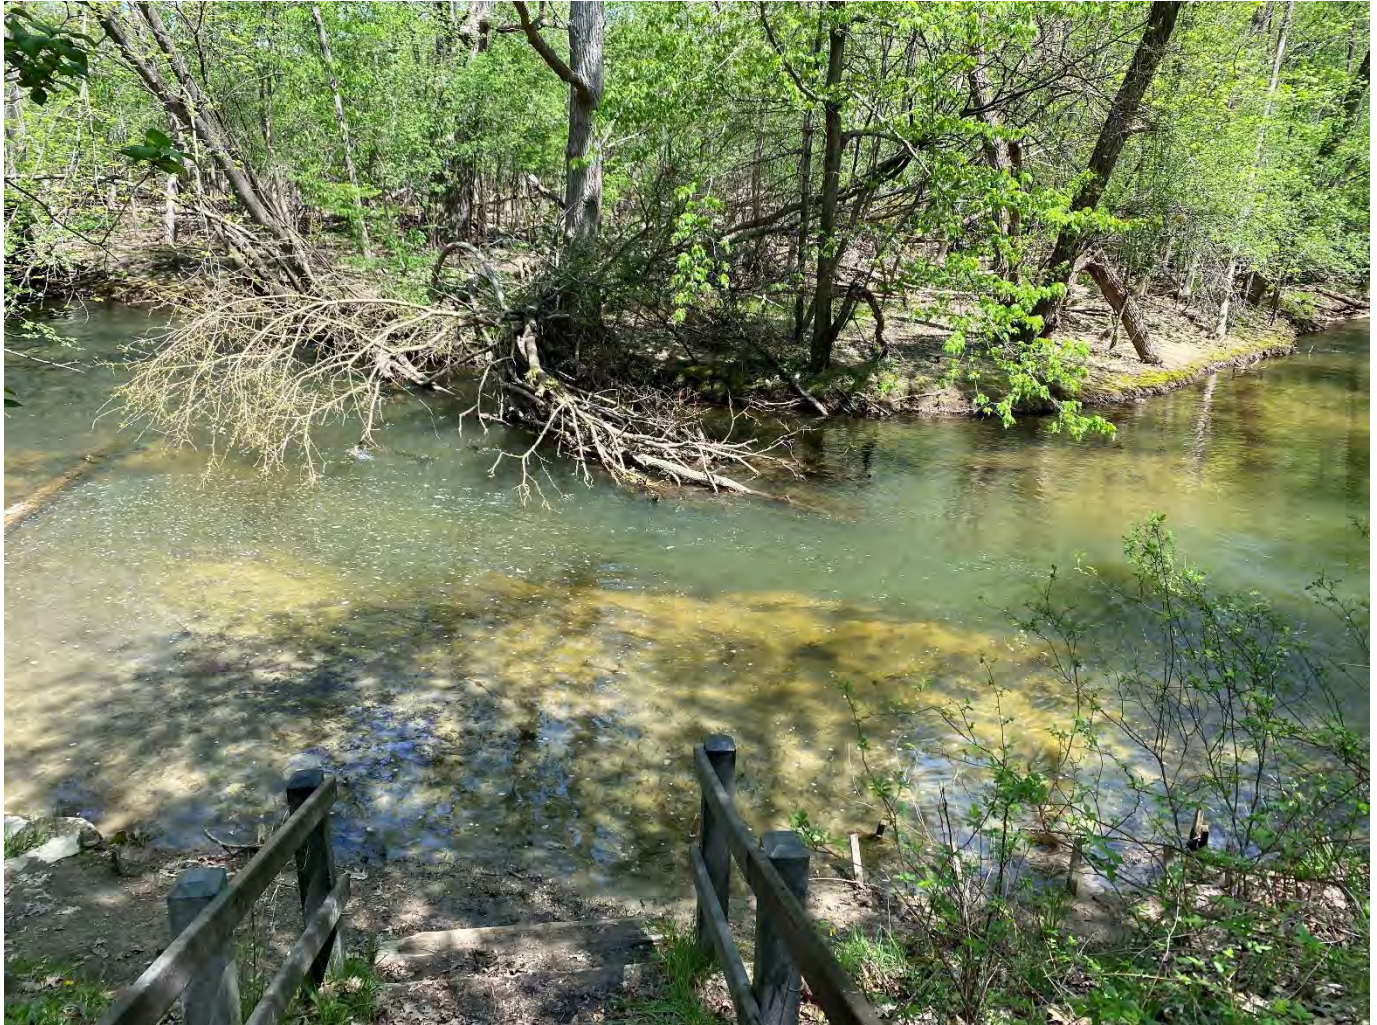
Habitat Structure 15 – An underwater log running parallel to the flow was placed on the far shore of this large deep pool as part of Phase 2's work. The log was covered by a fallen tree this winter making for a nice holding spot in the pool below some riffles.
