Paint Creek Habitat Restoration Project

2016 - 2022

Vanguard Trout Unlimited
Oakland County, Michigan

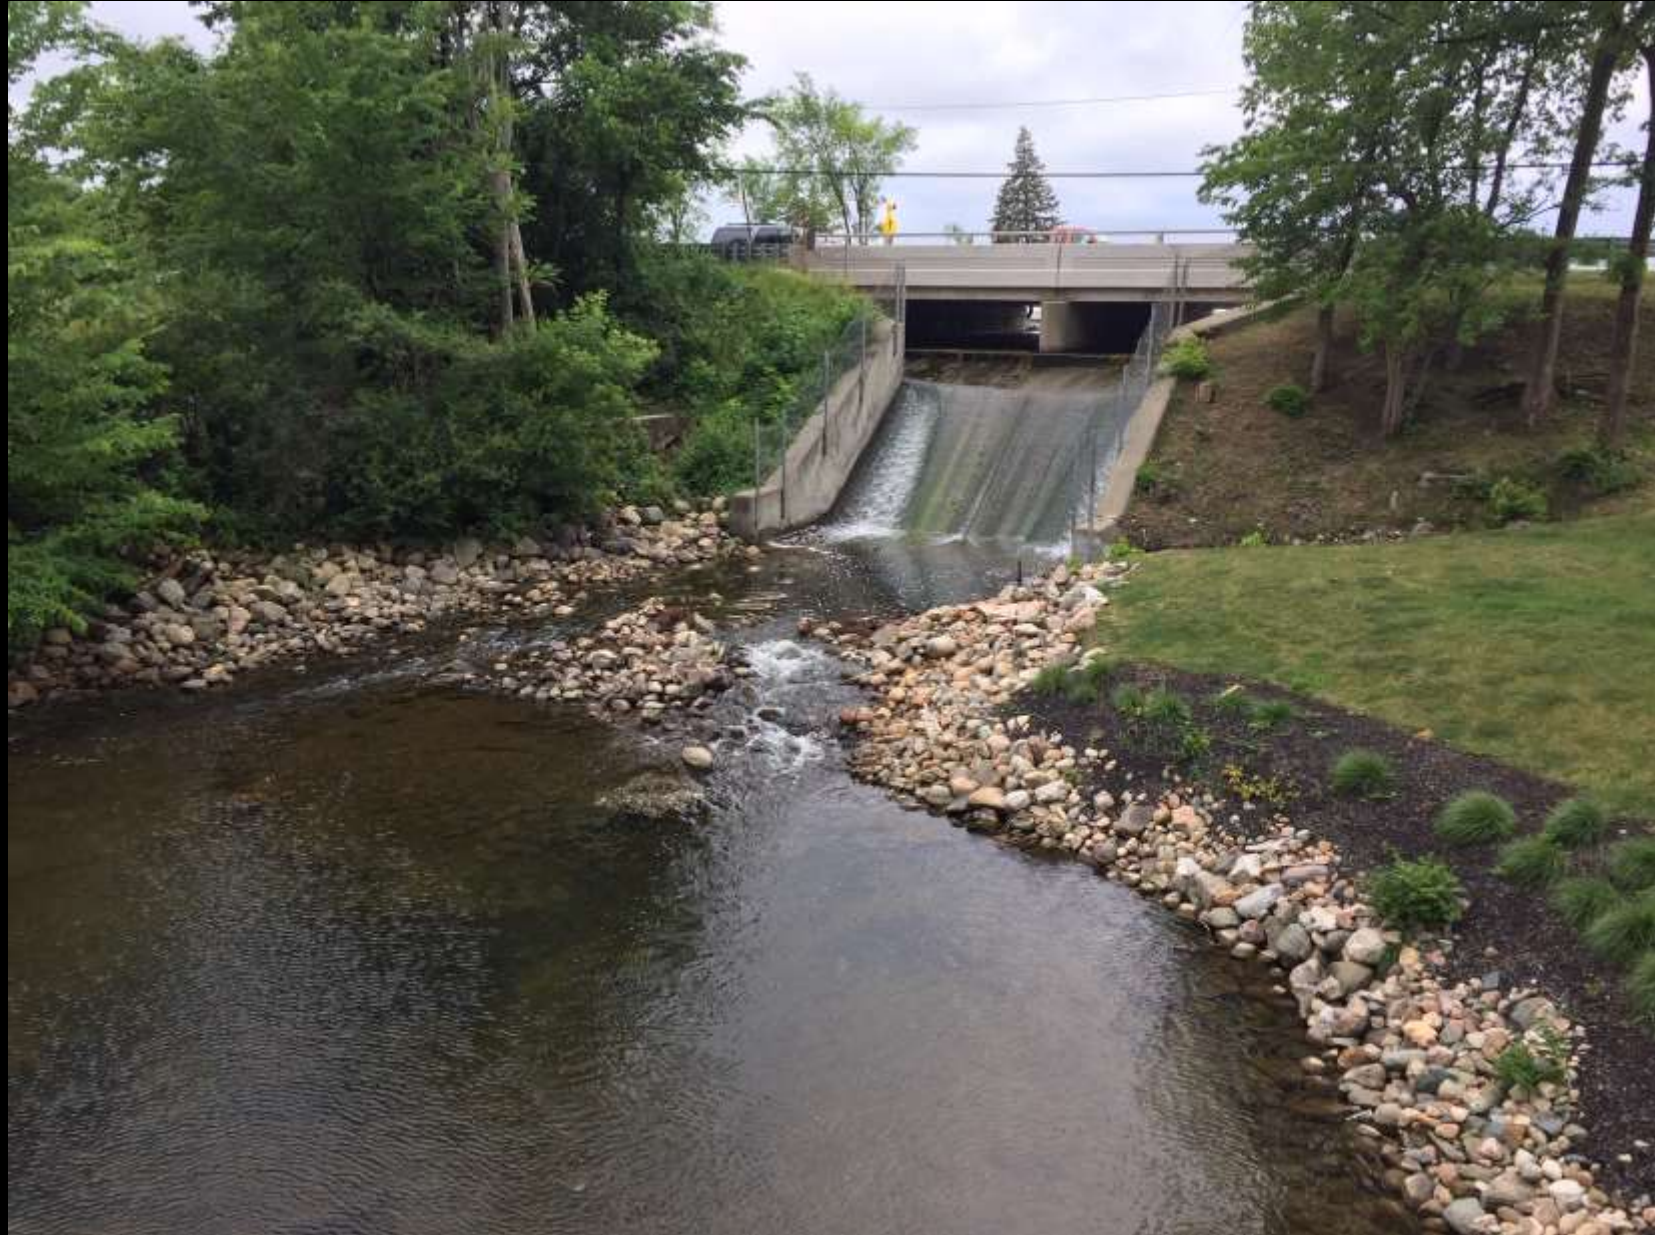
The Paint Creek Headwater Dam at Lake Orion

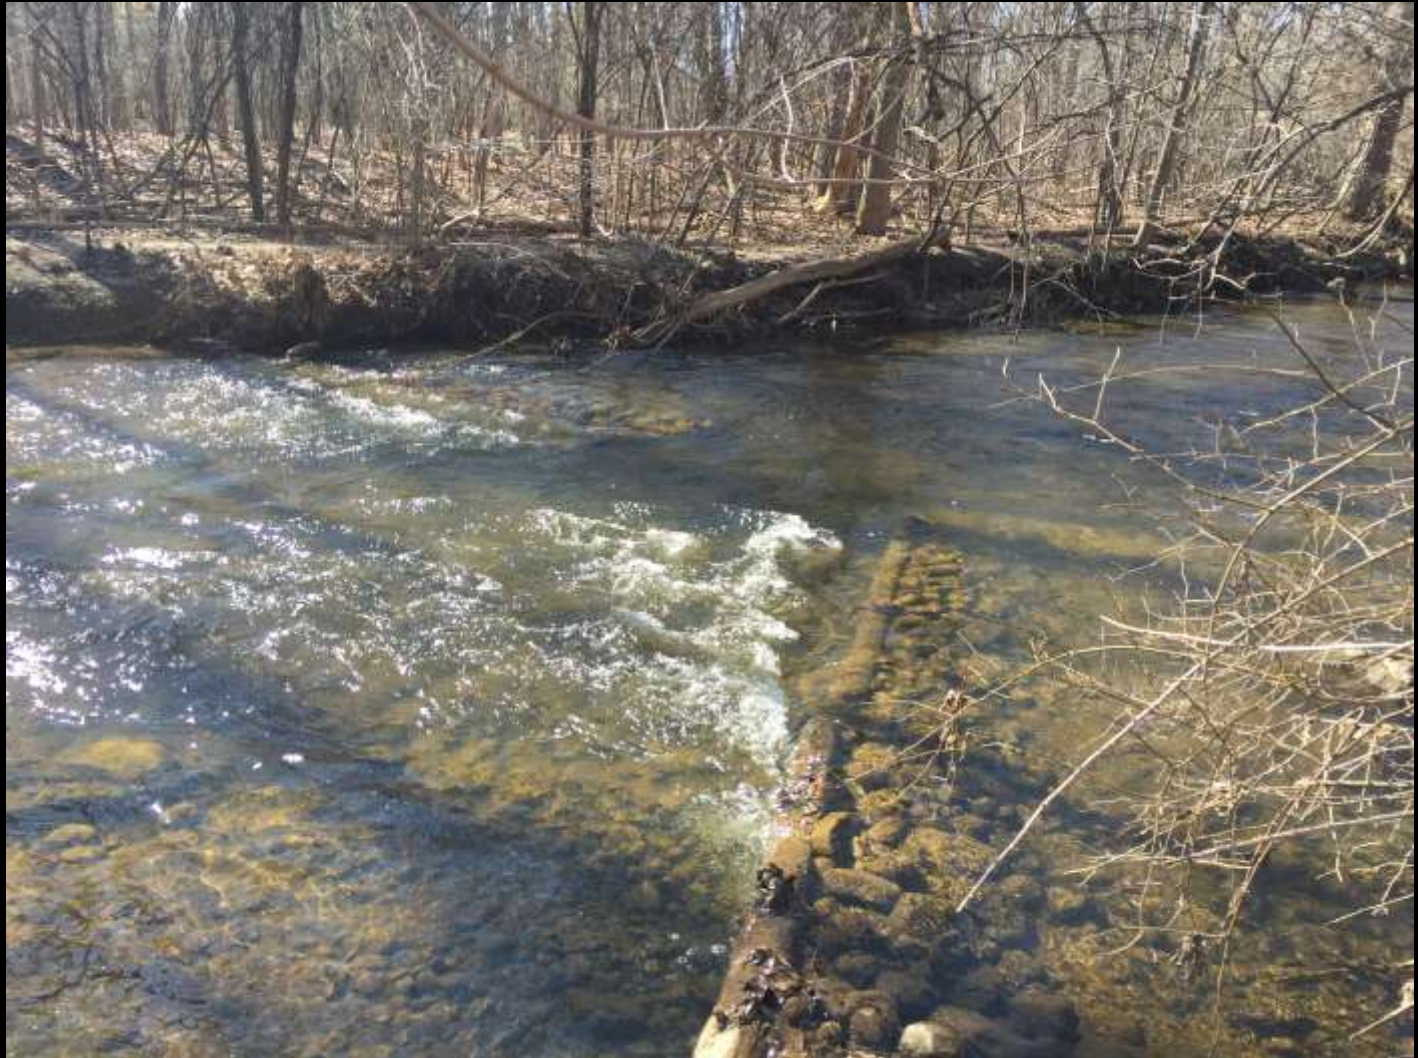
What are Vanes?

- Vanes are structures constructed in a stream to redirect flow to the center of the stream.
- They are used as part of natural stream restoration efforts to improve instream habitat and prevent bank erosion.

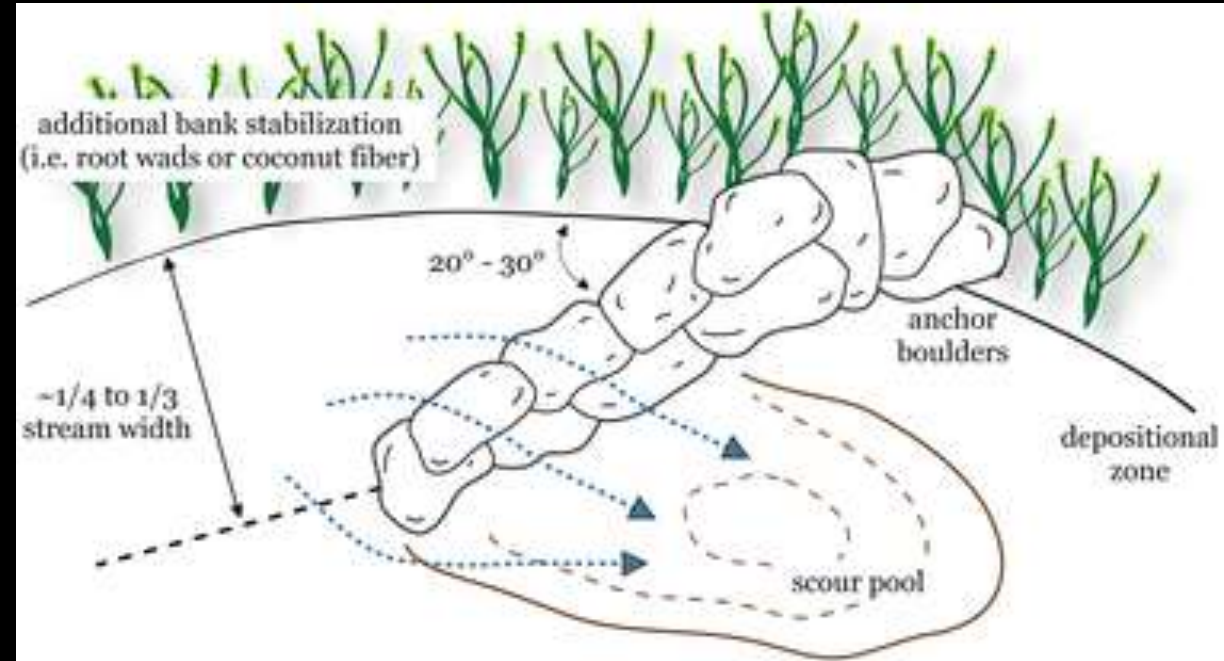
How Do Vanes Impact the Stream?

- **Modify flow direction away from streambanks**
 - The upstream angle of the structure is critical (20 – 30 degrees)
 - For the structure to work properly it needs to be built into the bank in the downstream direction.
 - The resultant stream flow will be at a 90° angle perpendicular to the vane.
- **Create a sand/soil depositional zone near banks to reduce streambank erosion**
- **Create a local scour pool near center of stream**

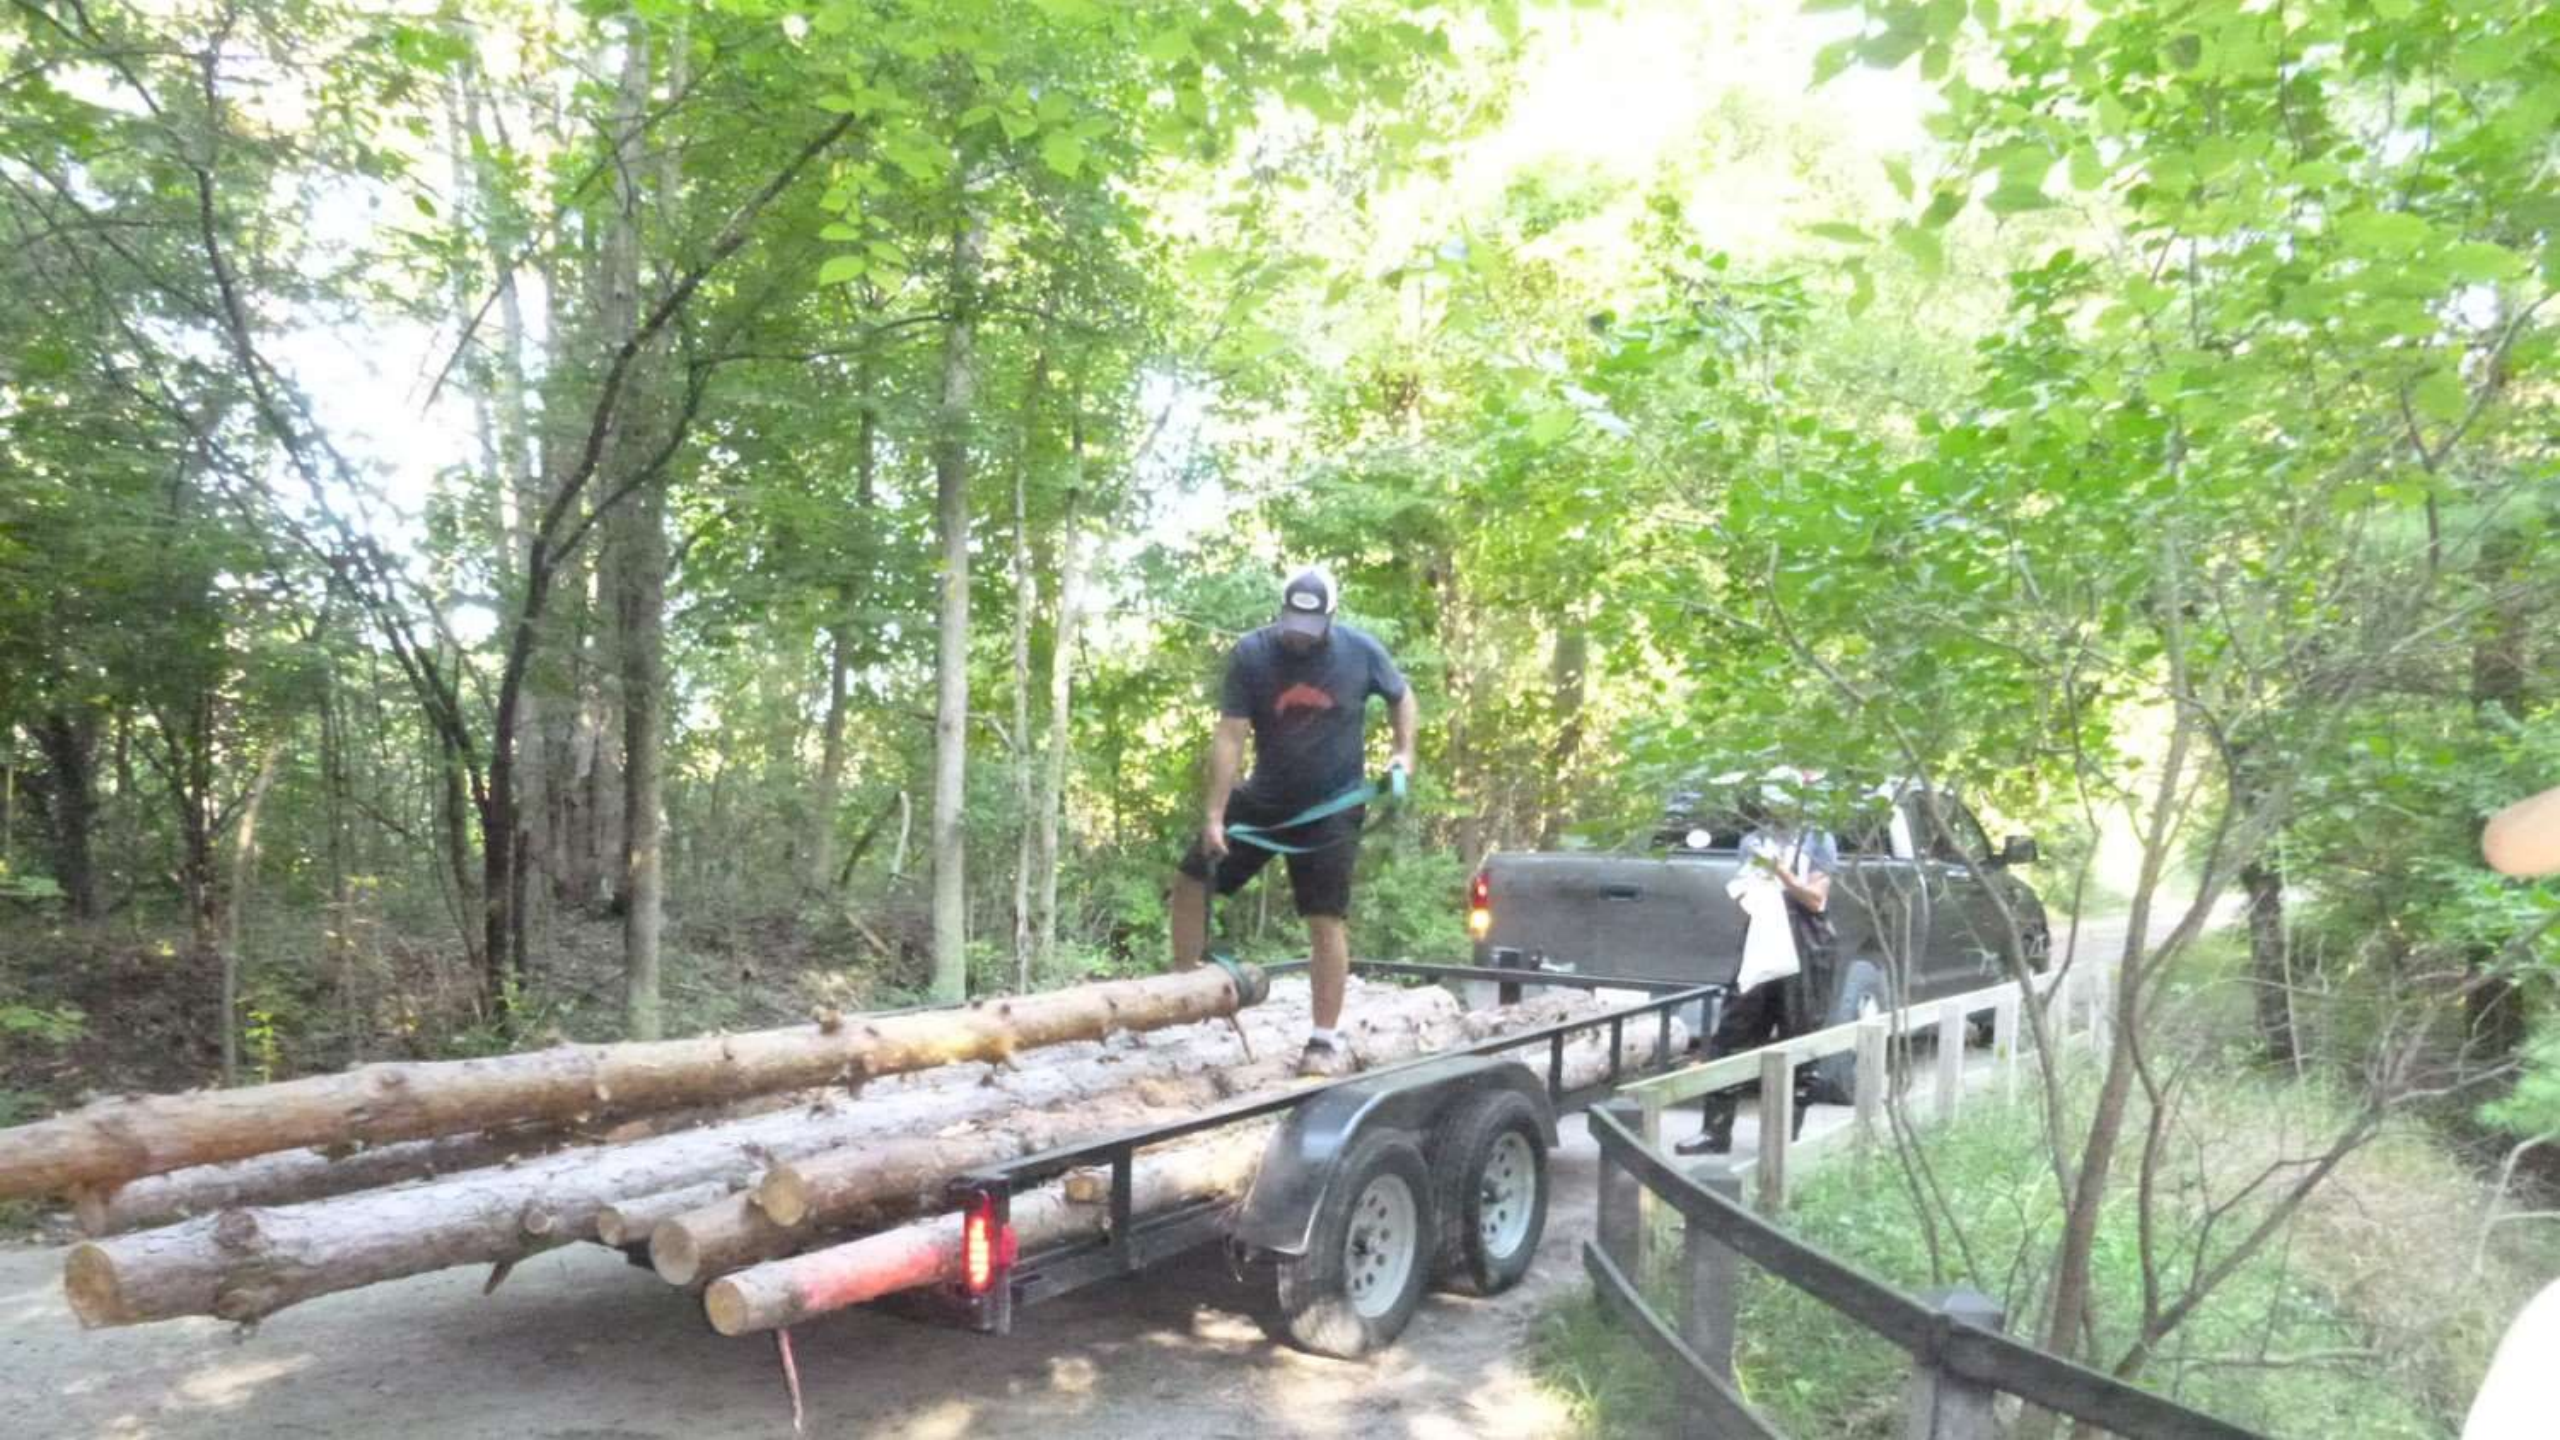
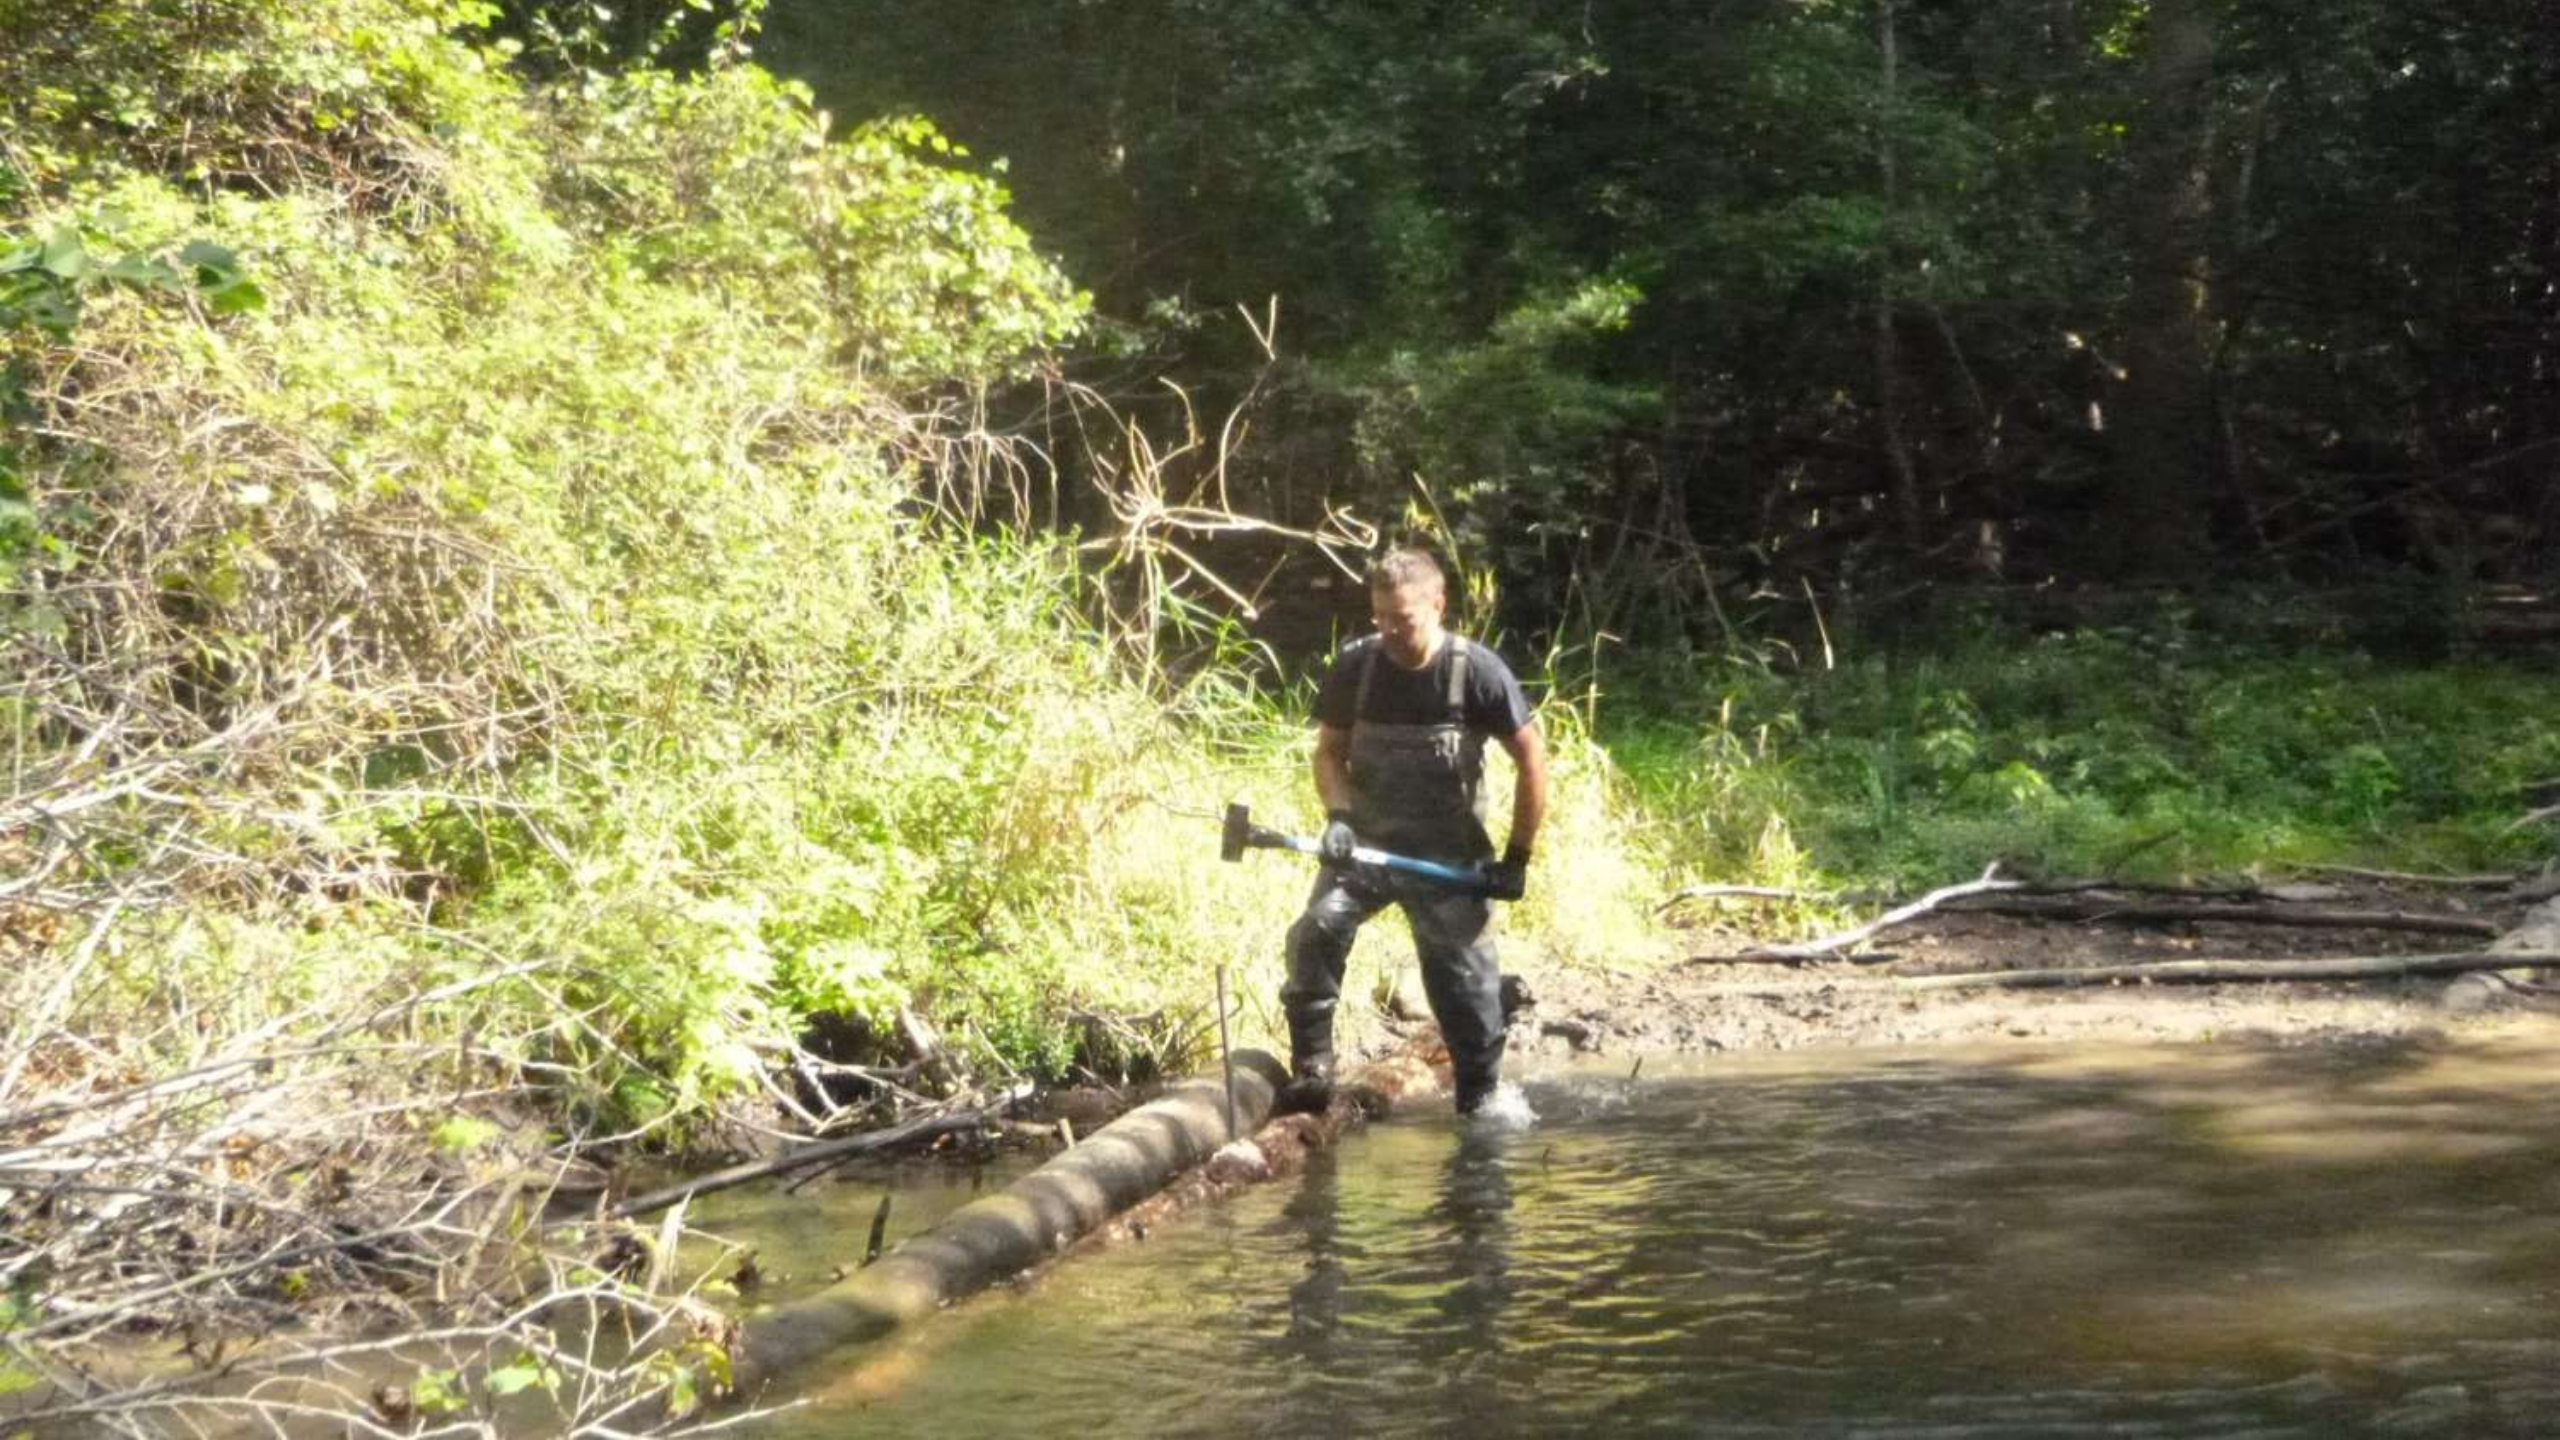
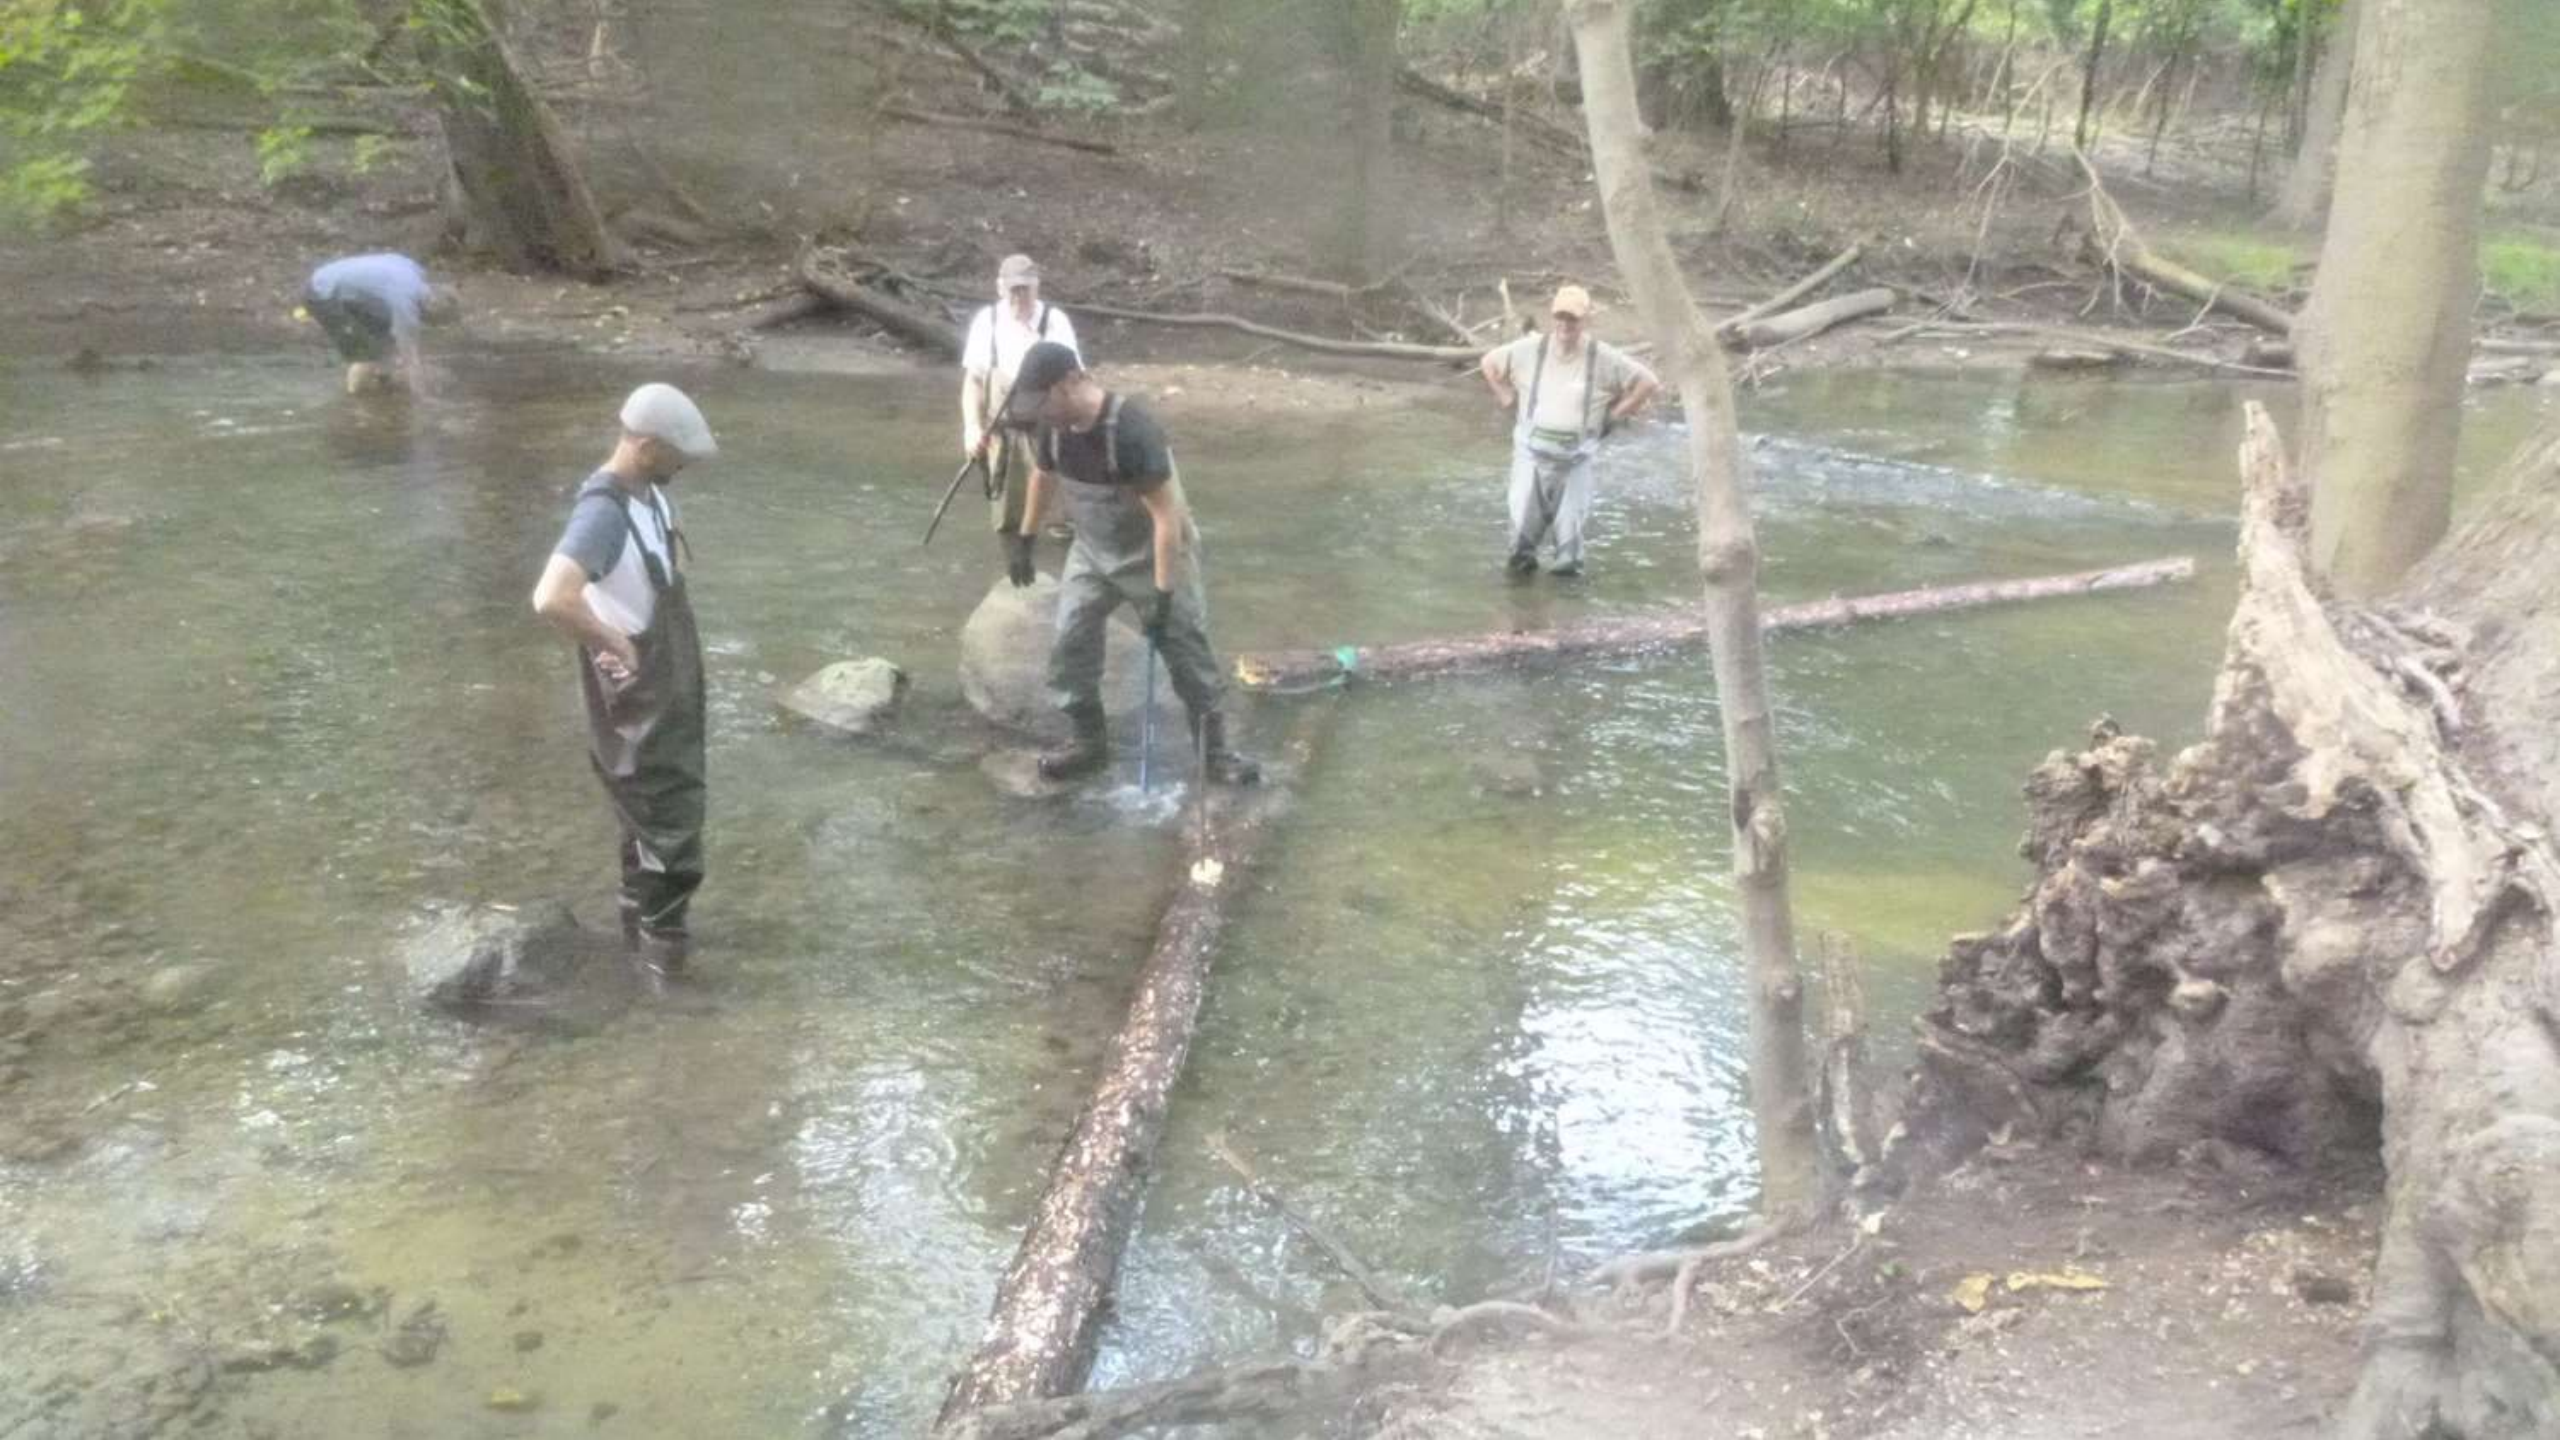
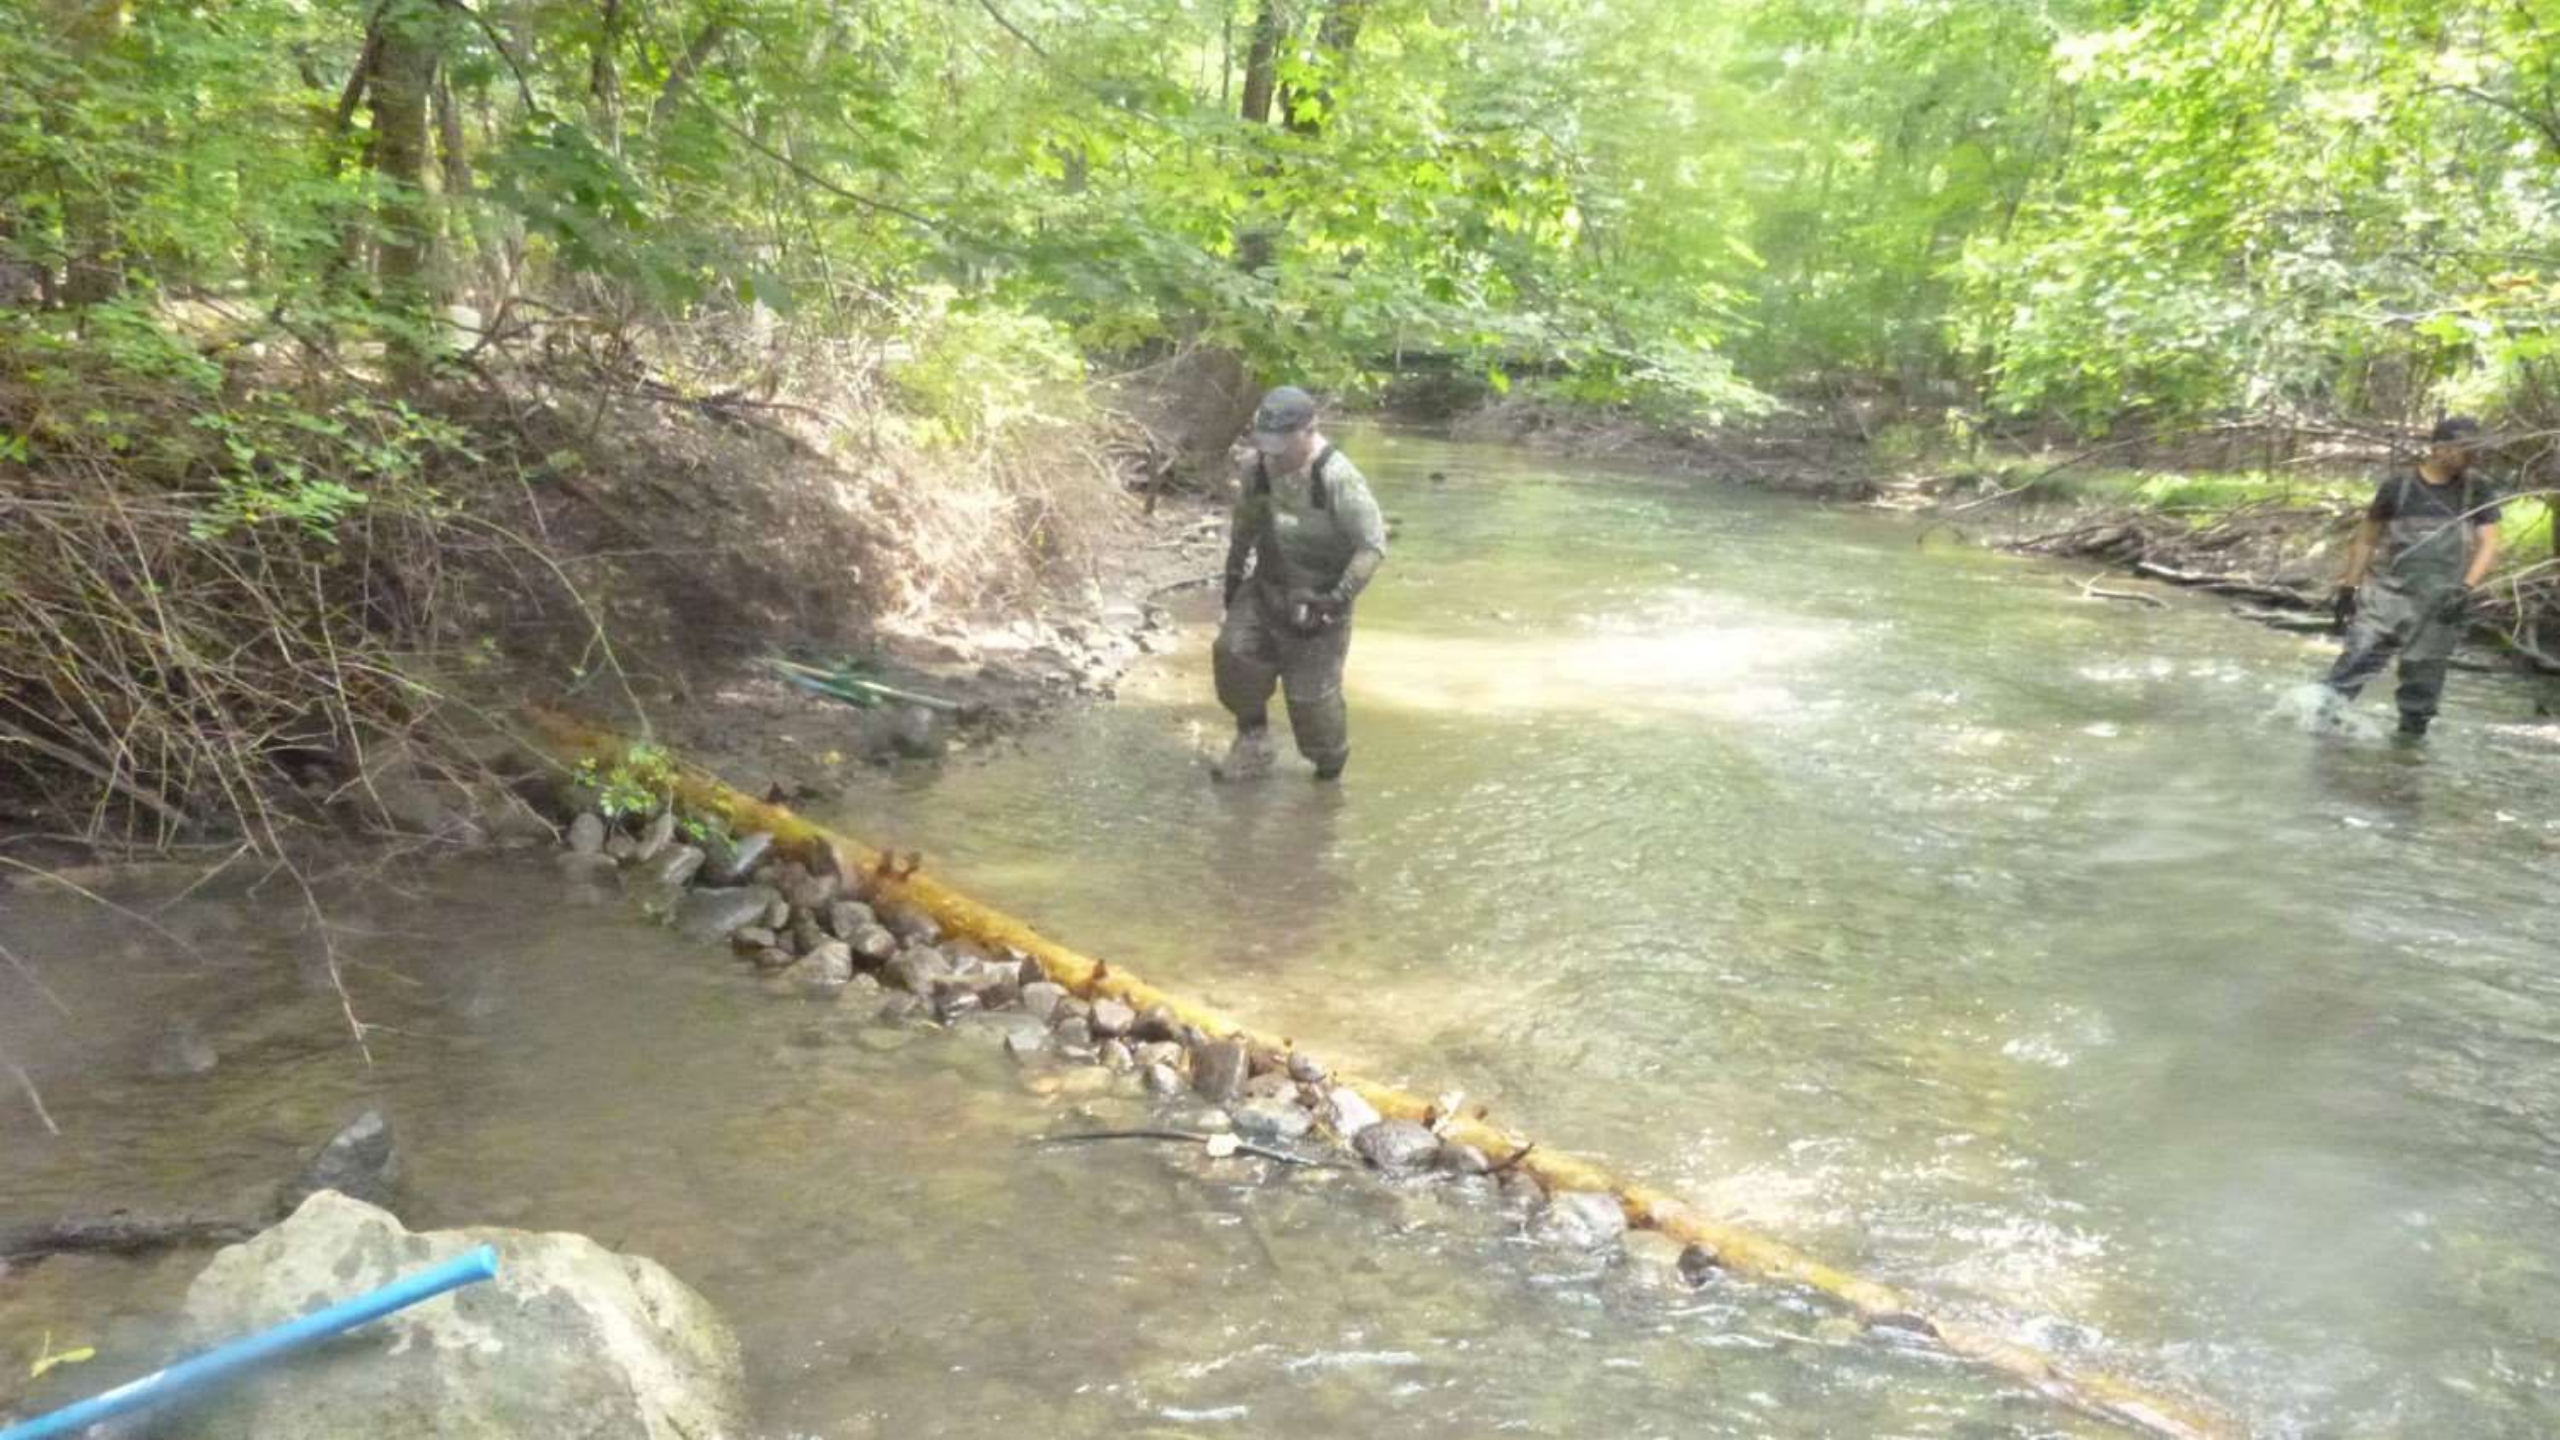
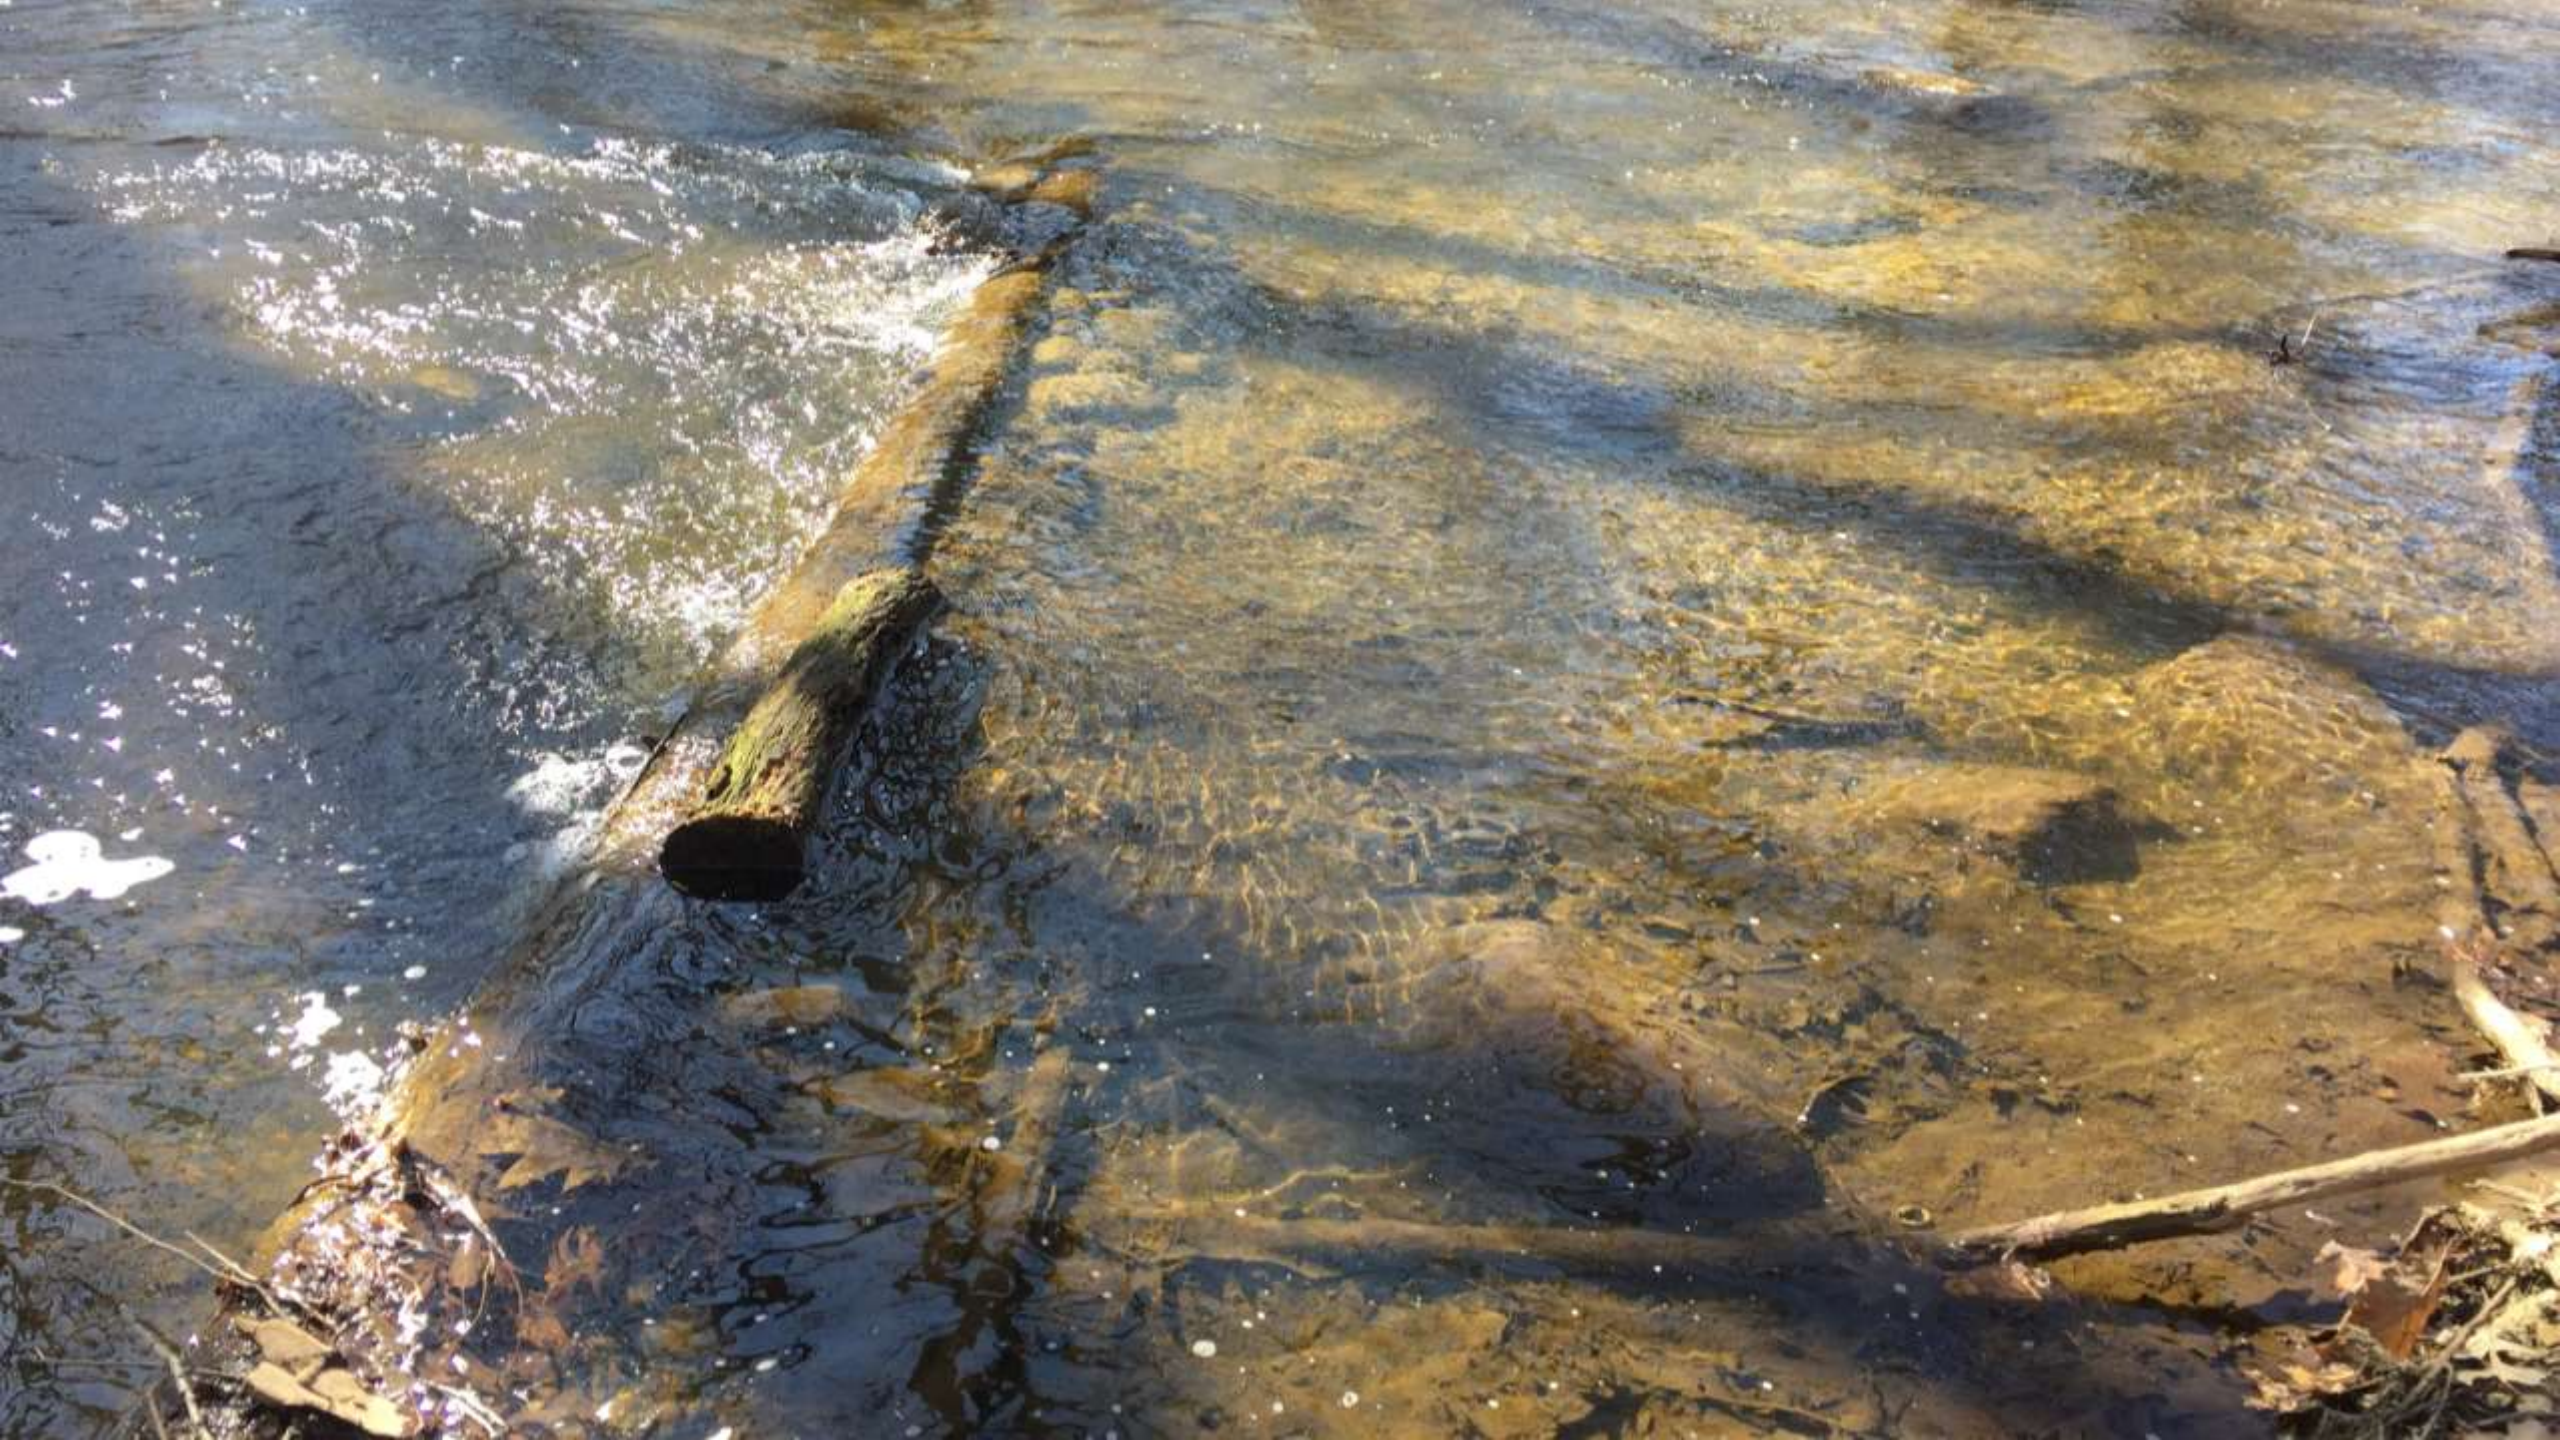
Phase 1

2019 In-Stream Habitat Restoration Work - Dinosaur Hill Nature Area
