Paint Creek Habitat Restoration Project

2016 - 2022

Vanguard Trout Unlimited
Oakland County, Michigan

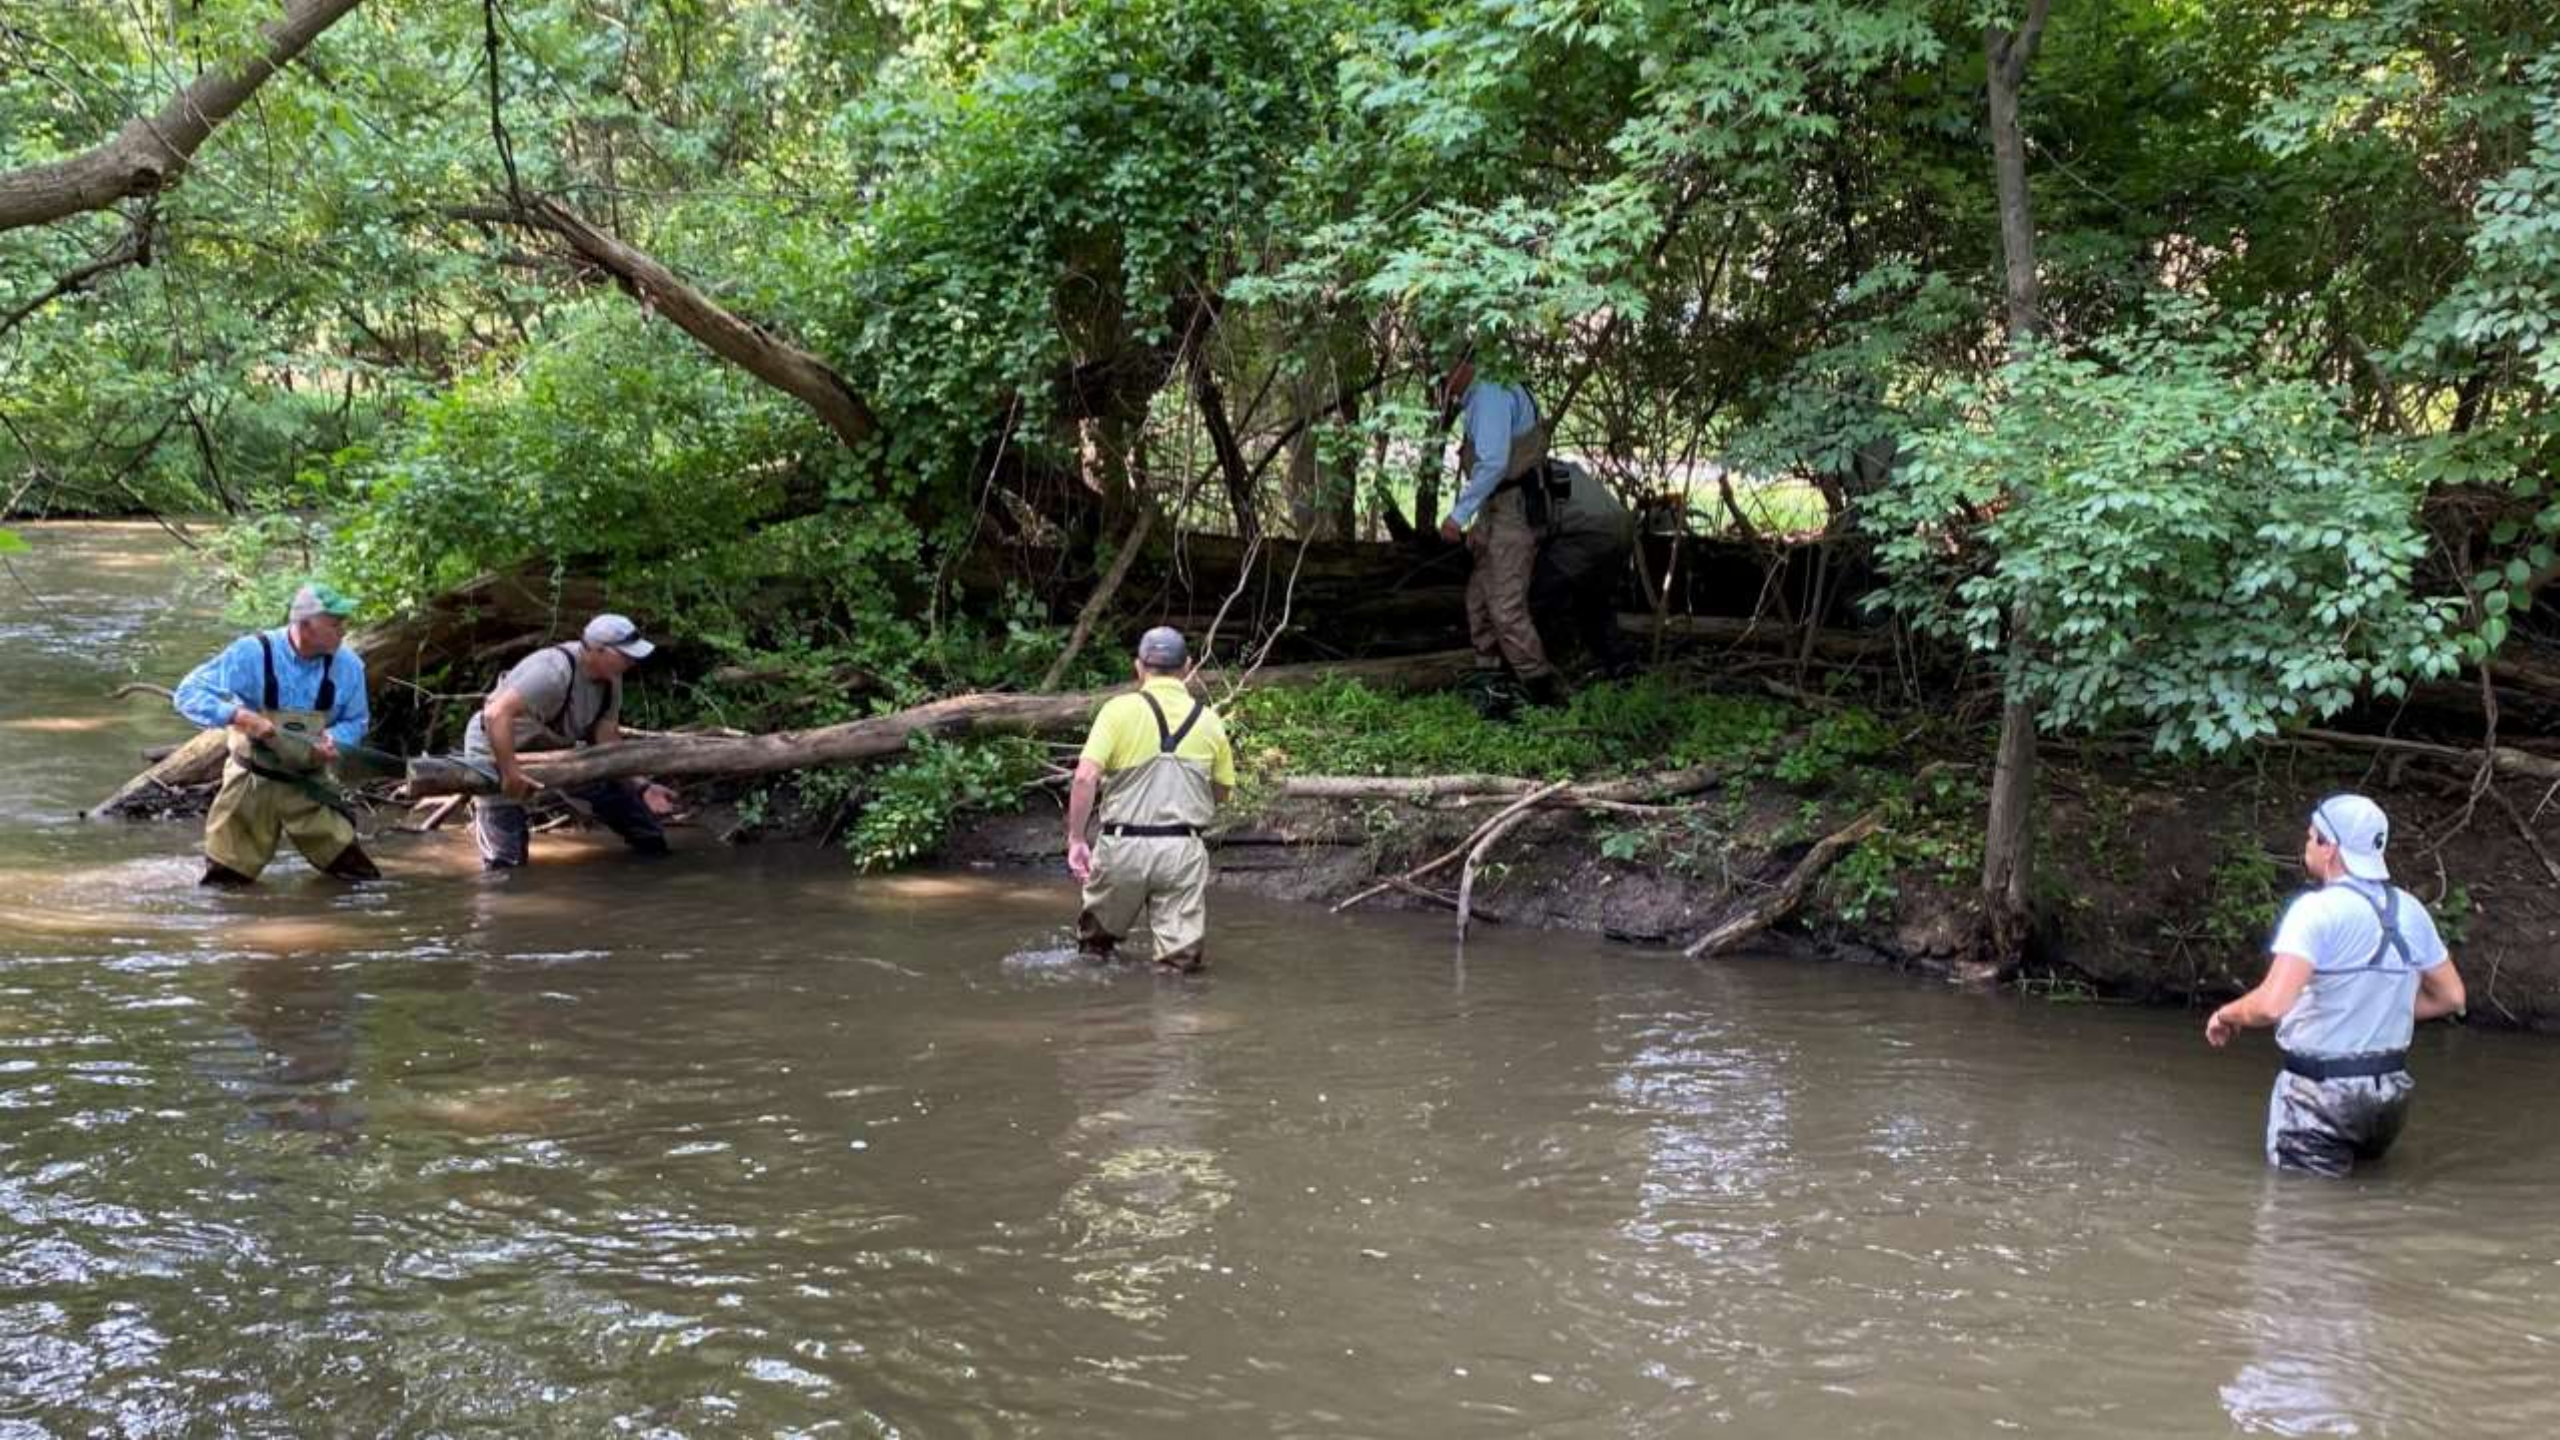
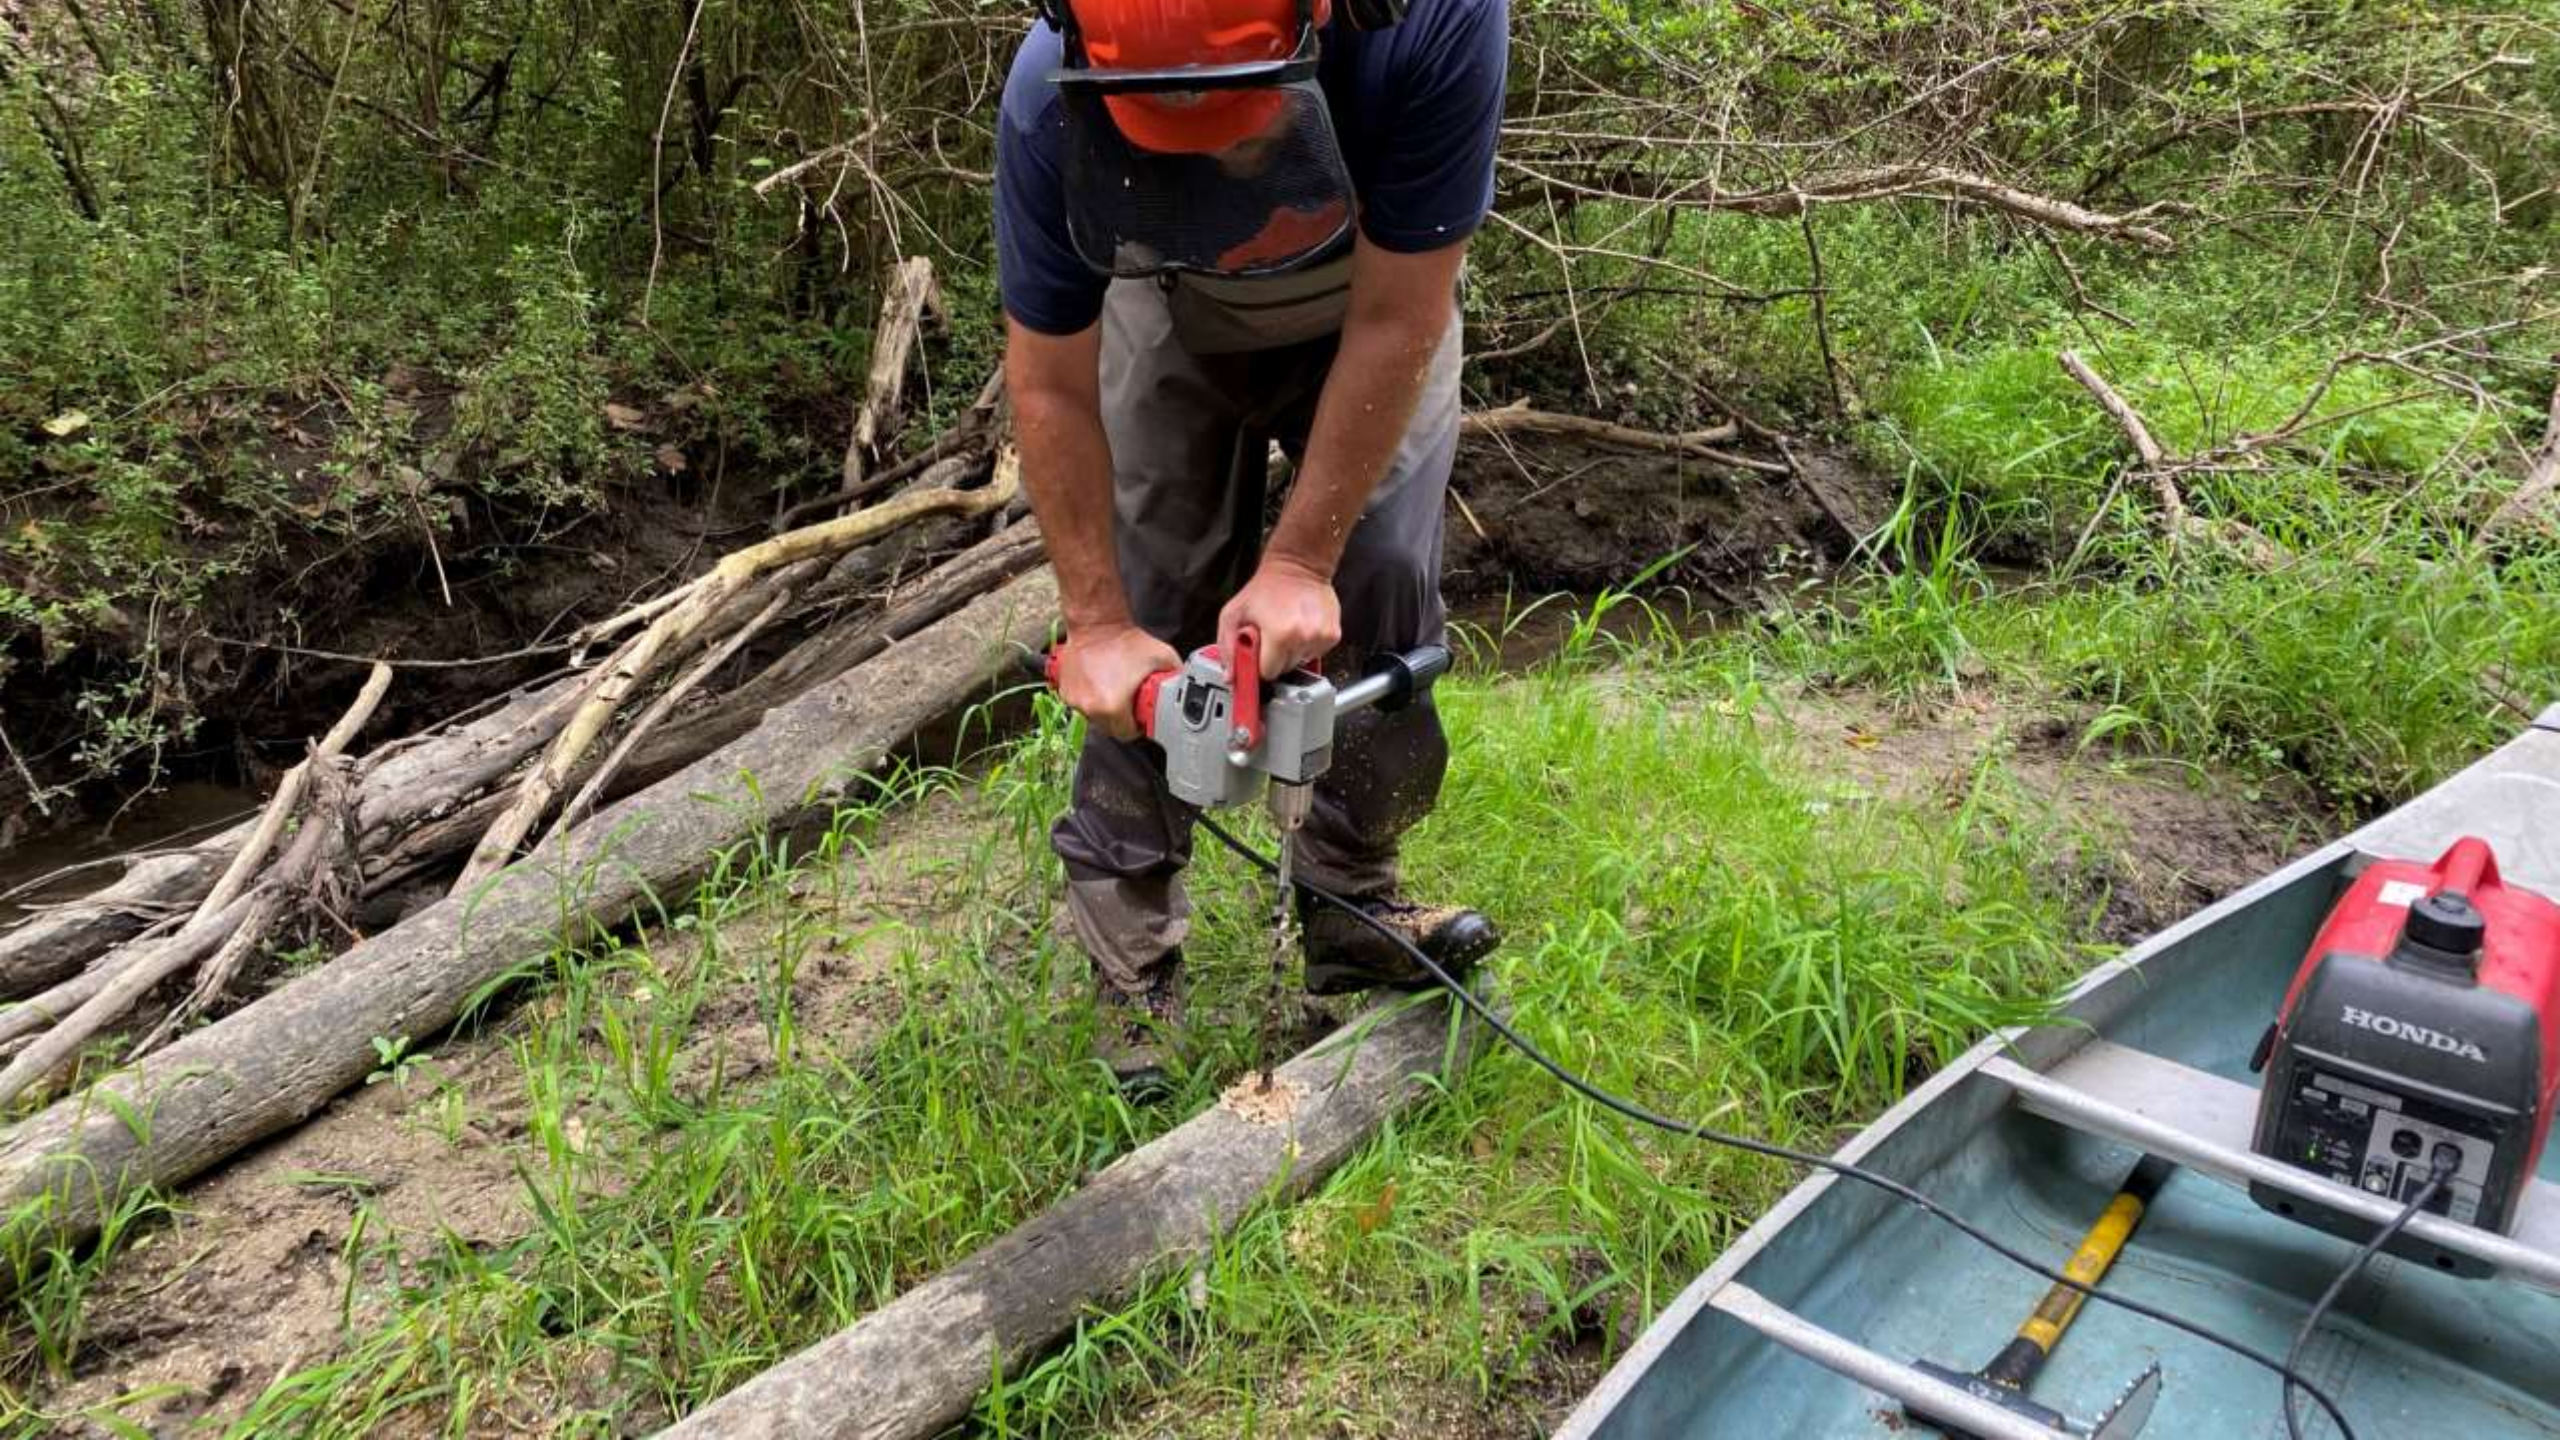
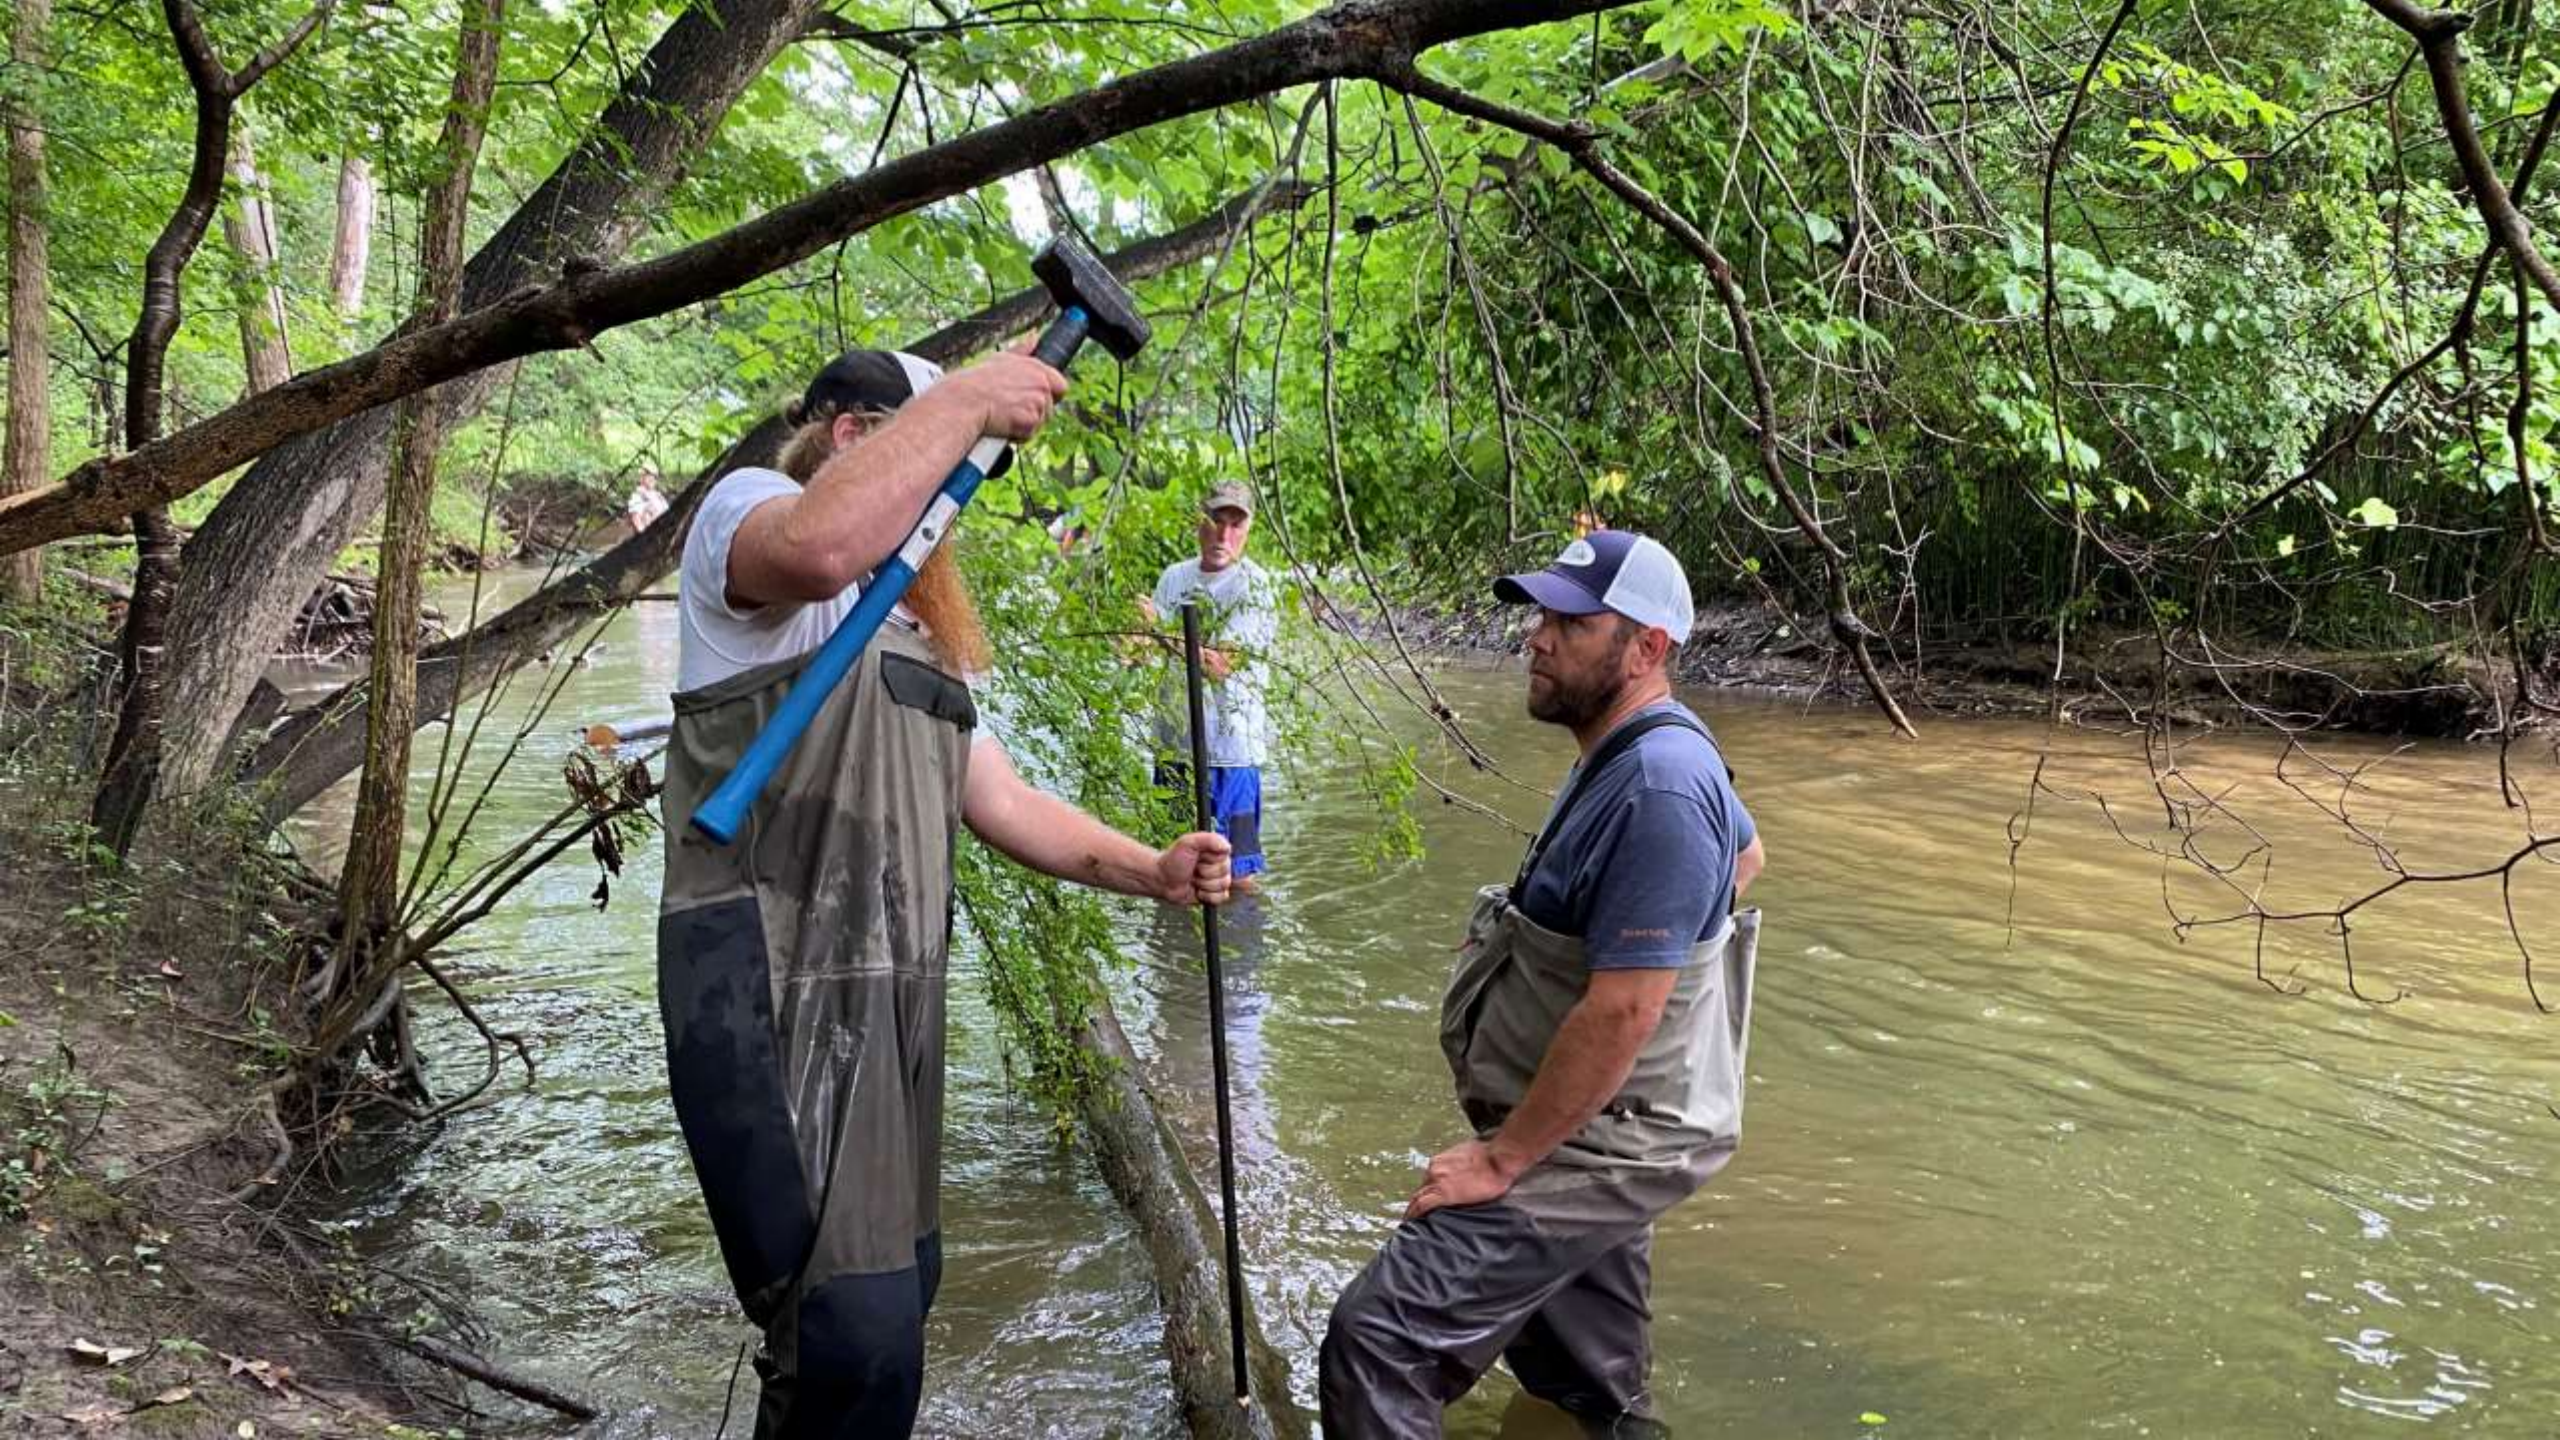
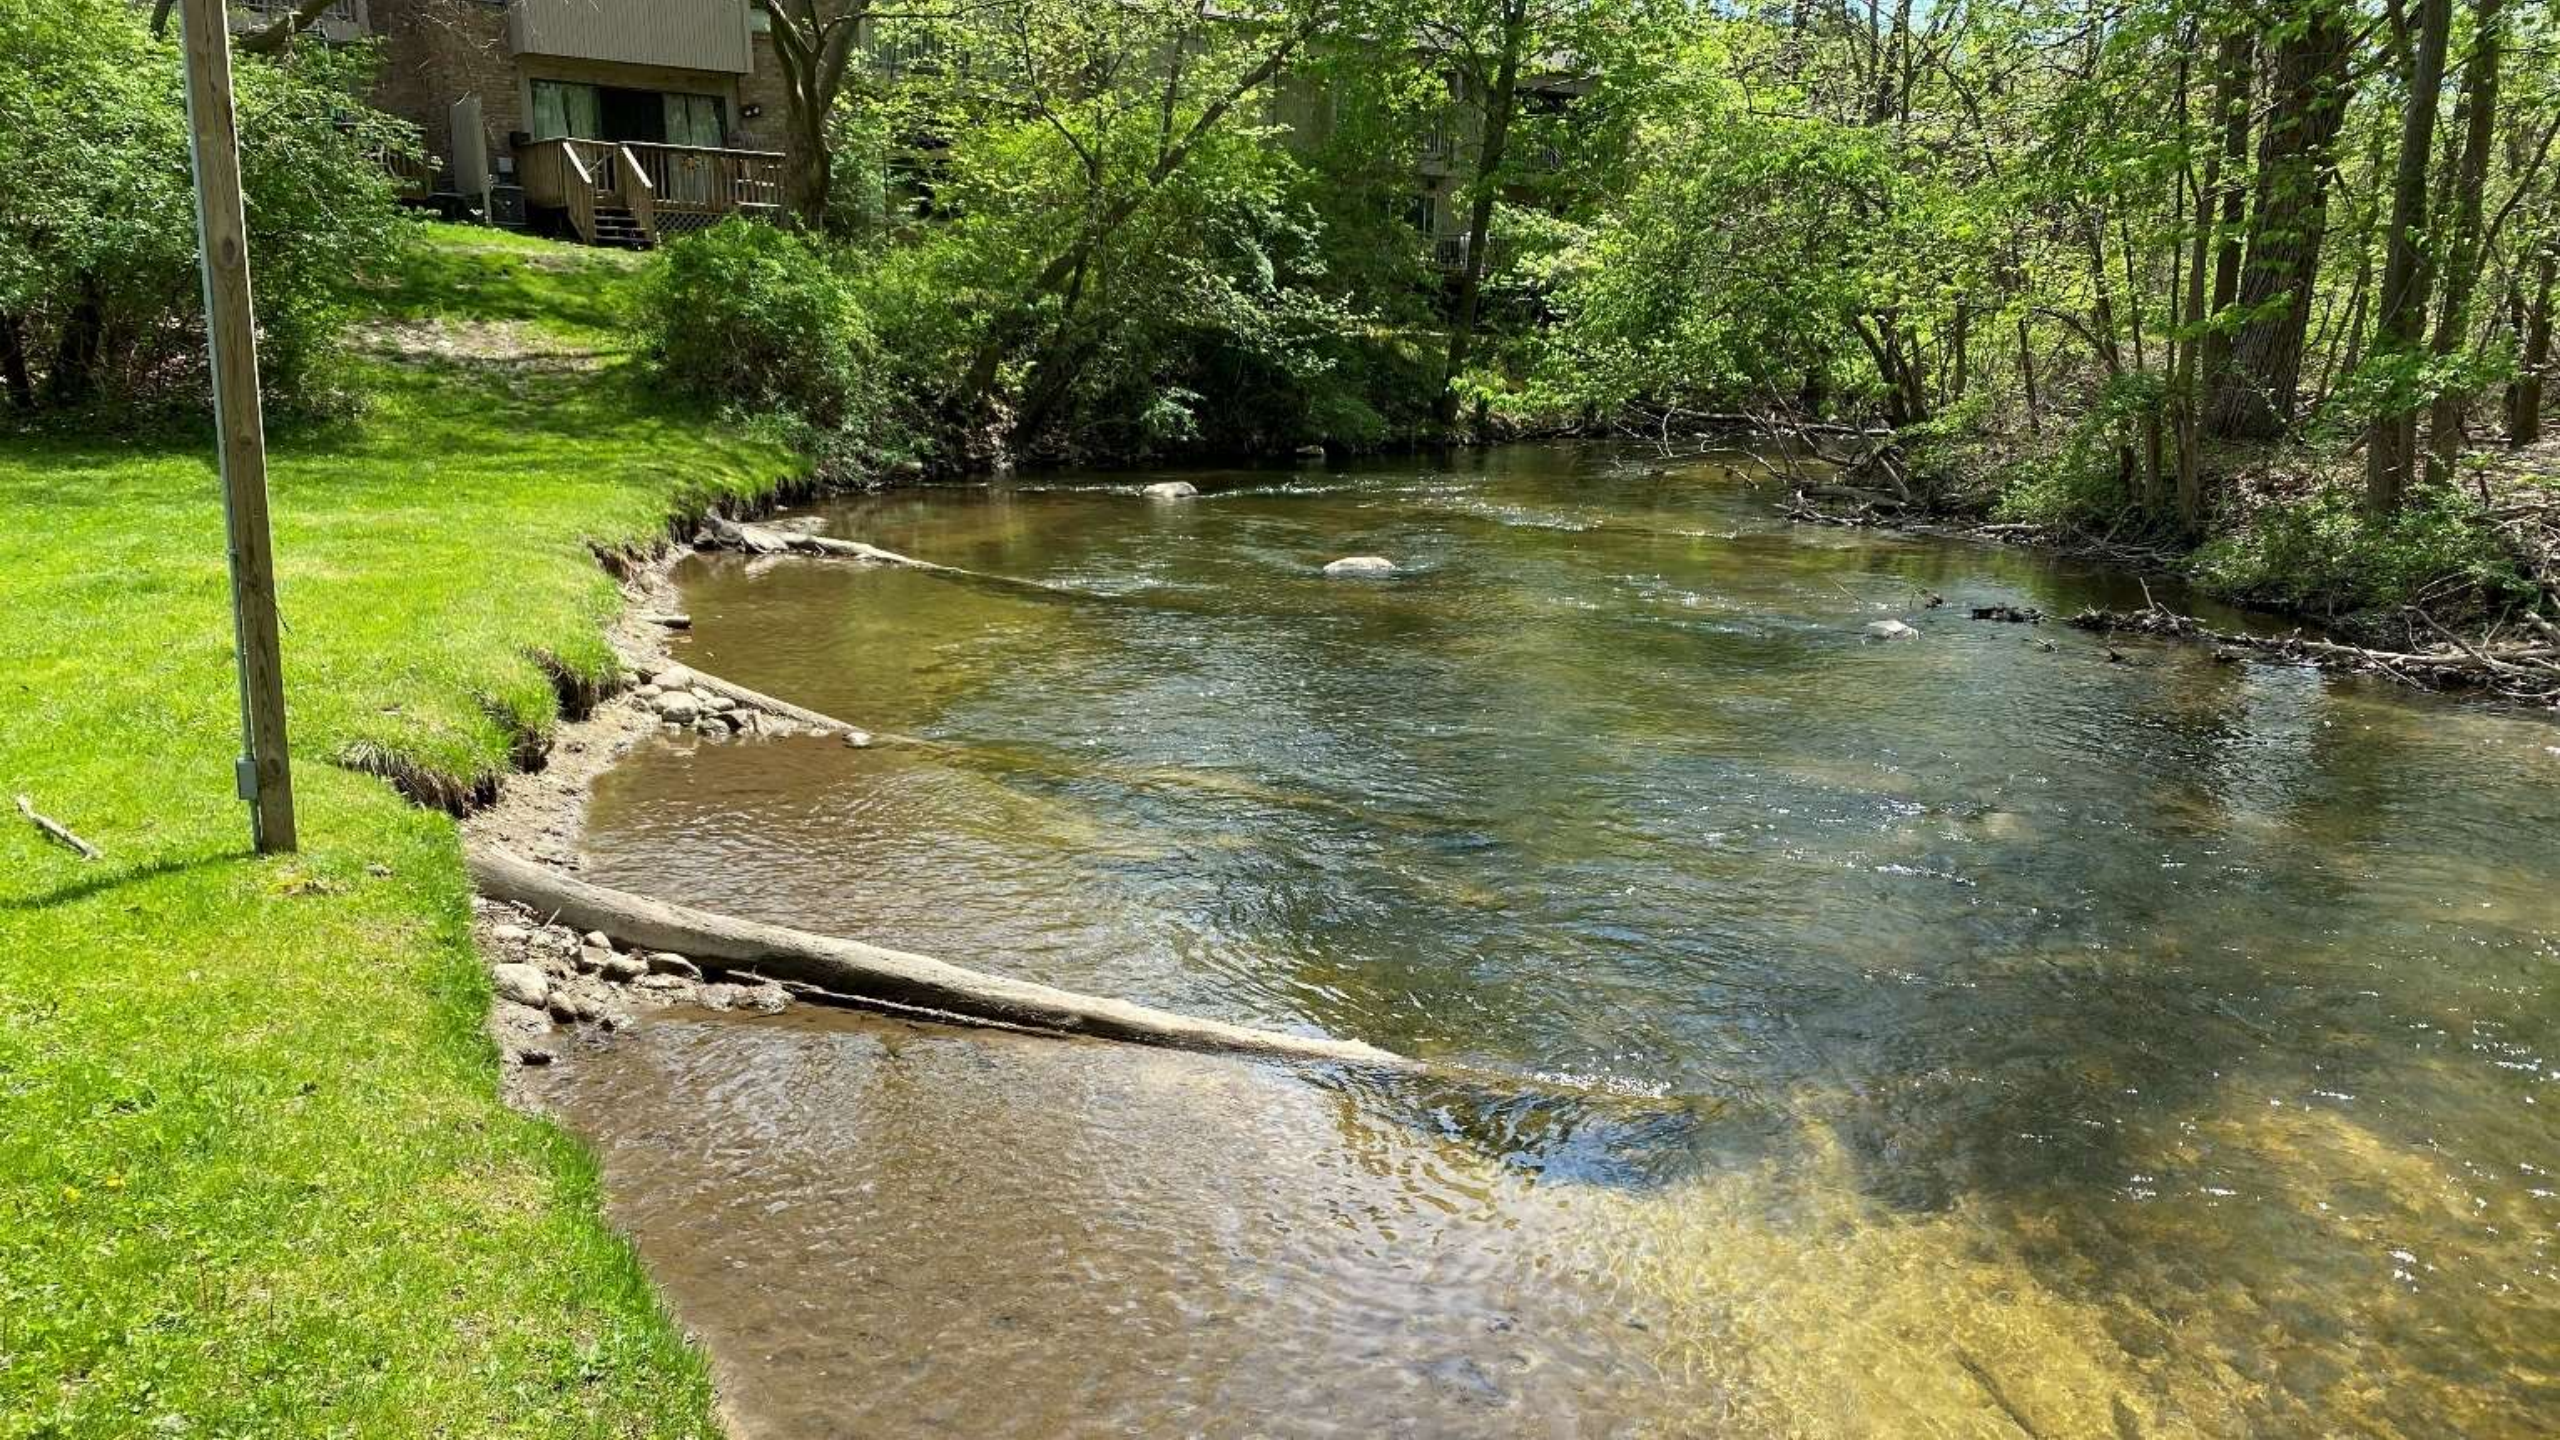
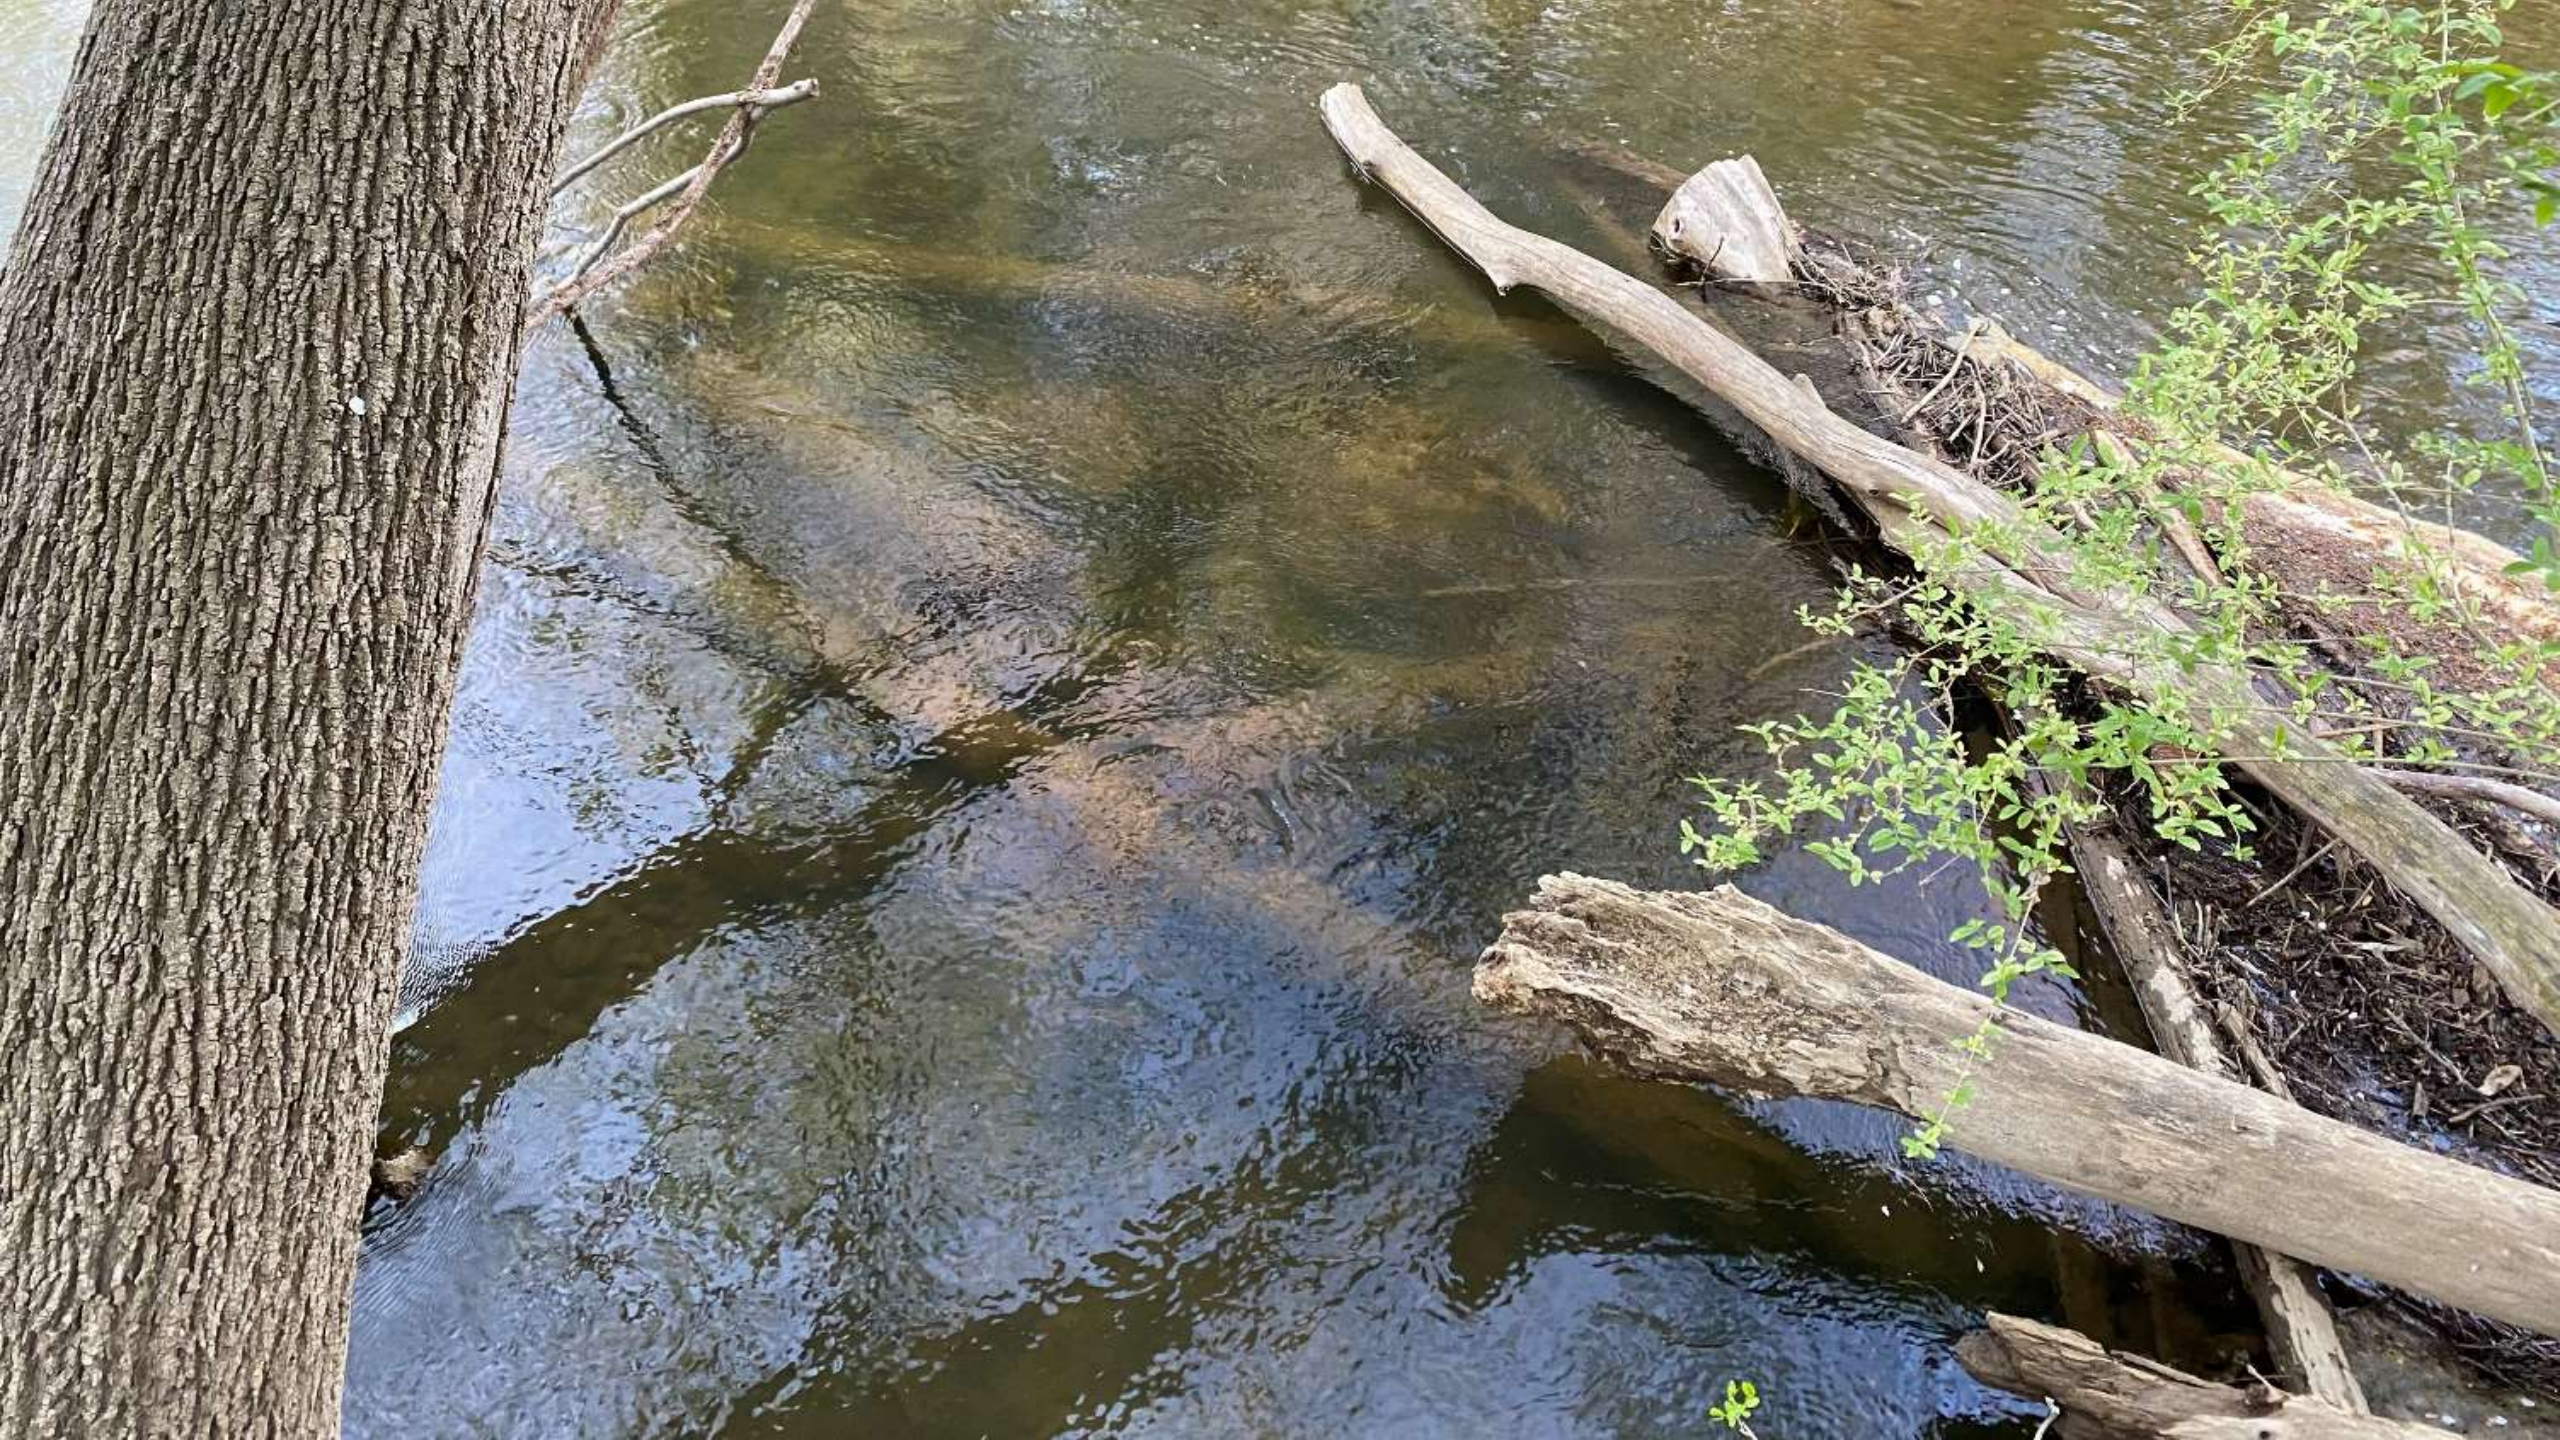
Phase 2

2021 In-Stream Habitat Restoration Work - Tienken Road to Dinosaur Hill Nature Area
