Paint Creek Habitat Restoration Project

2016 - 2022

Vanguard Trout Unlimited
Oakland County, Michigan

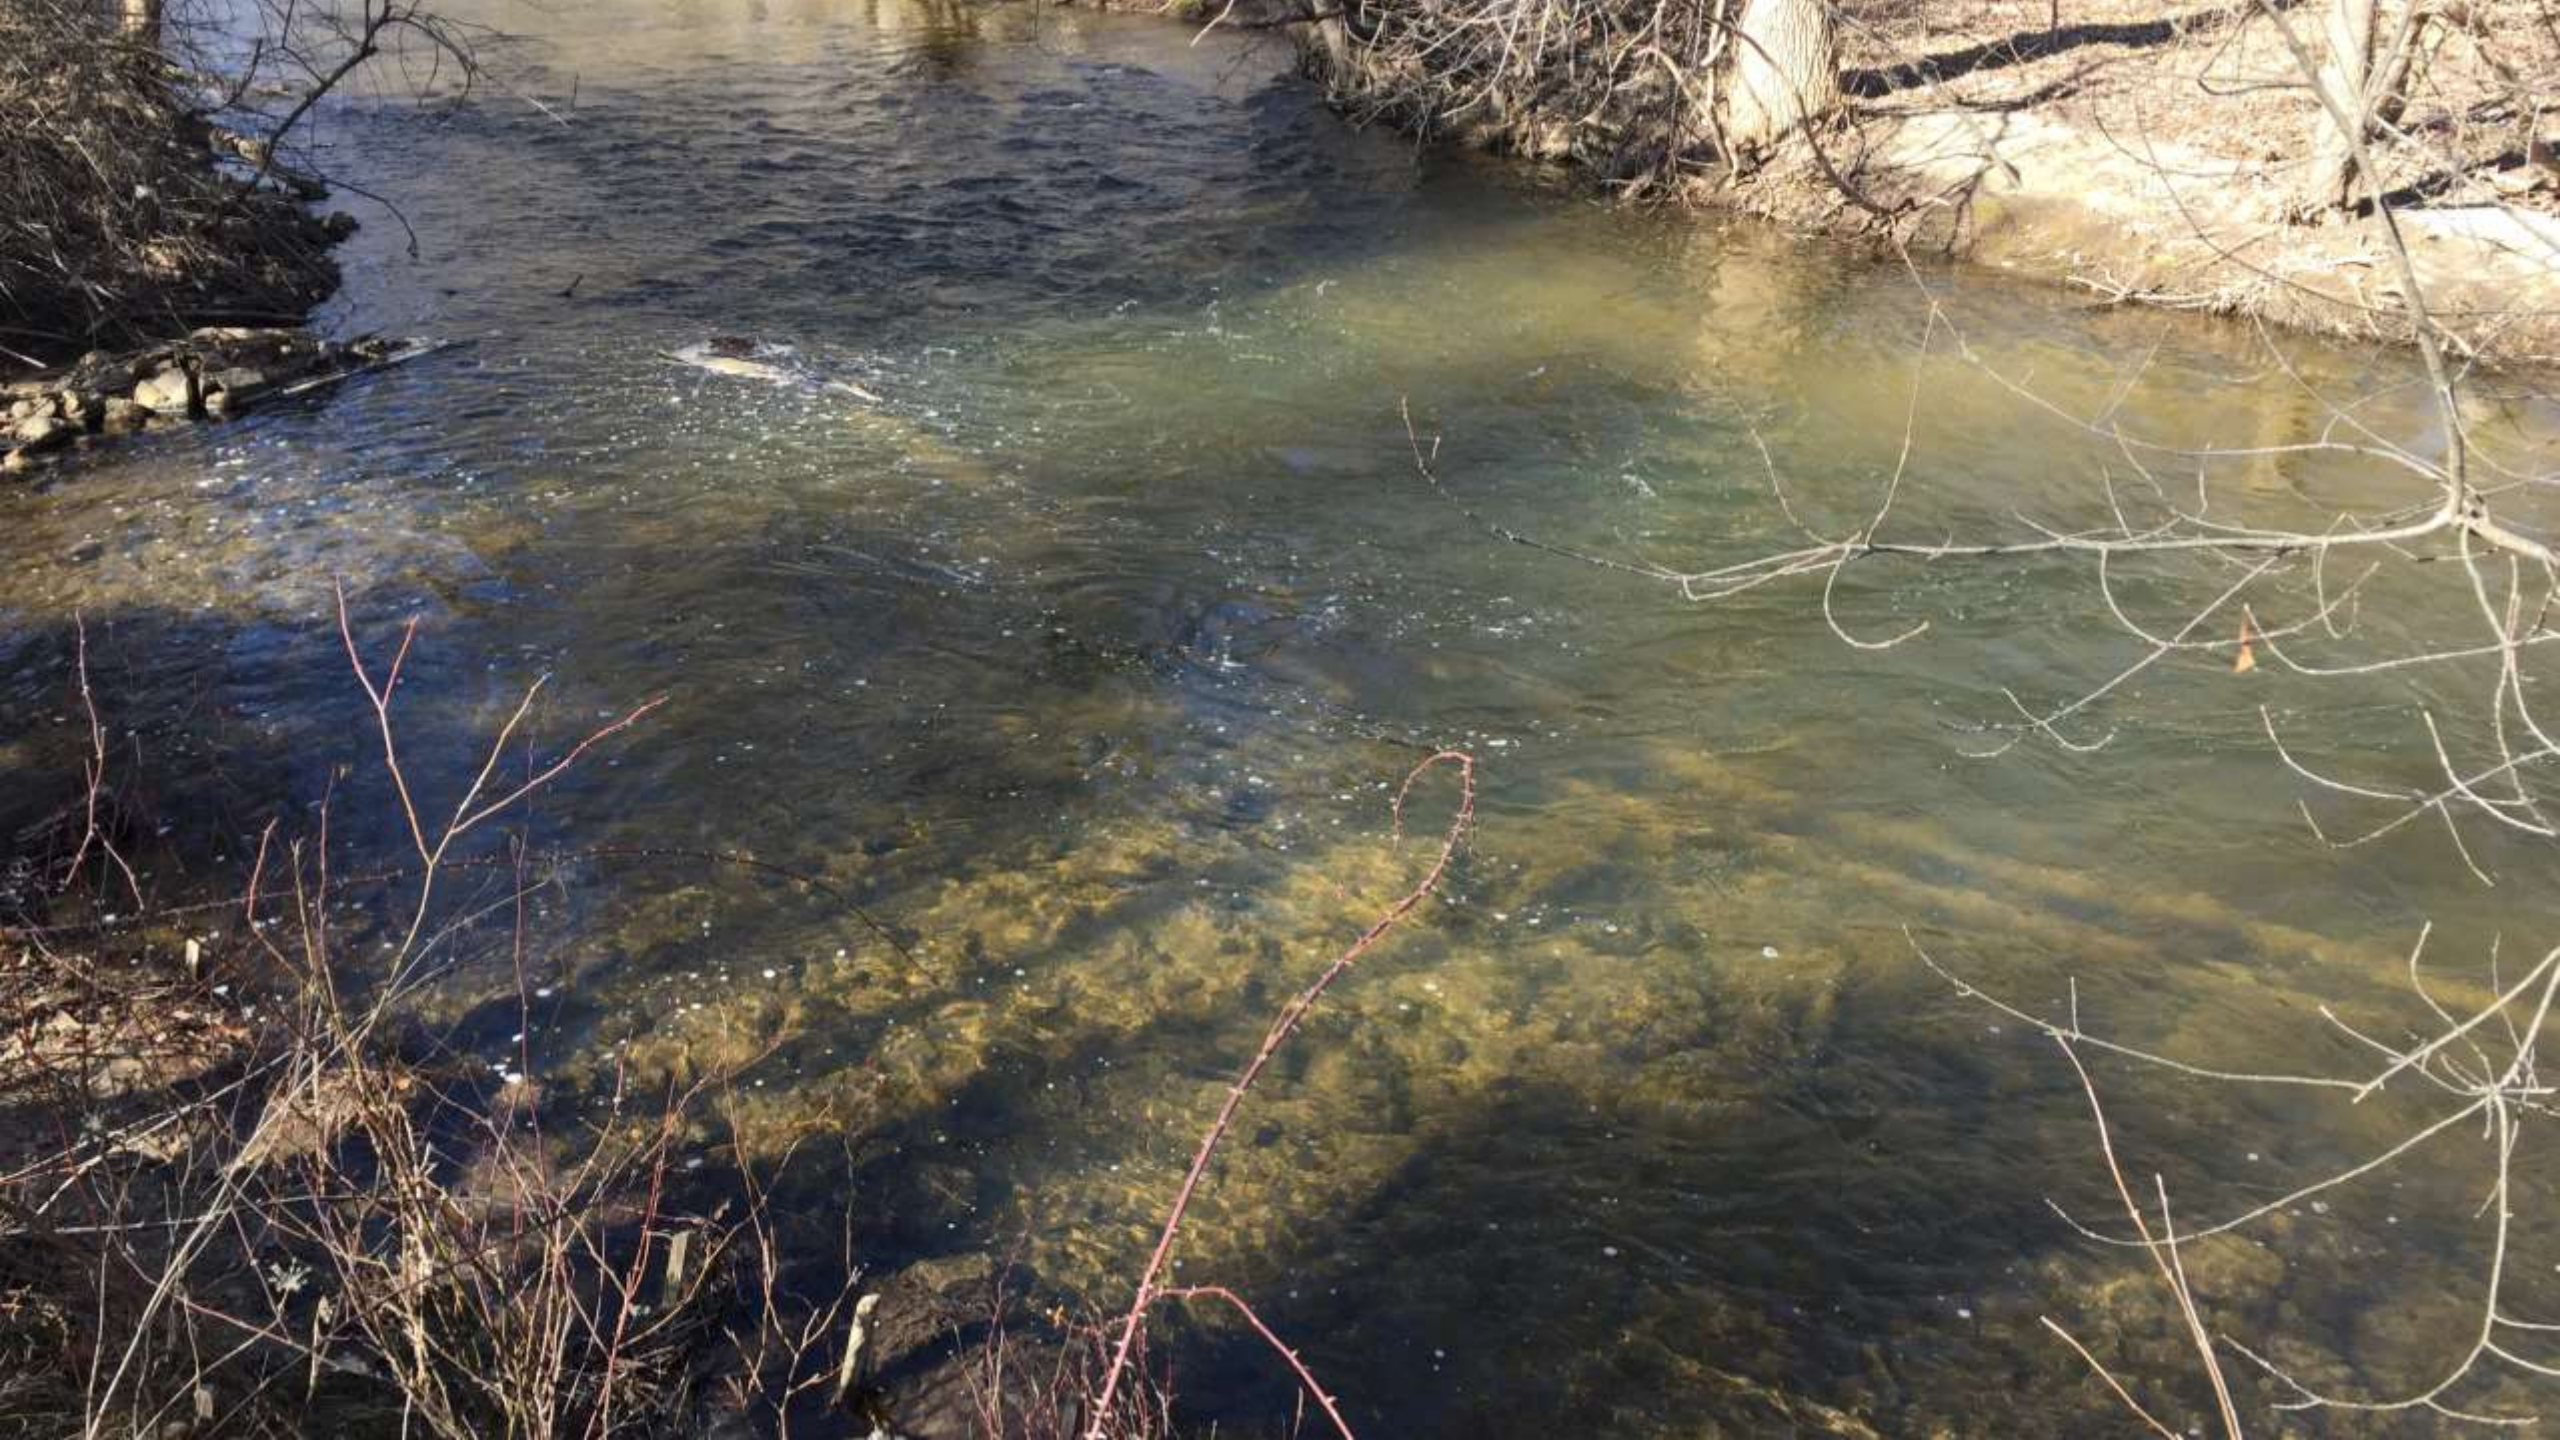
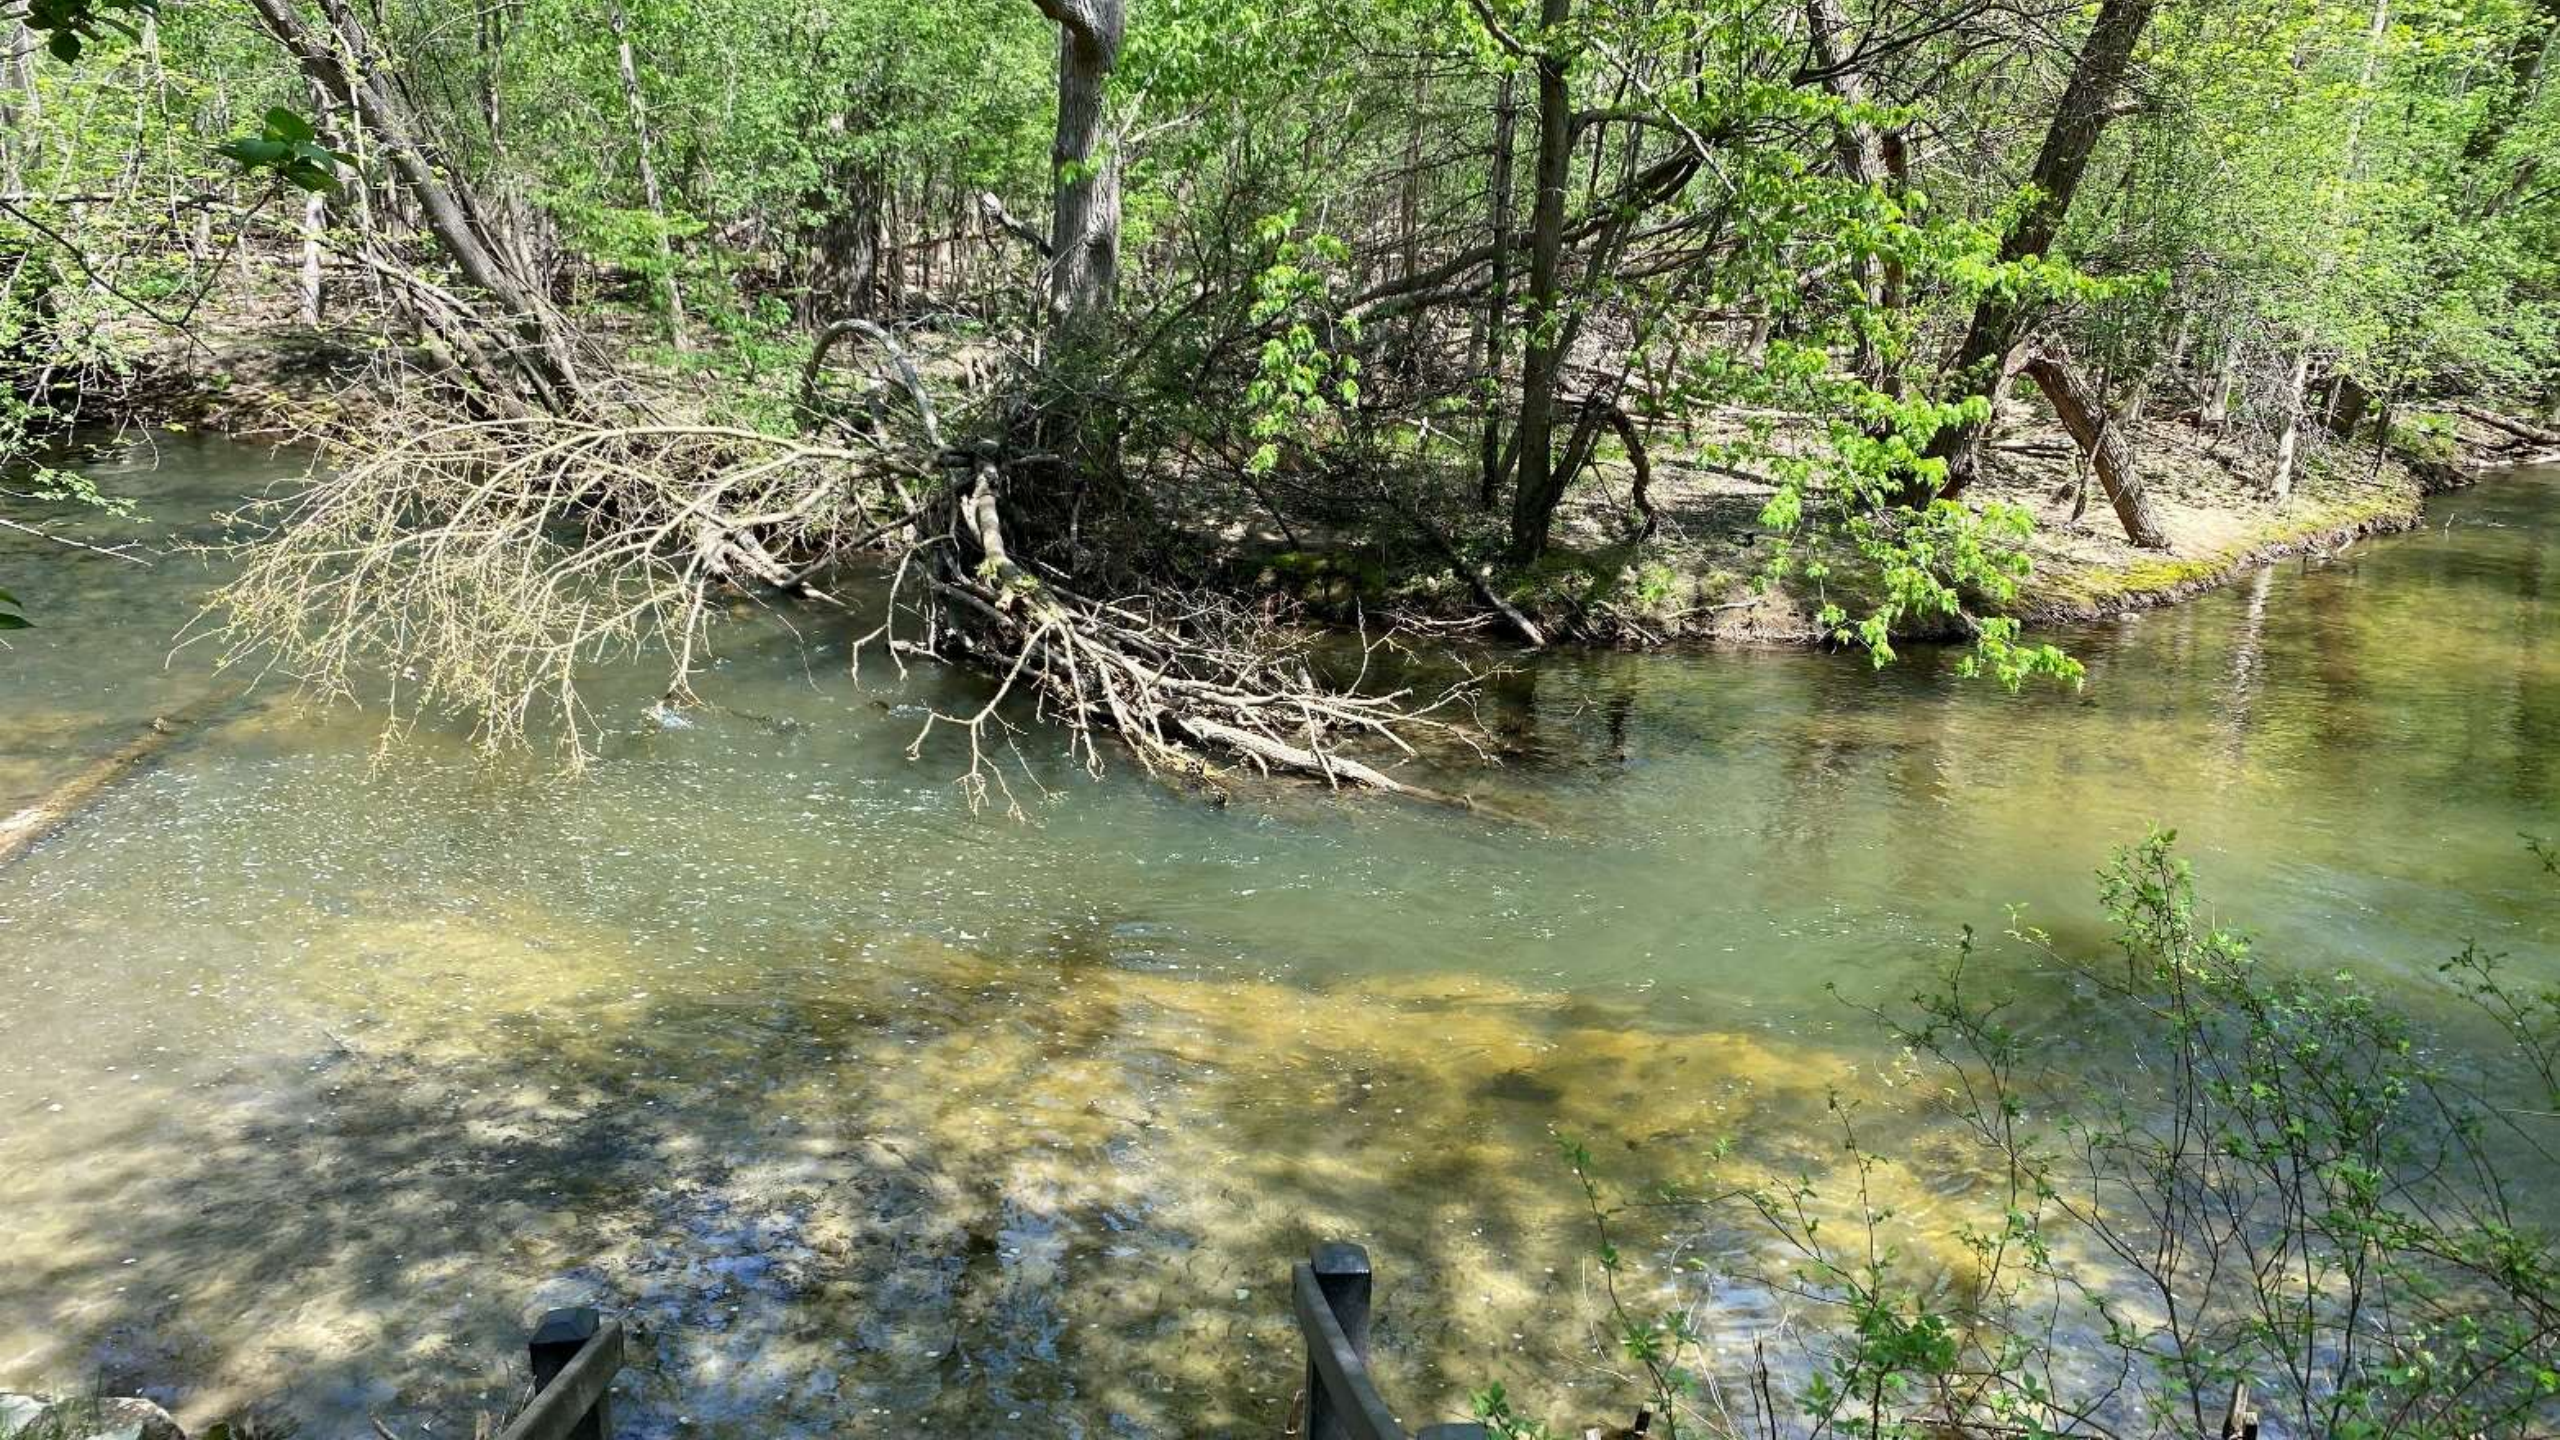
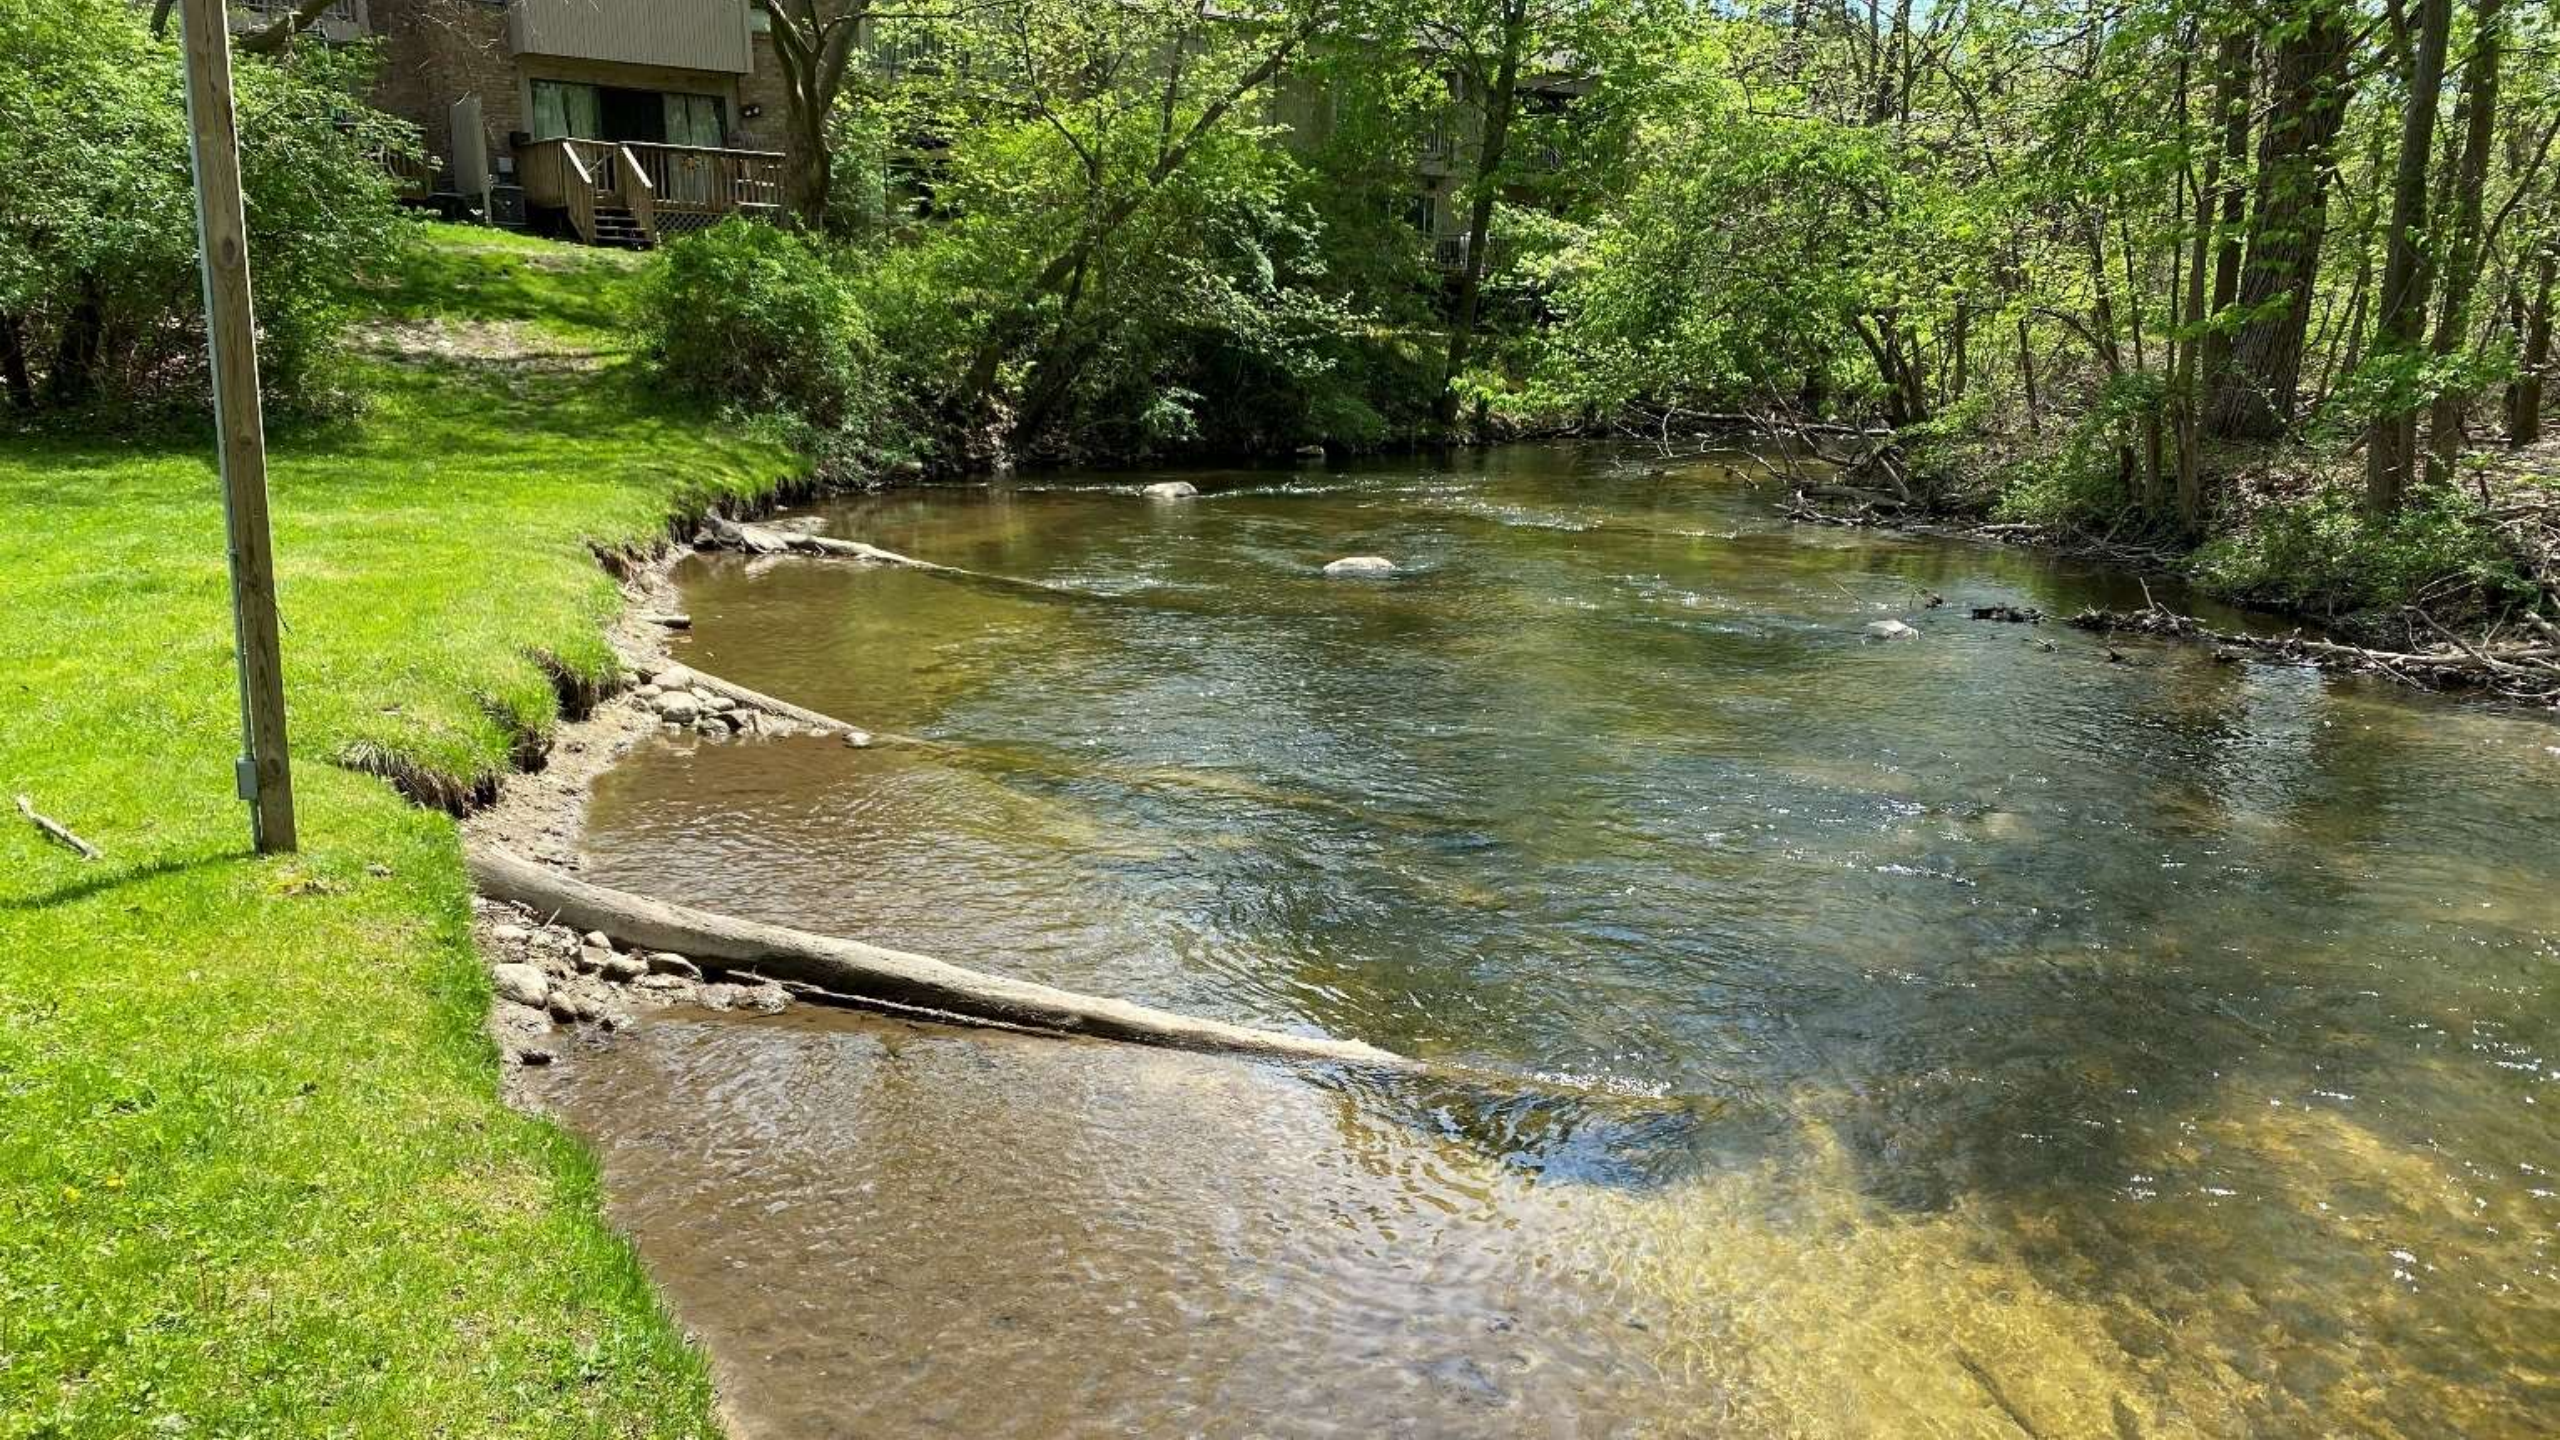
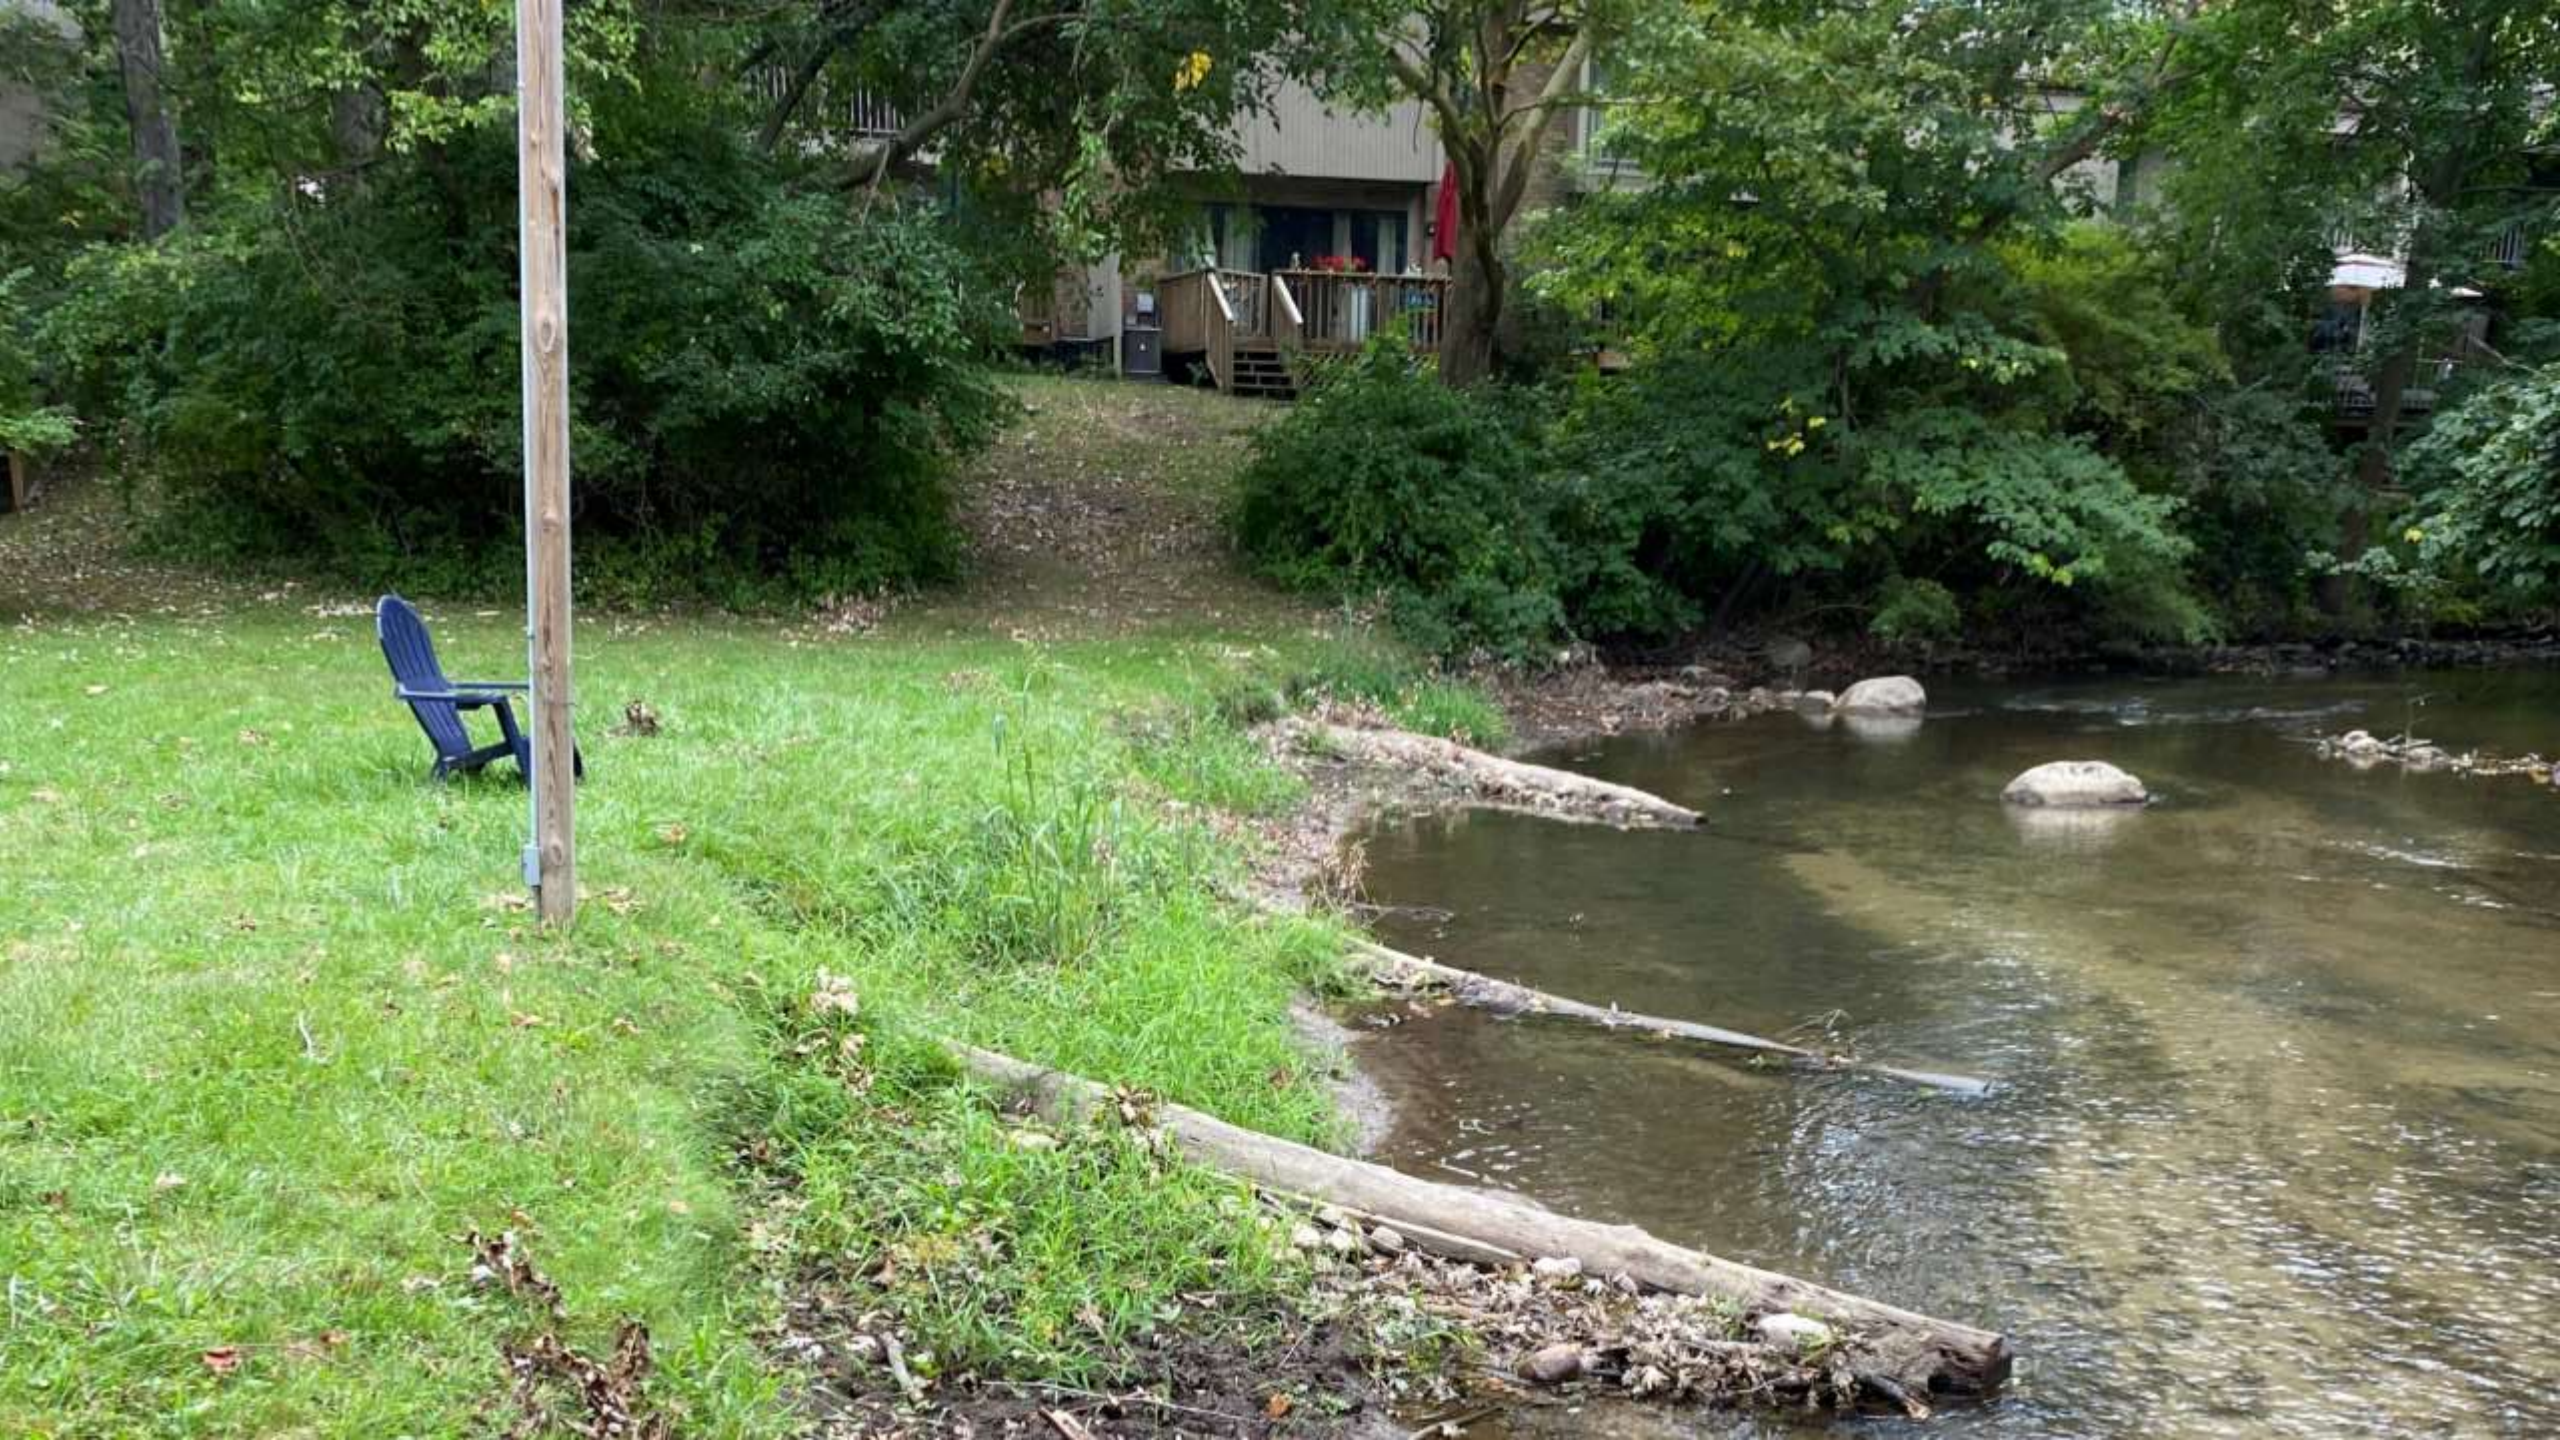
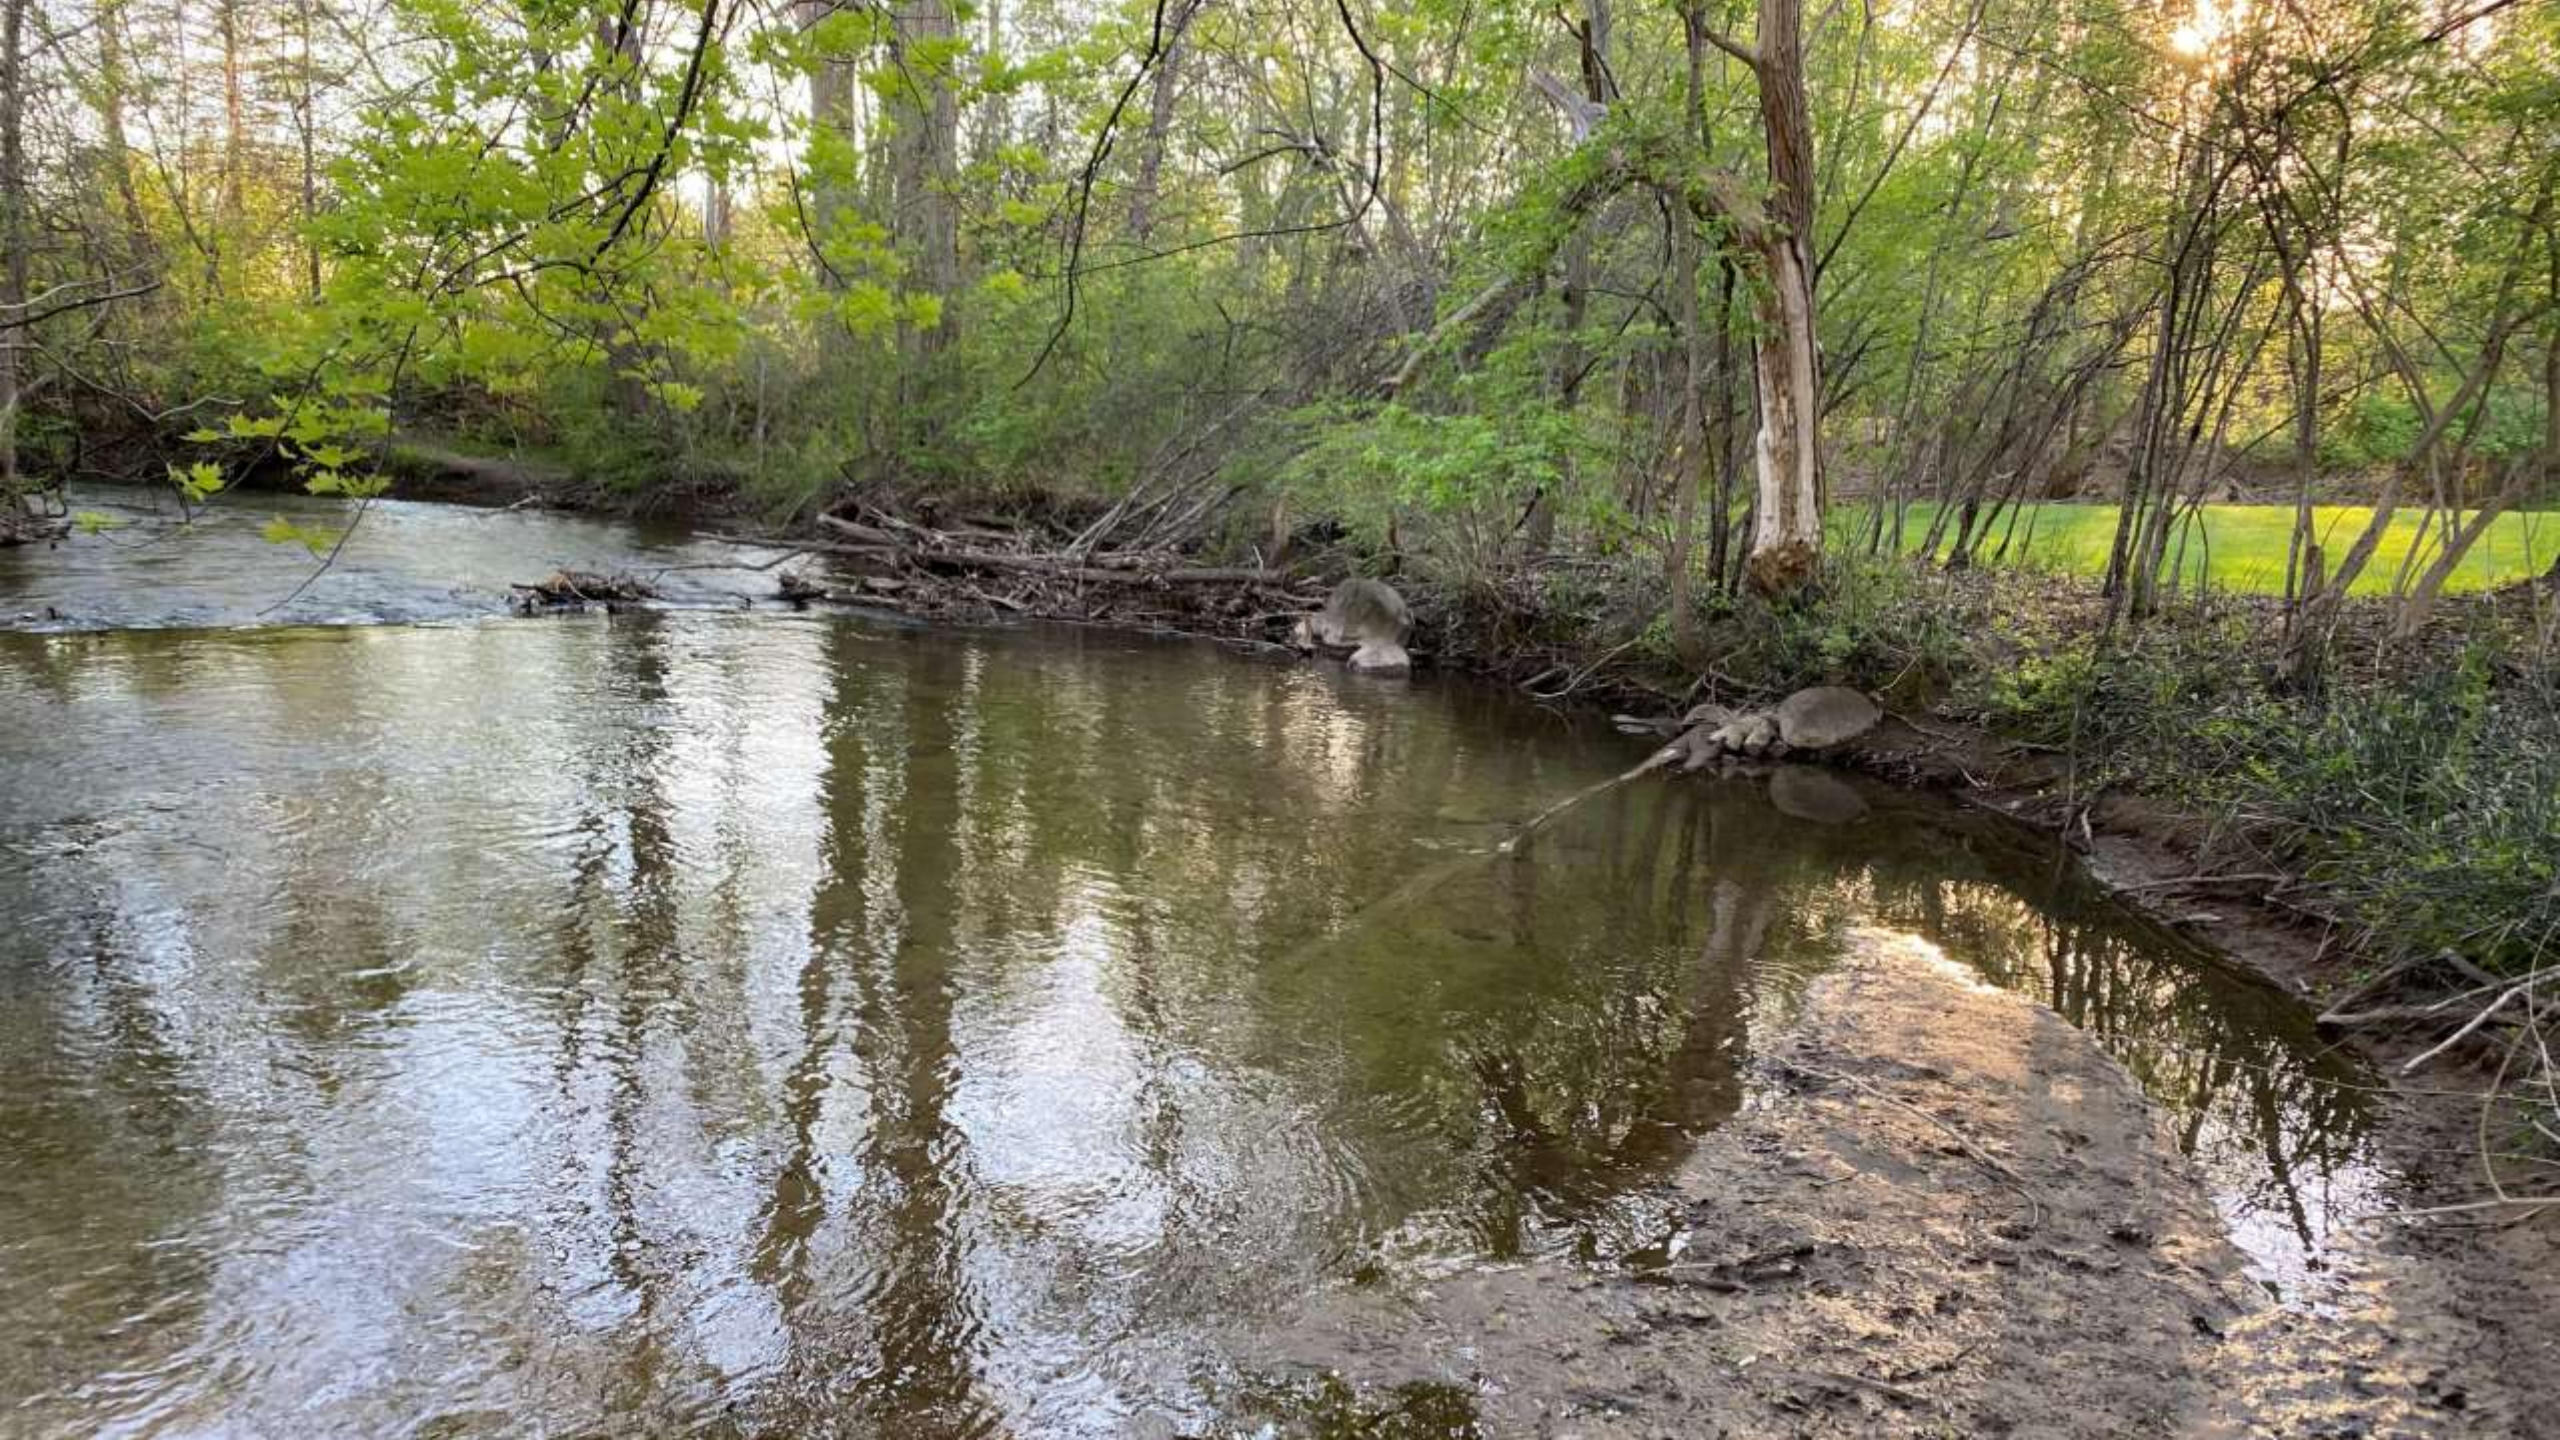
Before and after pictures

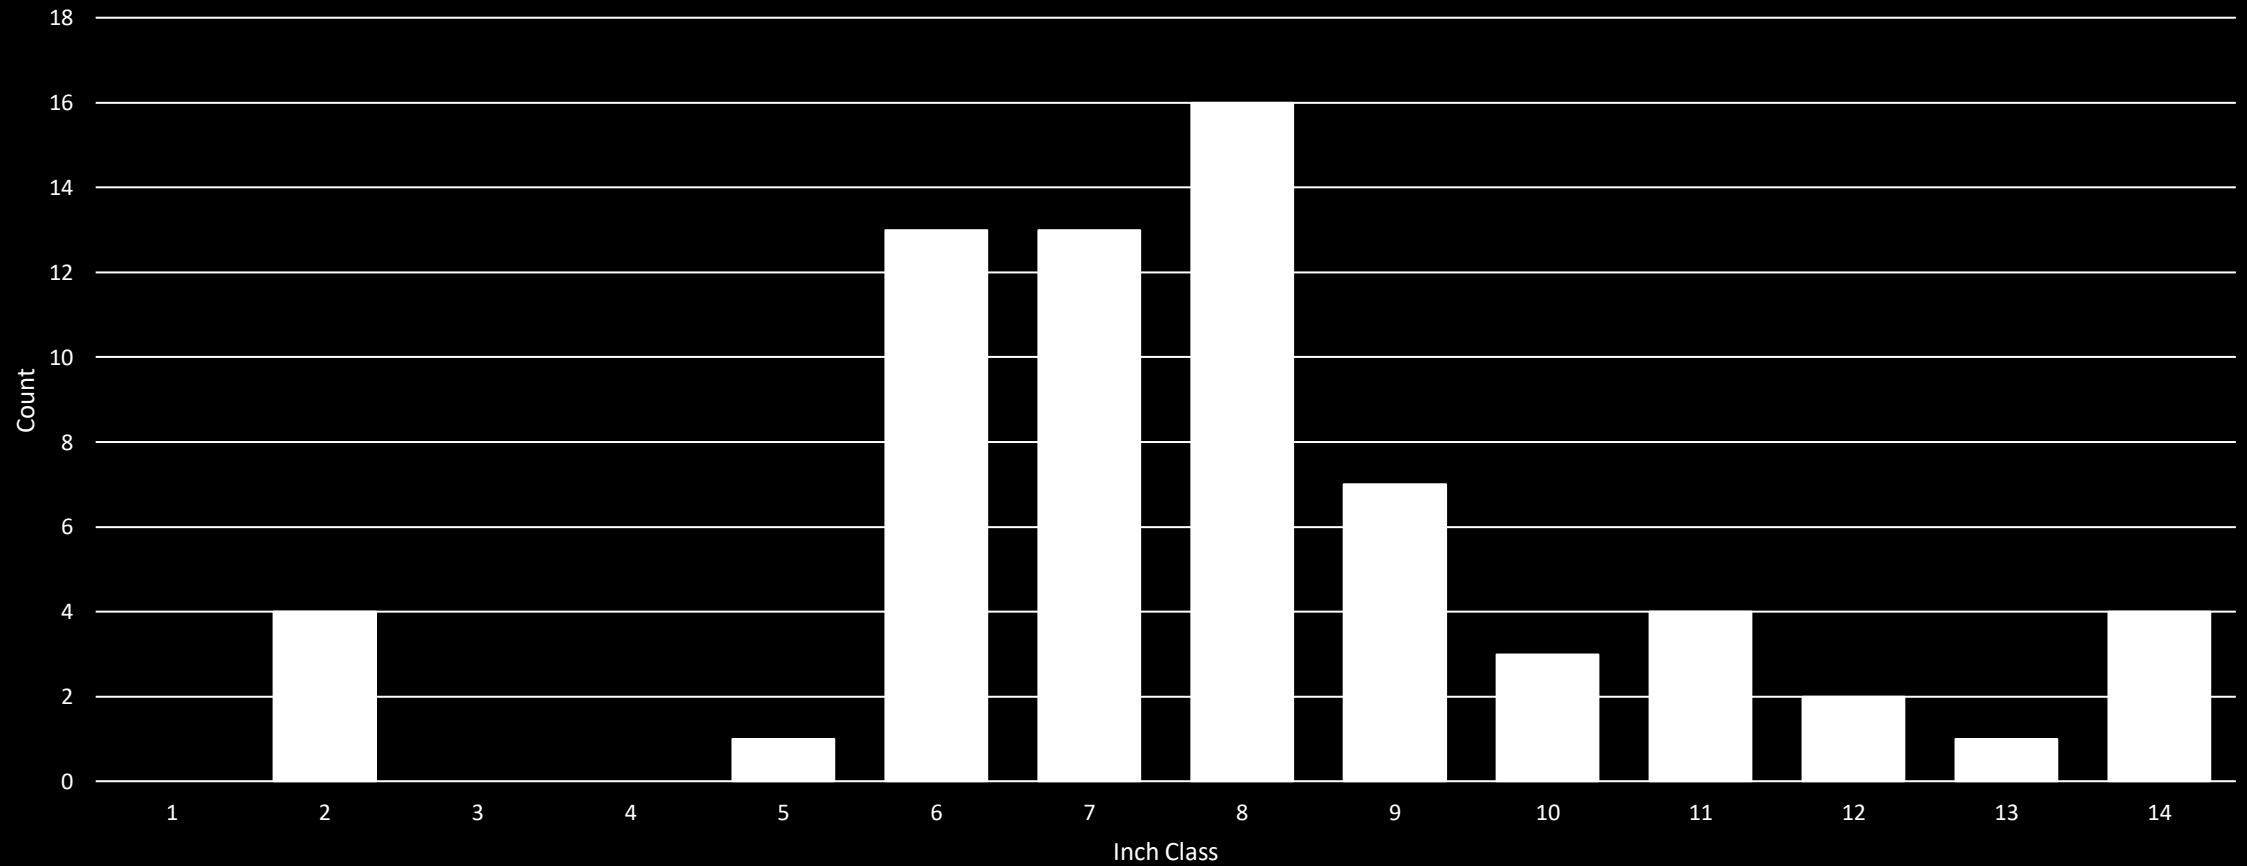
Dinosaur Hill Brown Trout Length Frequency 2019

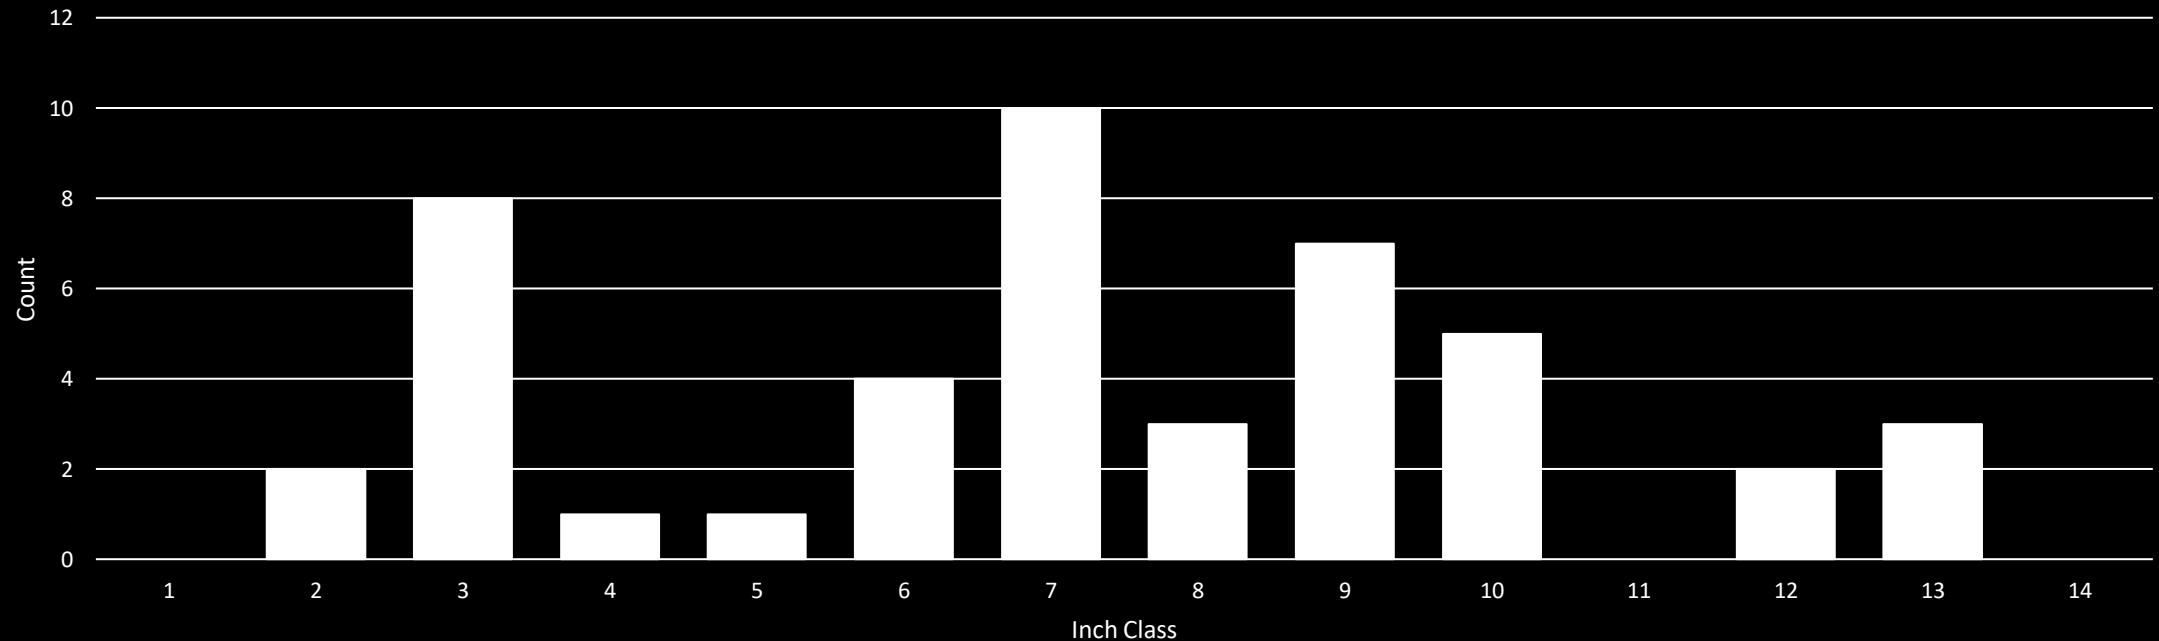
Dinosaur Hill Brown Trout Length Frequency 2020

No annual stocking was done in 2020 prior to this survey yet there are 2 to 4-inch fish. Natural reproduction is occurring!
