Paint Creek Habitat Restoration Project

2016 - 2022

Vanguard Trout Unlimited
Oakland County, Michigan

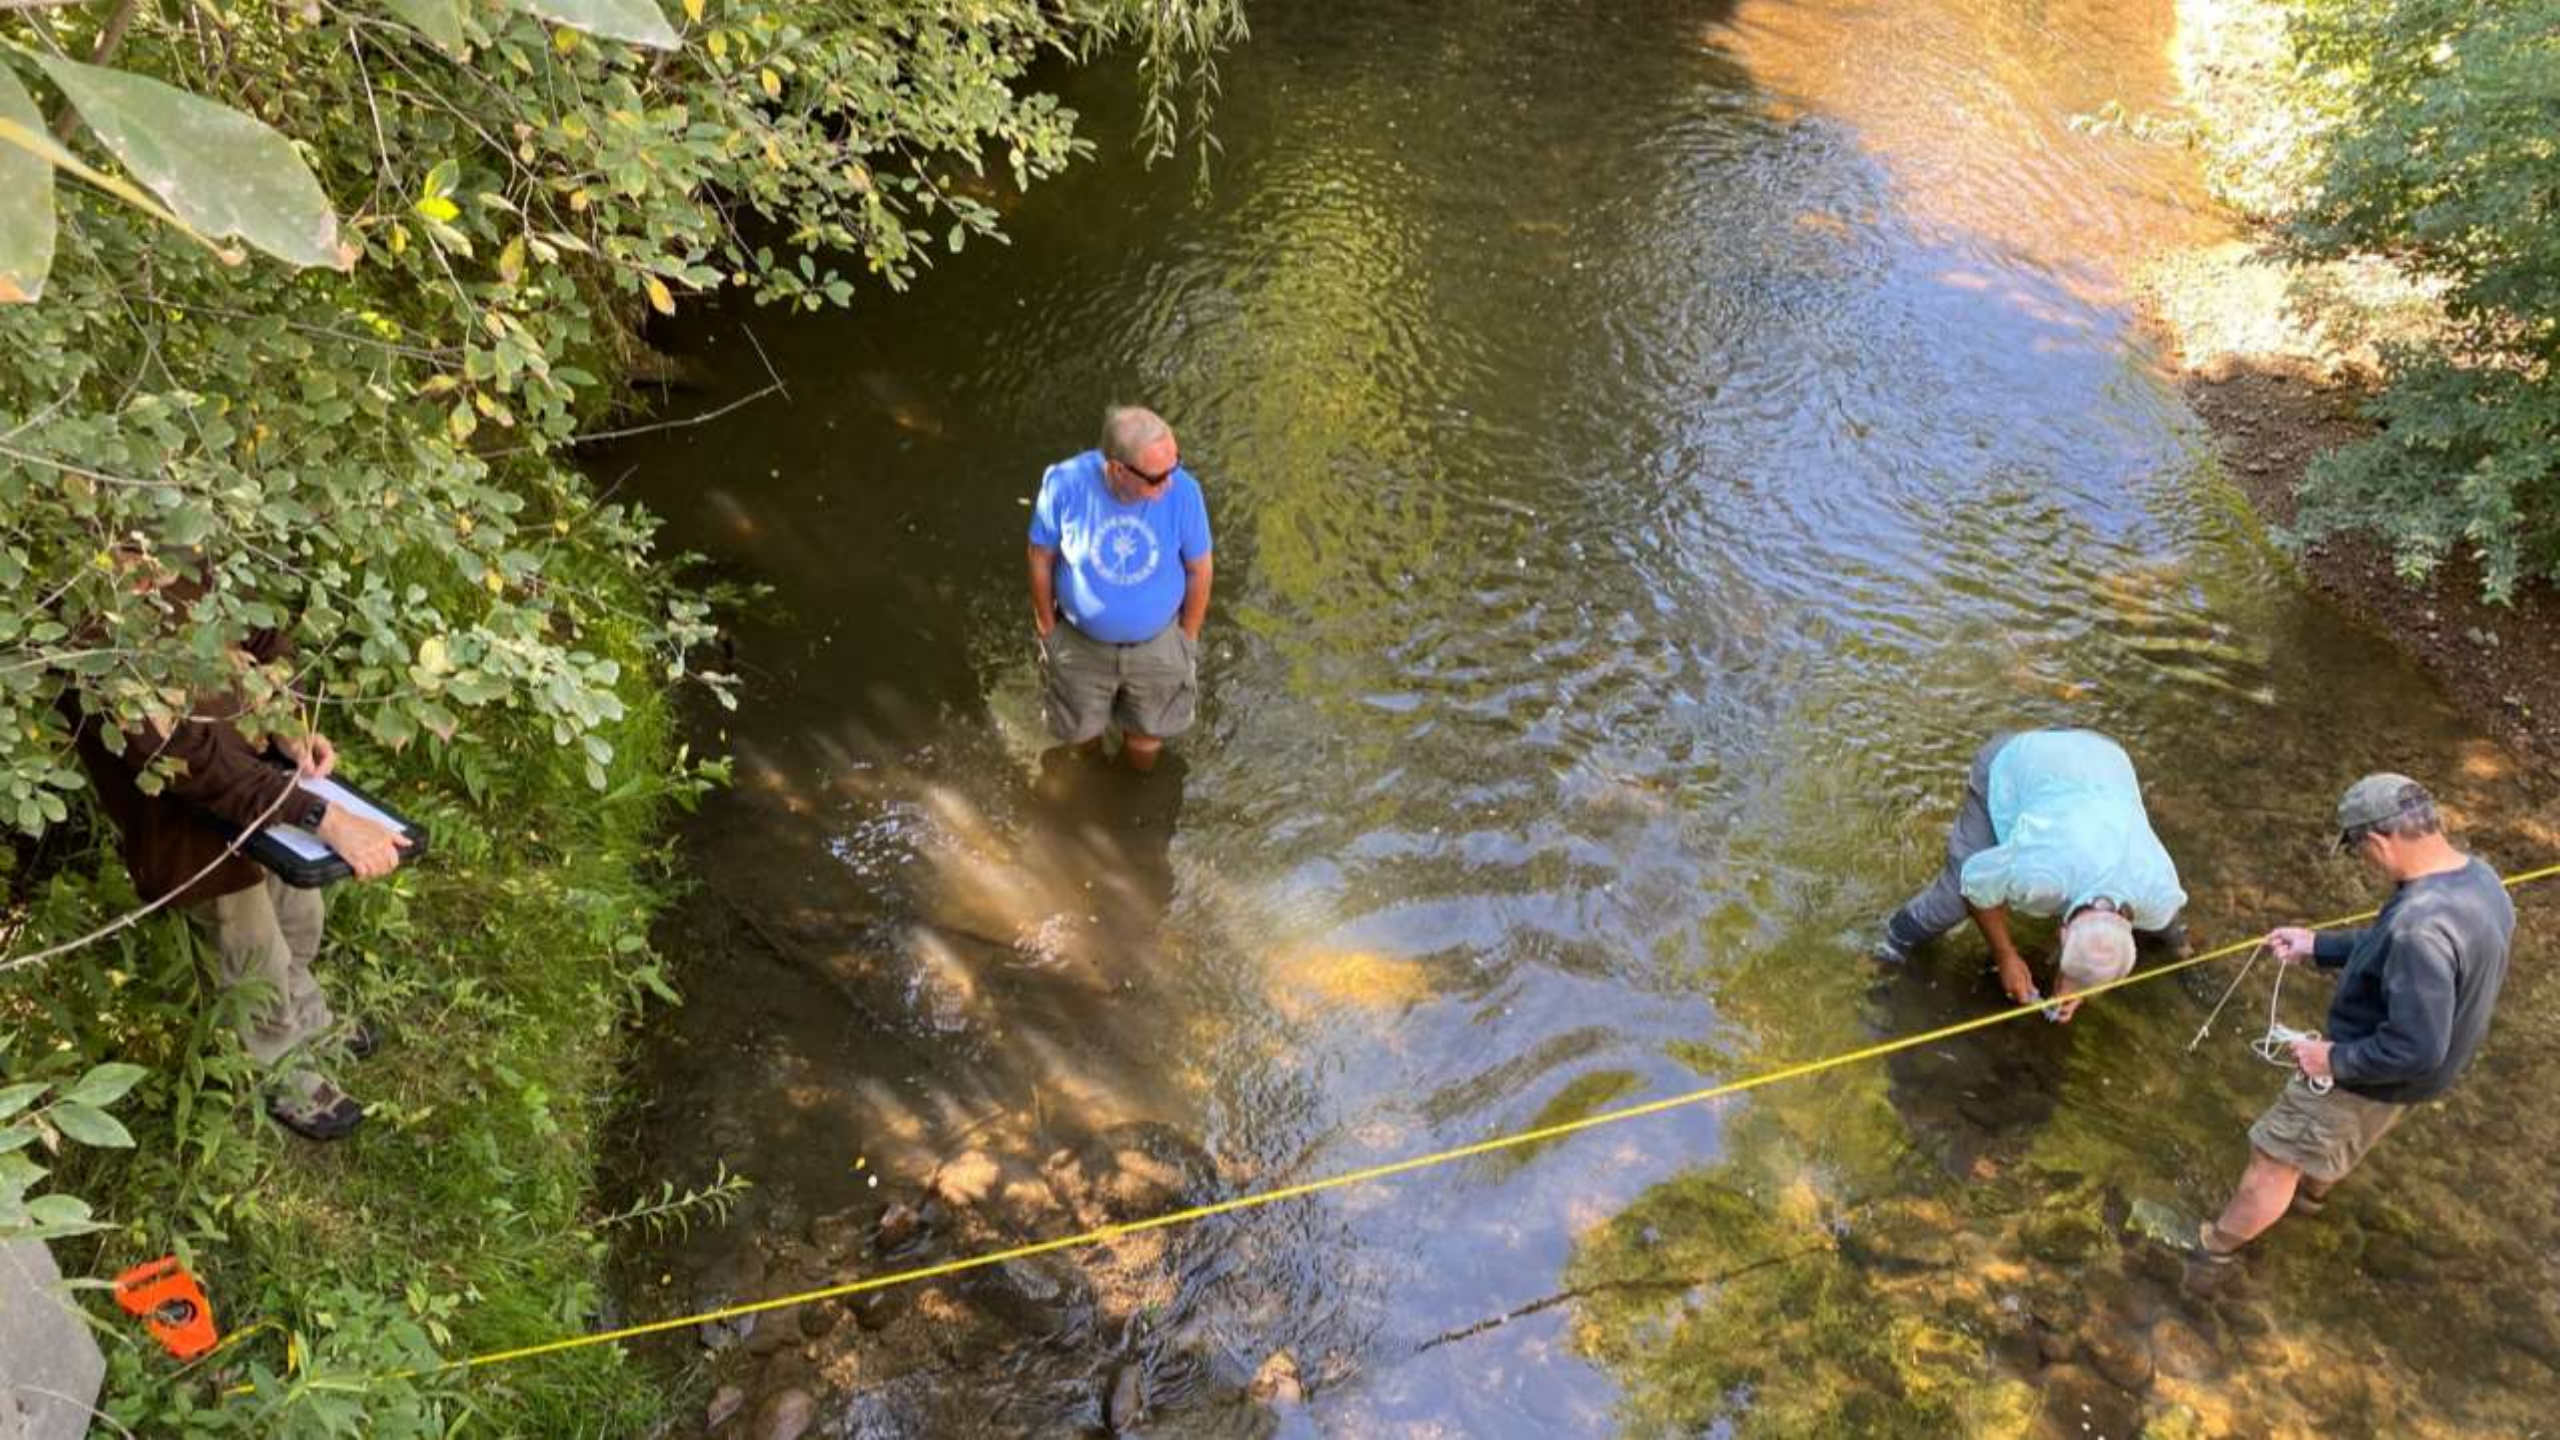
Bi-Annual Sediment Monitoring Surveys

- Four sites are surveyed every other year
- A transect line is made across the stream using a tape measure
- 100 samples are taken at specific intervals based on the current stream width

This data is used by Kristin Thomas to monitor if the stream beds are shifting in composition over time
