Vanguard Chapter – Oakland County Michigan
Paint Creek Woody Habitat Installation – Phase 2
May of 2022

Overview of Phase 2:

The report and photos show the installed Phase 2 in-stream woody debris habitat structures in a section of the Paint Creek that flows through Rochester Hills, Michigan. These pictures were taken in May of 2022, almost a year after installation, to document how the structures survived the winter and the seasonal spring high water events. This report can be compared to a similar one made after the structures were installed in the summer of 2021.

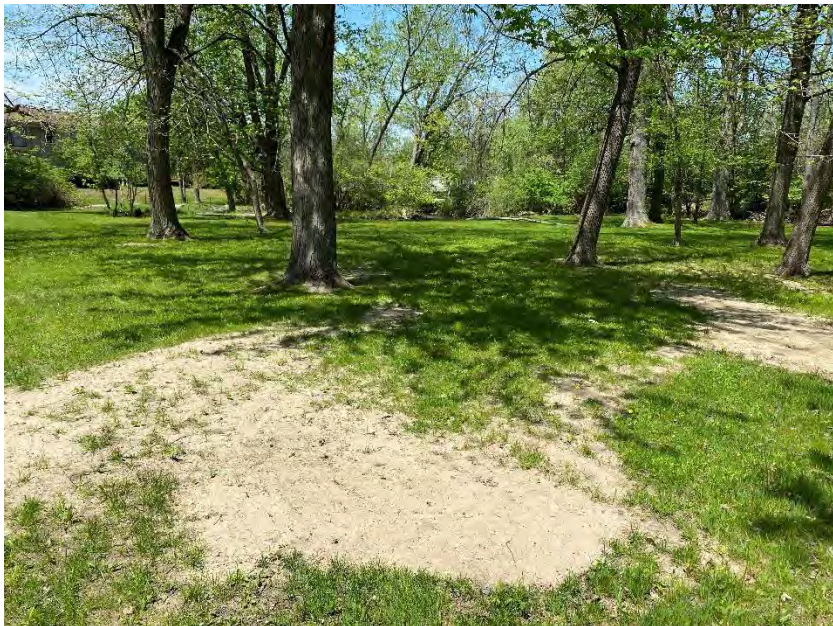
Looking upstream across the “Ox-Bow” where the river crossed and deposited sand as it receded back to the natural creek bed.
